**Preliminary Evaluation and
Engineering Assessment
Renaissance Park Golf Course**

Ratcliffe Golf Services, Inc.

August 9, 2017
File No. 02217302.00

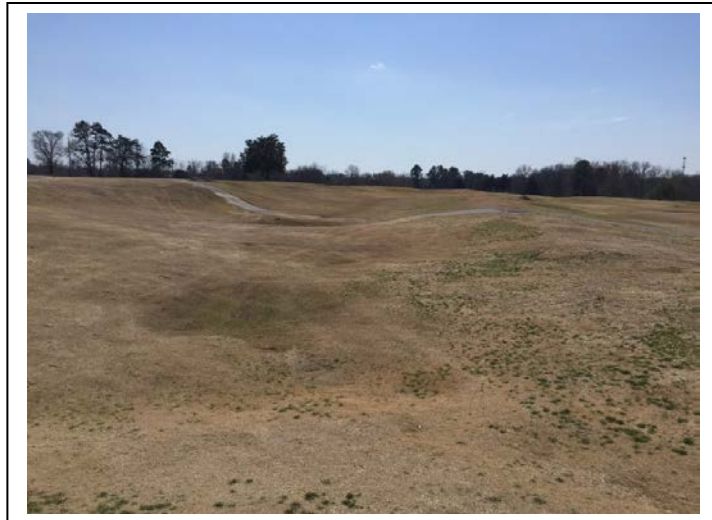
Large differential settlements were observed in Hole No. 1 fairway starting about 200 yards from the green which is manifested in significant grade changes over short distances, depressions (some closed and with ponded water), and appeared hummocky in places. The orientation and magnitude of the settlements suggest “trench-style” landfilling occurred in this location in which case waste depths may vary significantly in short distances.

As shown in the photo to the right, the grade of the cart path is abruptly steep and undulating, which can pose a safety hazard for golf carts rolling over.

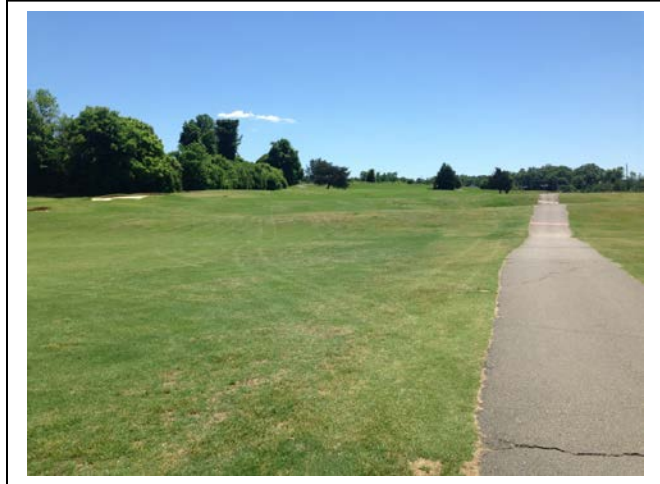
Irregular surface conditions, manifested as including random undulations and abrupt depressions, were observed in the fairway and along the entire cart path on Hole No. 2. The irregular cart path and turf areas make for a very unpleasant and “bumpy” drive in a golf cart, contributes to poor drainage and localized ponding. The resulting sloping lies, localized depressions and ponding negatively impact the playability of this hole, which is regarded as poor.

The settlement pattern suggests the waste was disposed as an “area fill” as opposed to trench fill like Hole No. 1.

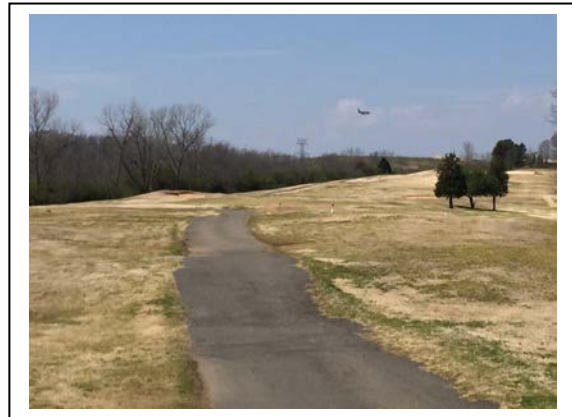
Differential landfill settlement and poor drainage has caused obvious damage to the cart path near the tee box at Hole No. 4. The turf areas in this area also has signs of excess landfill settlement and poor drainage, while the paved cart paths show distress from settlement in the form of open cracks, loose pieces of pavement, small dips and undulations. In addition, the landfill settlement in Hole No. 4 fairway negatively impacts drainage and playability.

The playability of the green at Hole No. 4 has been negatively impacted by landfill settlement over the years. Similar the change in grade at the green on Hole No. 1, MCRP personnel report the No. 4 green now slopes from left to right, but used to slope right to left.

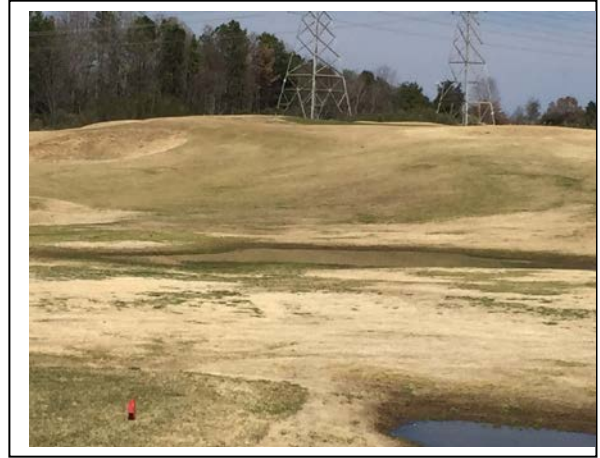
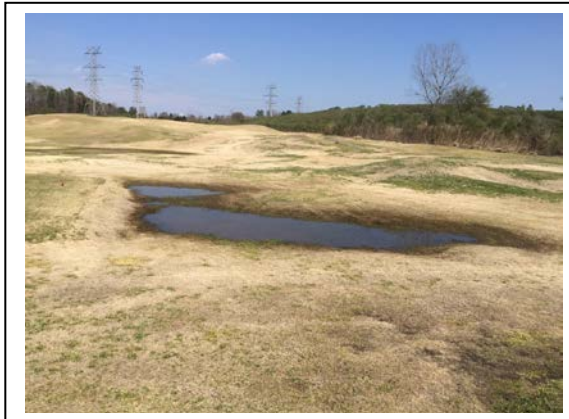
Numerous circular-shaped closed depressions, some including ponded water, were observed at Hole No. 5's tees and fairway on this par 3. The ponded water is unsightly (murky and silty), results in soft ground conditions, poor vegetative growth and are breeding areas of insects and thus not desirable for many reasons. Ponded water on a landfill is not good.

The photos below were taken on the tee box looking towards the green. While such depressions occur in most landfills, regardless of waste depth variations, and usually results from localized and variable compression properties or types of waste disposed, the resulting depressions are not conducive to a golf course.

Due to localized variations in waste composition, properties and depths, localized settlement is common and results in depressions and can collect surface drainage water. This subsequently leads to infiltration of water through the soil cover and ultimately into the underlying waste, which increases the moisture content of the waste and increases the rate of organic decomposition. This "cycle" will continue until ponding of liquid is eliminated.

This option could be used to repair depressed areas with ponding (such as Hole No. 5). This option could also be used to re-construct tee boxes. The costs for the routine grading and maintenance option will be a function of the future settlement rates and the volume of material required to re-grade areas.

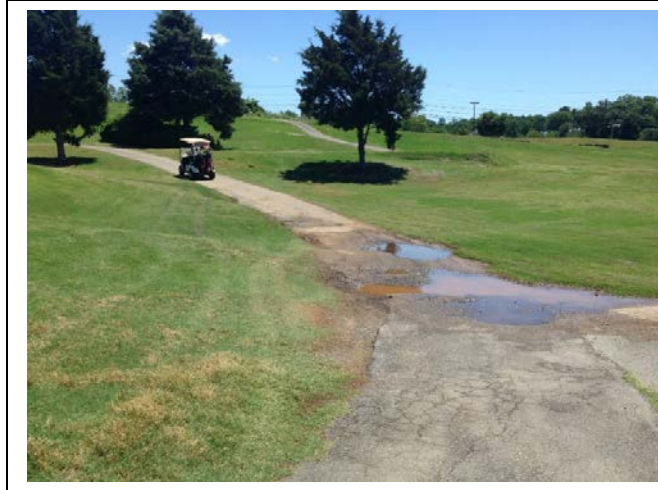
At Hole No. 8, the cart path has cracked pavement, settlement and poor drainage which impacts the playability of this hole.

Similar to the fairway on Hole No. 2, the turf areas on Hole No. 8 are irregular, poorly shaped with abrupt depressions. Drainage on this hole is poor due to settlement and the turf in the fairway is saturated. Stressed vegetation was also observed on this hole which may be caused by landfill gas intrusion into the root zone.
