Public Participation

Vision for Center Street

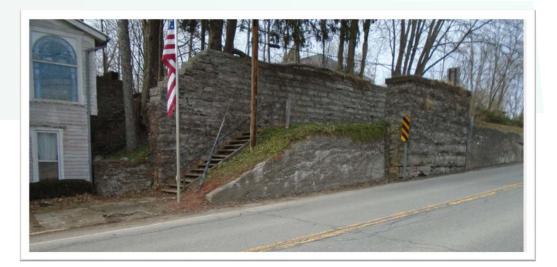
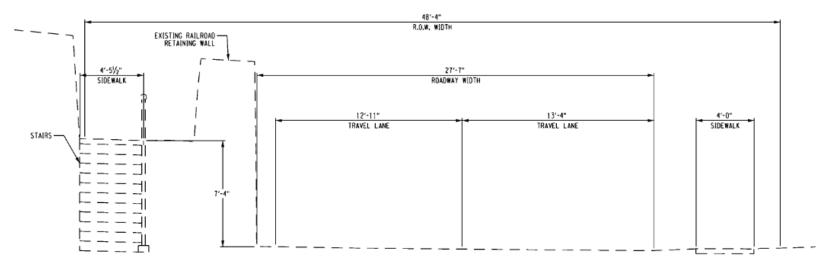
CROSS SECTION 1
SOUTH CENTER STREET AT RR RETAINING WALL
NOT TO SCALE

Unique Design Challenges

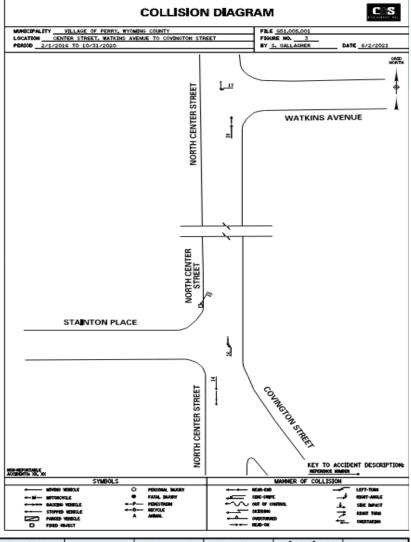
- Traffic Volume & Accident Analysis
- Accidents rate along corridor is about 14% above the Statewide Average

Entire Year Analysis	Total # Accidents	AADT ¹	Segment Length	Total Acc Rate	Avg Acc Rate ²	% > AAR
Center Street Segment				·		
South Main Street to Village Line	27	4514	1.1	3.10	2.72	14%
