**Greenbag Road Improvement Project
Environmental Assessment
Monongalia County, West Virginia**

State Project: U331-857-0.67
Federal Project: STP-0857(019)D

August 2020

ENVIRONMENTAL ASSESSMENT

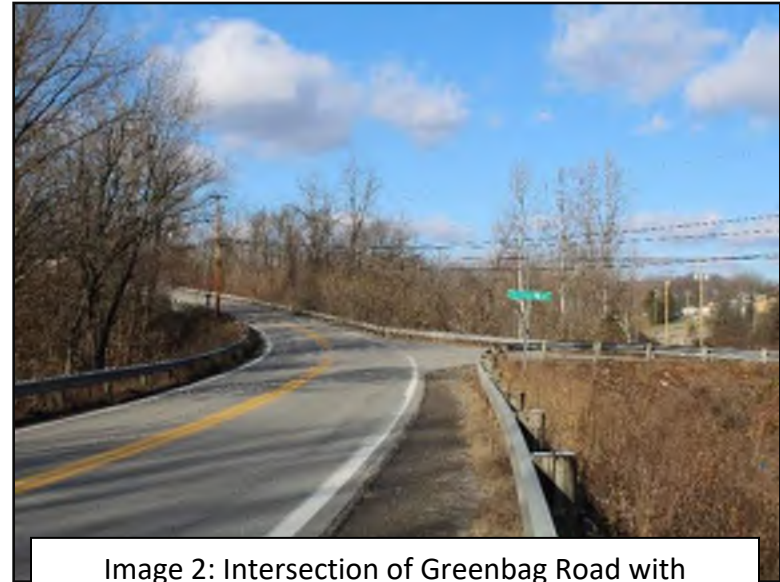
Image 2: Intersection of Greenbag Road with Mississippi Street

Traffic congestion in the Greenbag Road (CR 857) corridor has been investigated and documented in two different reports. The preliminary study was completed by the MMMPO and documented in the *Greenbag Road Corridor Study* (2015). The WVDOH developed a project based on recommendations from this study as part of the Roads to Prosperity program. The WVDOH directed Stahl Sheaffer Engineering to develop designs for the Project which included a traffic study titled *Greenbag Road (CR857) Preliminary Investigation and Engineering Traffic Study* (2019a). Both the MMMPO corridor study and the traffic study determined that traffic flow through the Greenbag Road (CR 857) corridor is controlled by the *level of service (LOS)* at the major intersections in the corridor. These major intersections include the Mississippi Street (CR 857/1) intersection (**Image 2**) and the Dorsey Avenue/Kingwood Pike (CR 81) intersection (**Image 3**).

With one exception, the current traffic conditions operate at LOS D, which is considered acceptable; however, expected growth in the region will negatively impact the flow of traffic and degrade the LOS at both intersections to LOS F. The traffic congestion at the major intersections will continue to extend farther back until impacting the surrounding intersections at M Tec Drive, Bluegrass Village Driveway, and Luckey Lane (CR 81/6). The exception to the current LOS is for the southbound traffic on

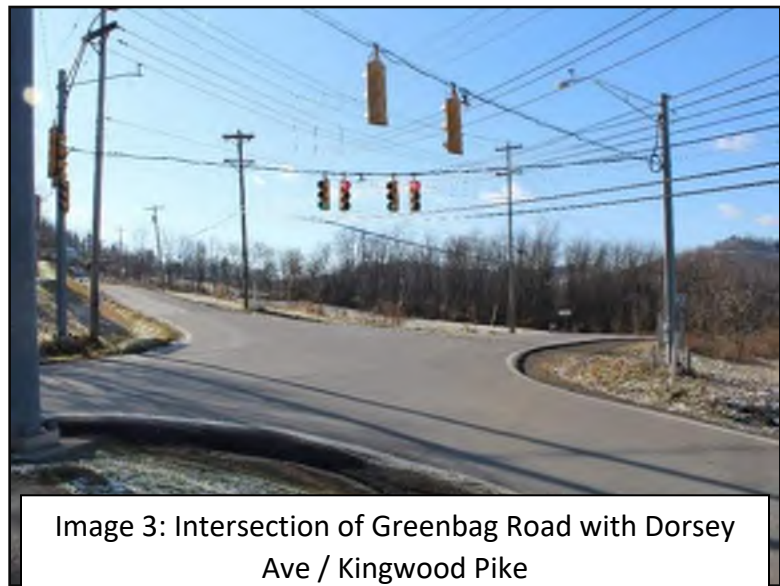
Image 3: Intersection of Greenbag Road with Dorsey Ave / Kingwood Pike

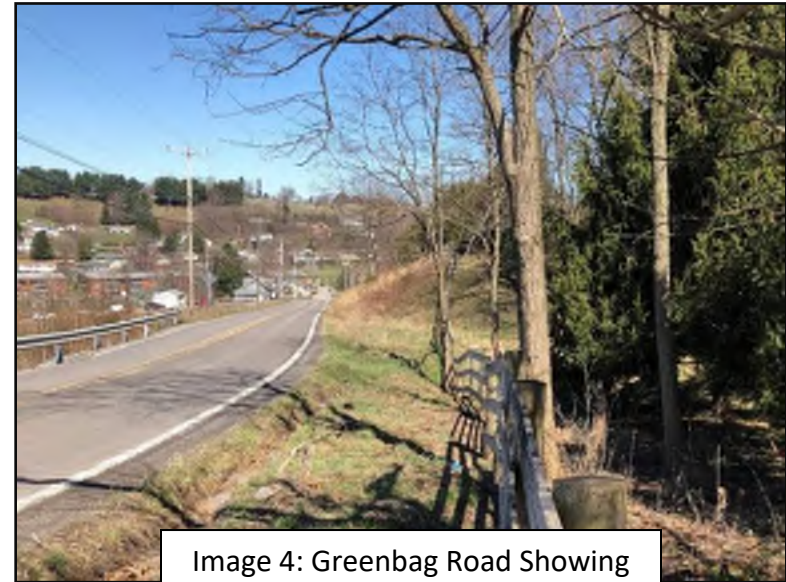
Image 4: Greenbag Road Showing Lack of Safe Pedestrian Facilities

Numerous neighborhoods and facilities, including the Mountaineer Mall, Giant Eagle, the Mon Tech Education Center, White Park, Dorsey’s Knob Park, Bluegrass Village, South Middle School, and Mountainview Elementary School, are located close to the Greenbag Road (CR 857) corridor and do not currently have safe connections for non-motorized travel (**Image 4**). Community involvement in the development of the MMMPO Corridor study report identified pedestrian facilities to connect the neighborhood schools with the commercial and residential areas as a key issue for community safety and access.

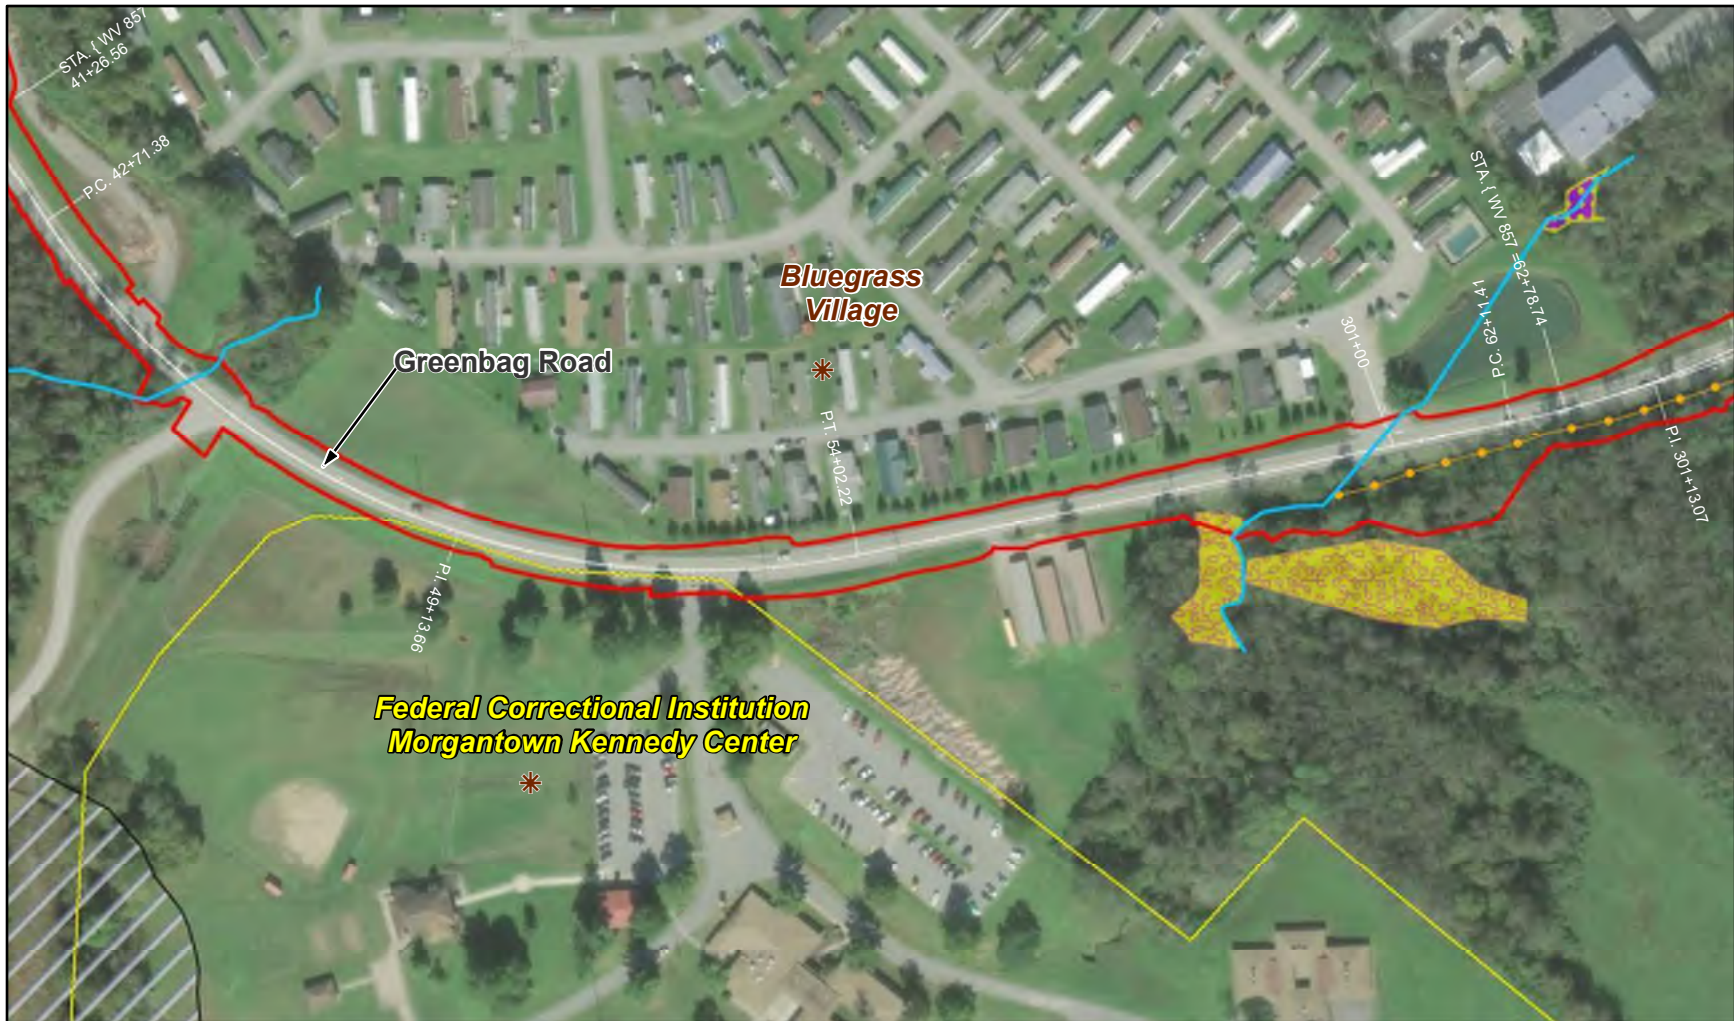
| | <p>Figure 14 (Sheet 3 of 6) Detailed Environmental Features Map Preferred Alternative 2, Options C / F West Virginia Division of Highways Federal Project STP-0857(019)D/State Project U331-857-0.67 00 Greenbag Road Improvement</p> | <ul style="list-style-type: none"> Limits of Disturbance NRHP Eligible Resource Productive Agriculture * Point of Interest | <ul style="list-style-type: none"> ● Intermittent Stream — Perennial Stream Floodway 100-year Floodplain | <ul style="list-style-type: none"> Palustrine Emergent Wetland Palustrine Forested Wetland Palustrine Scrub/Shrub Wetland | |

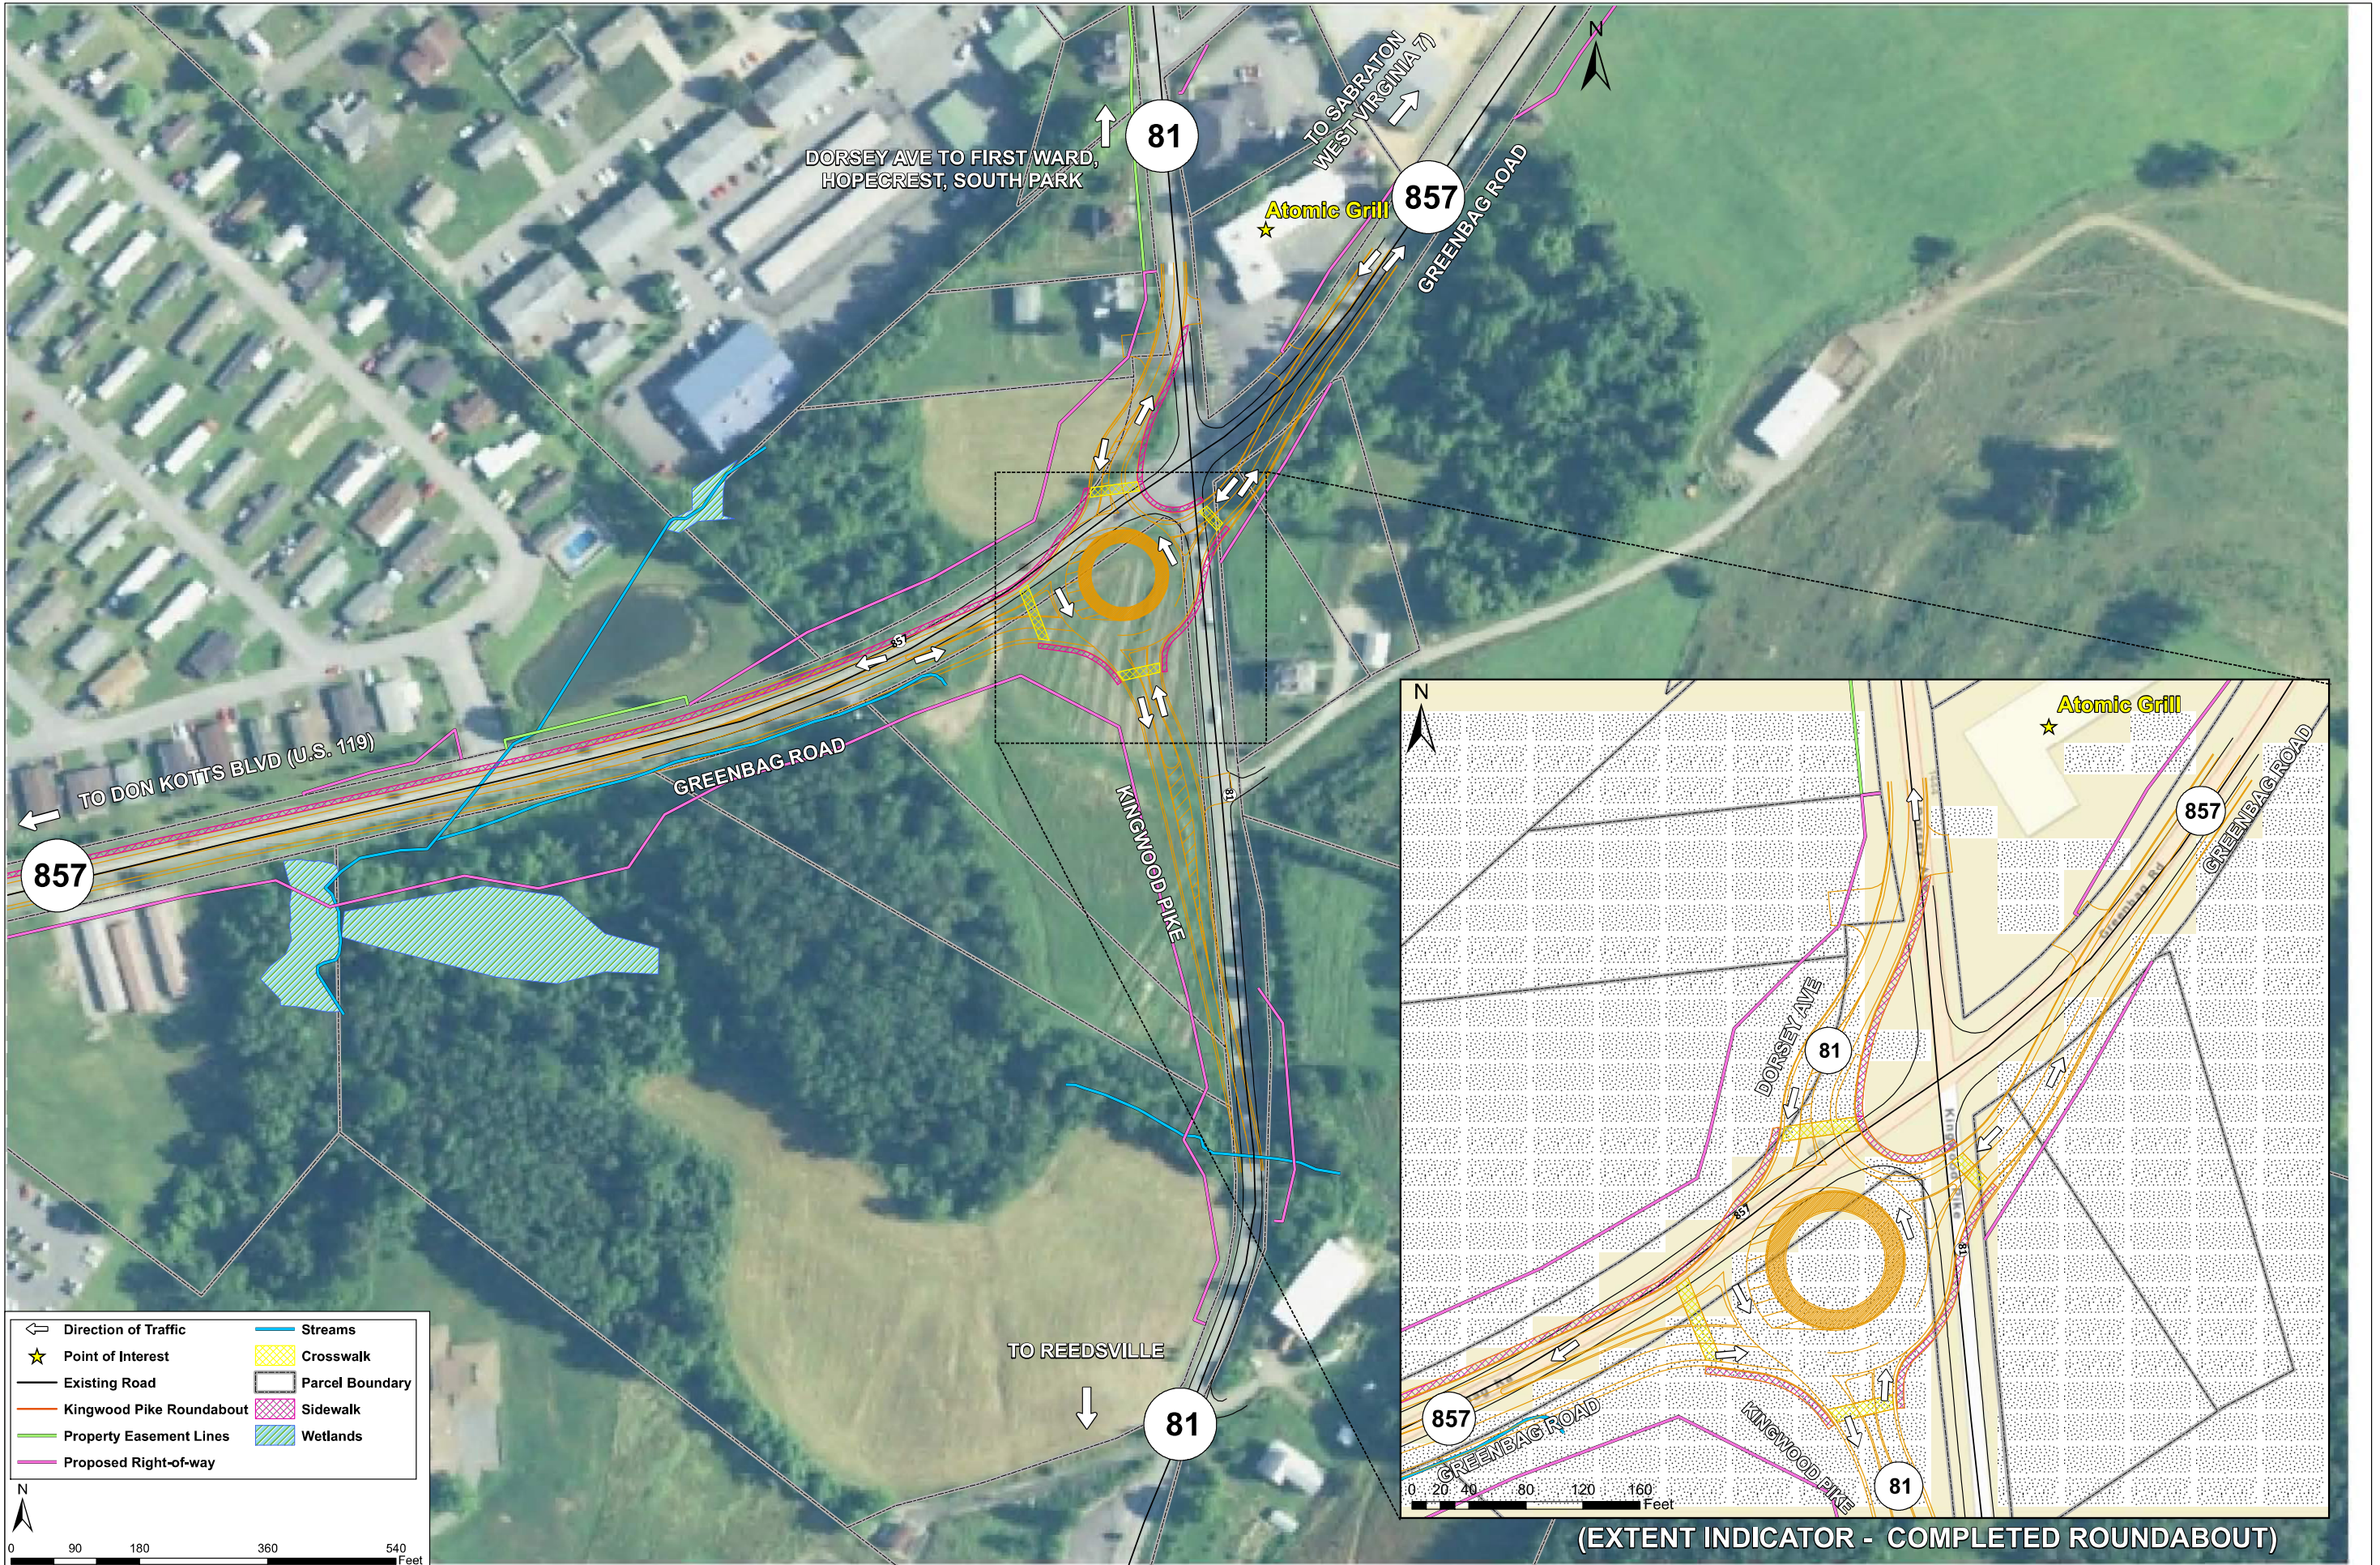
(EXTENT INDICATOR 1 - ROUNDABOUT CONSTRUCTION)

(EXTENT INDICATOR - COMPLETED ROUNDABOUT)

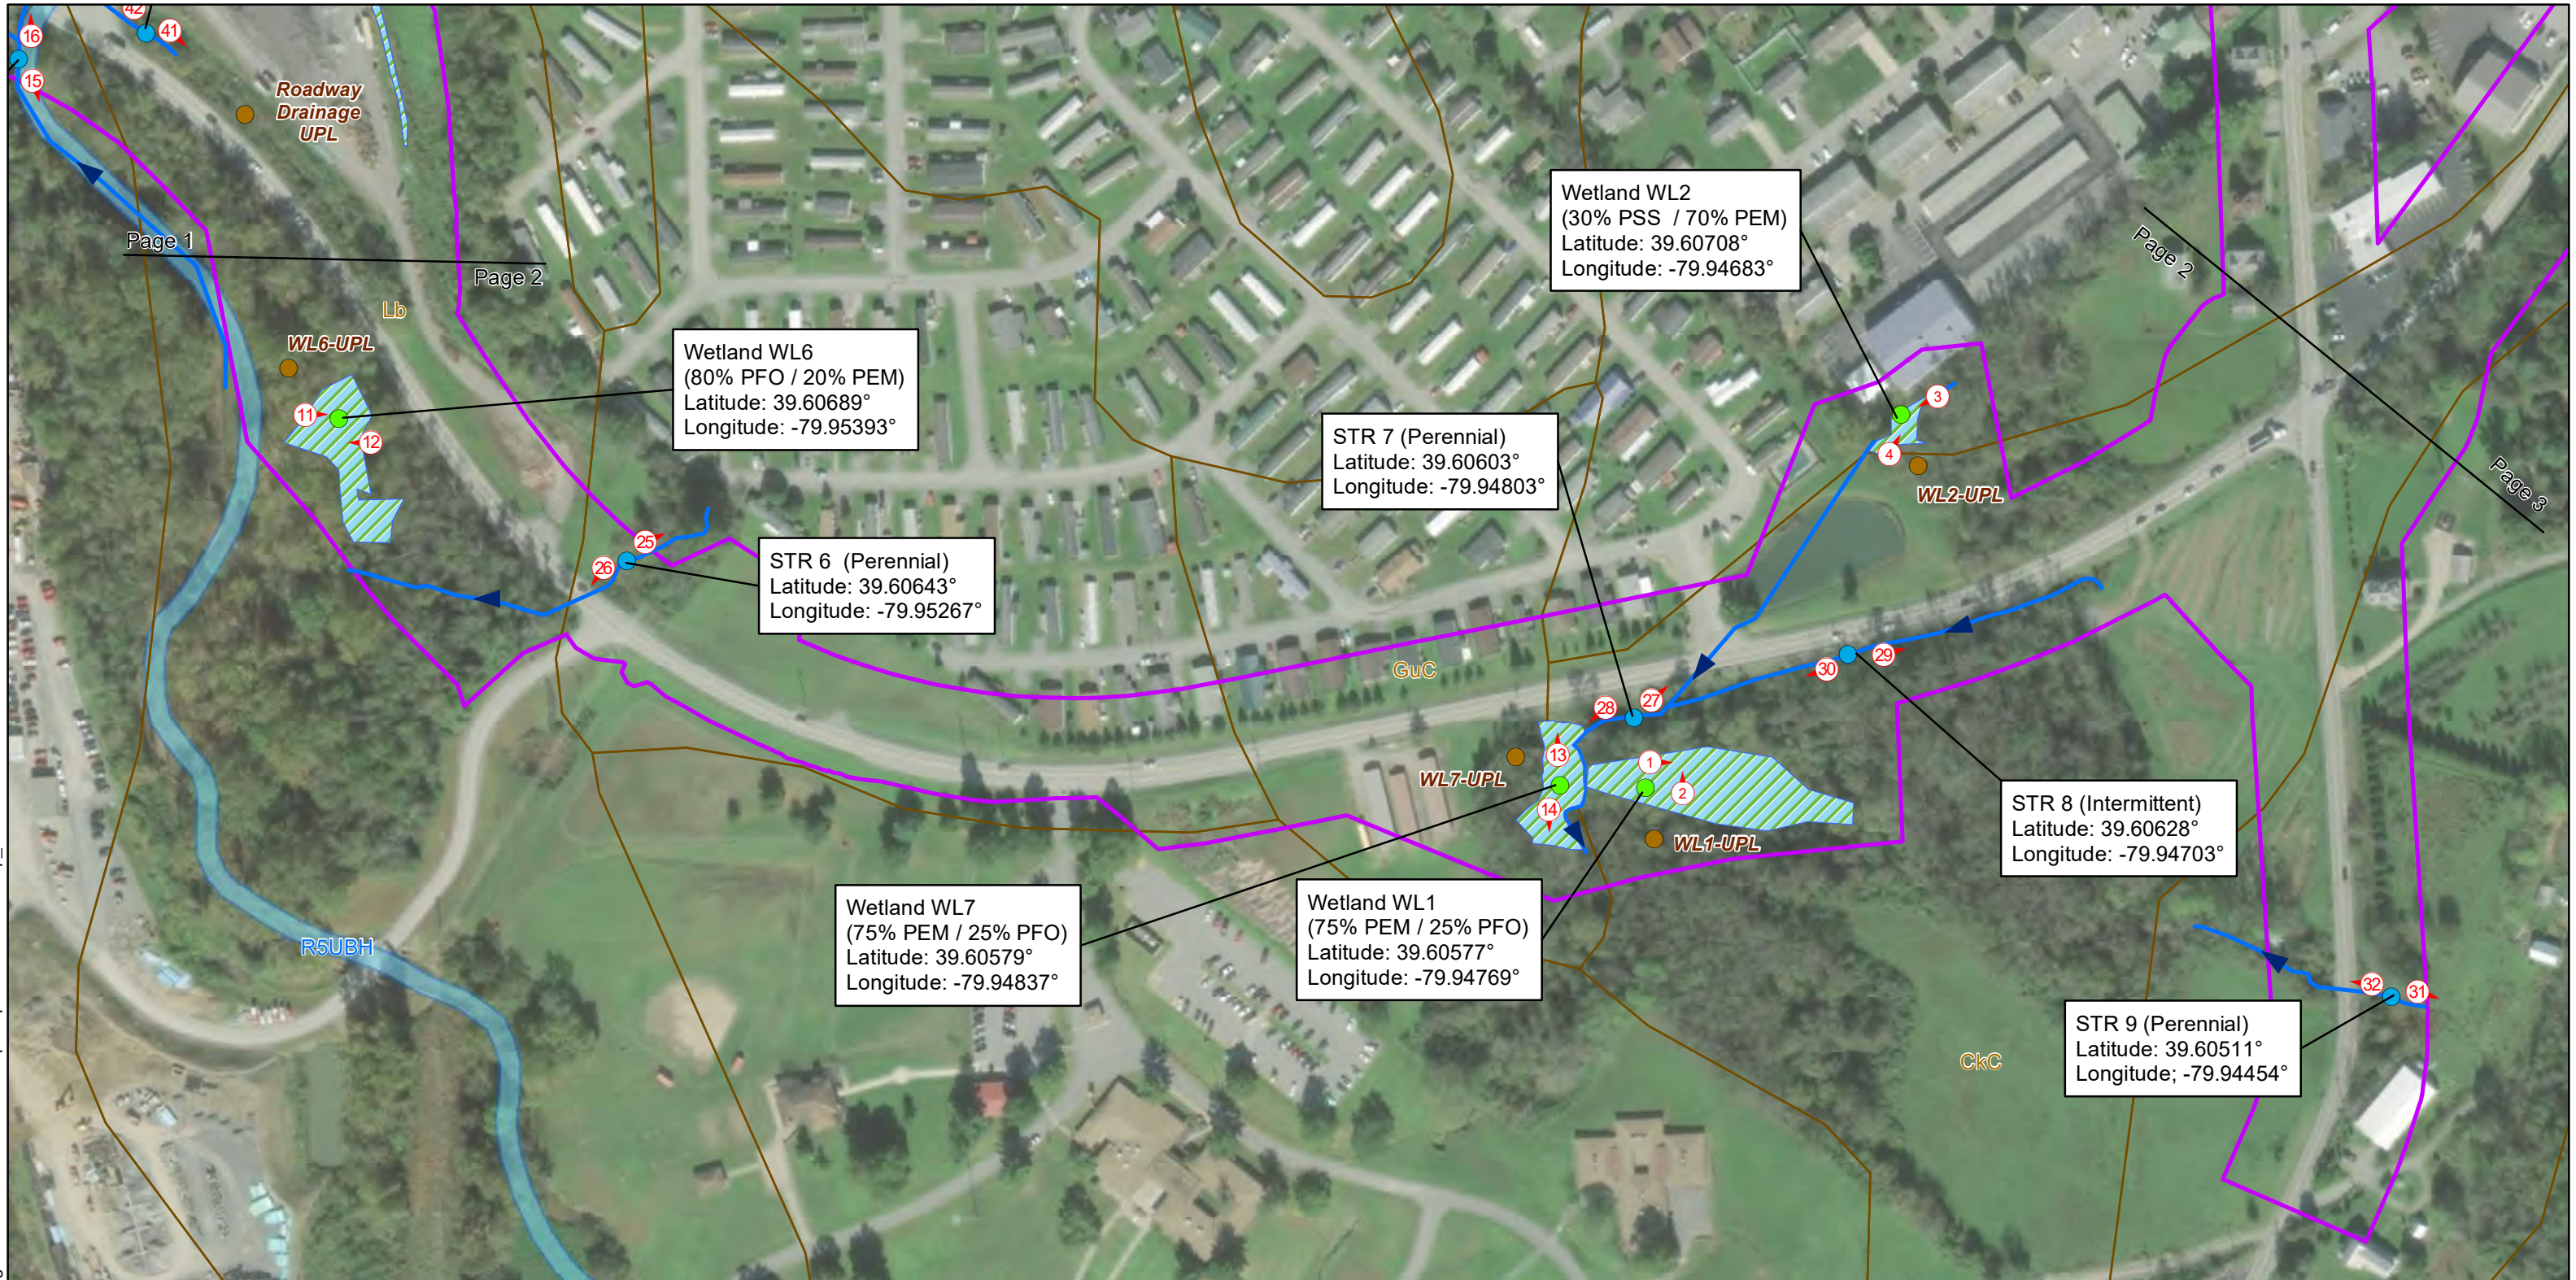
Greenbag Road Improvement Project
 West Virginia Division of Highways
 Monongalia County, West Virginia
 USGS Quadrangle - Morgantown South
 Aquatic Resource Map
 Page 2 of 4

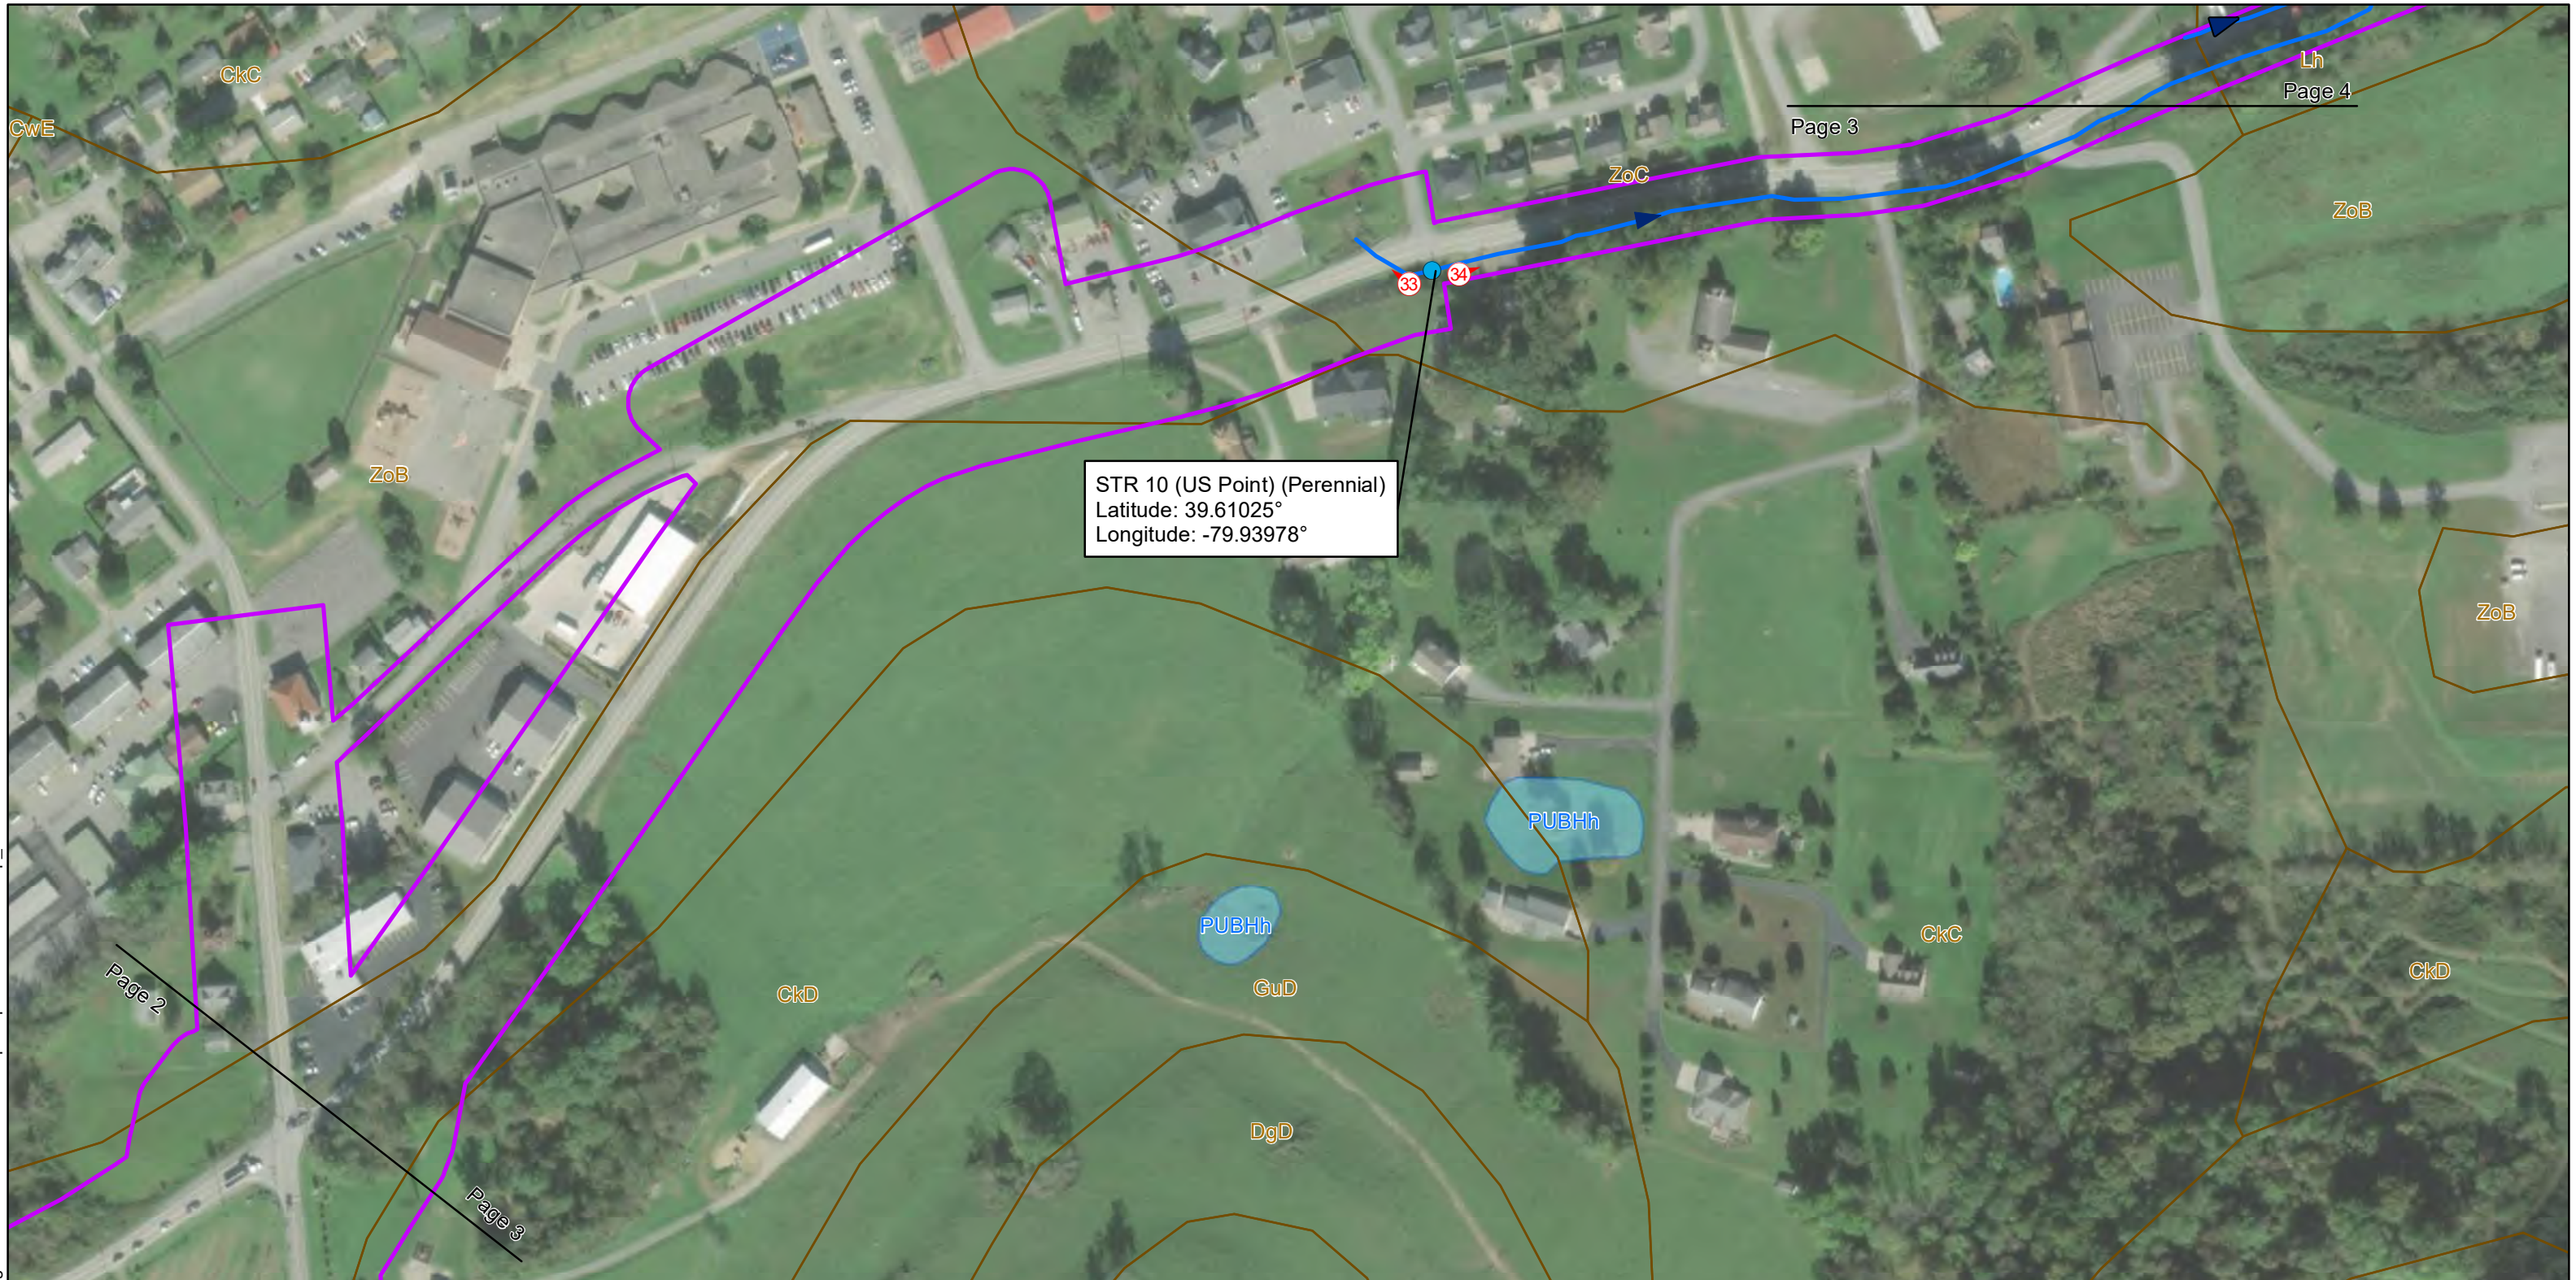
Greenbag Road Improvement Project
West Virginia Division of Highways
Monongalia County, West Virginia
USGS Quadrangle - Morgantown South
Aquatic Resource Map
Page 3 of 4

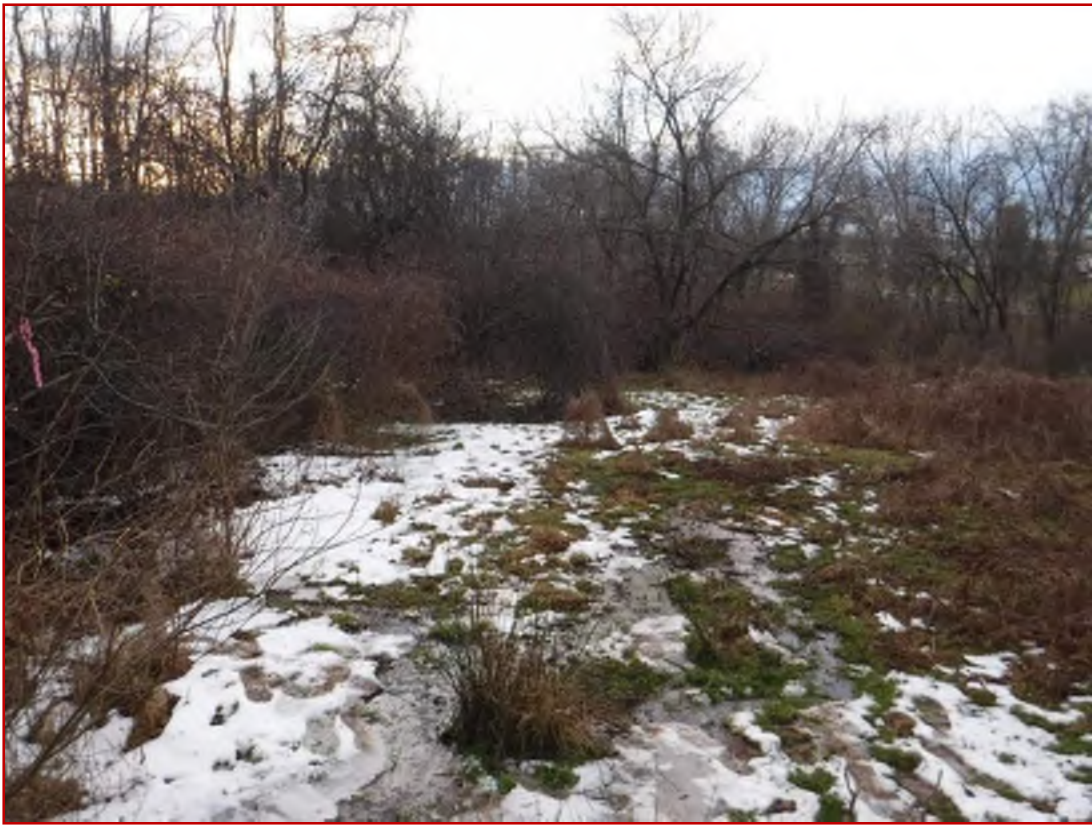
Photo 1: Wetland WL1 – Facing East (2.4.19)

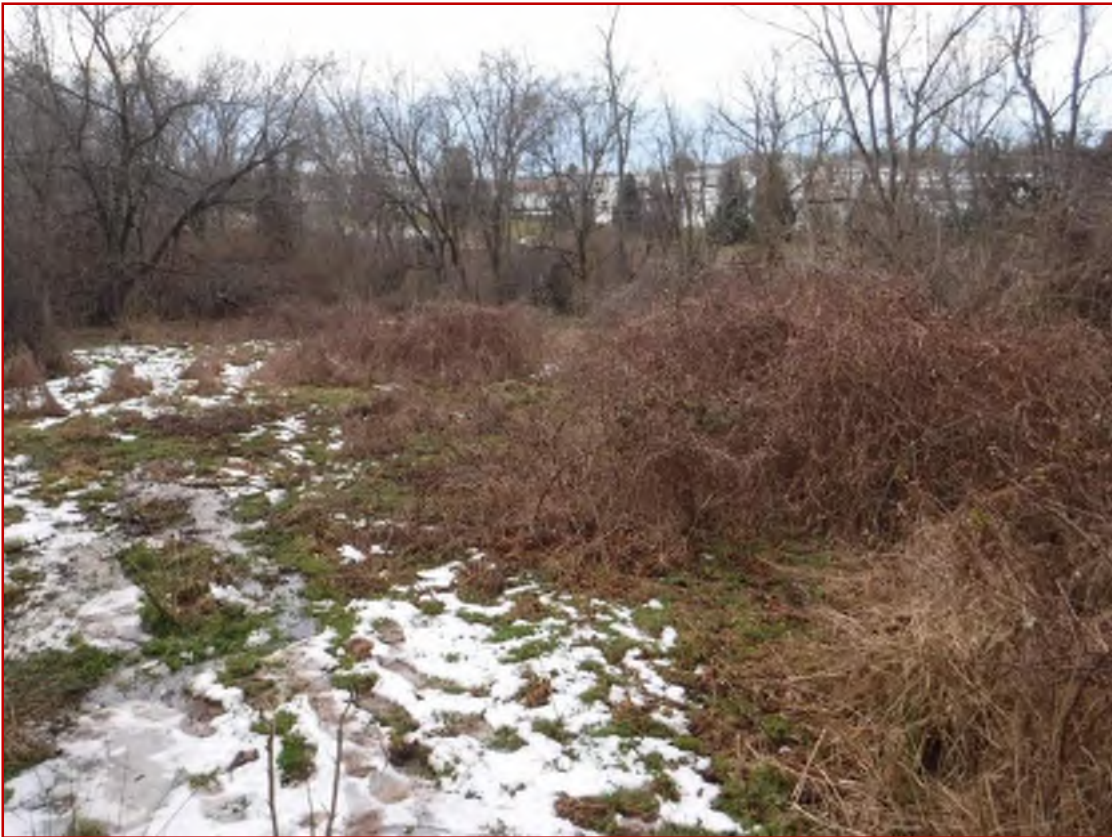
Photo 2: Wetland WL1 – Facing North (2.4.19)

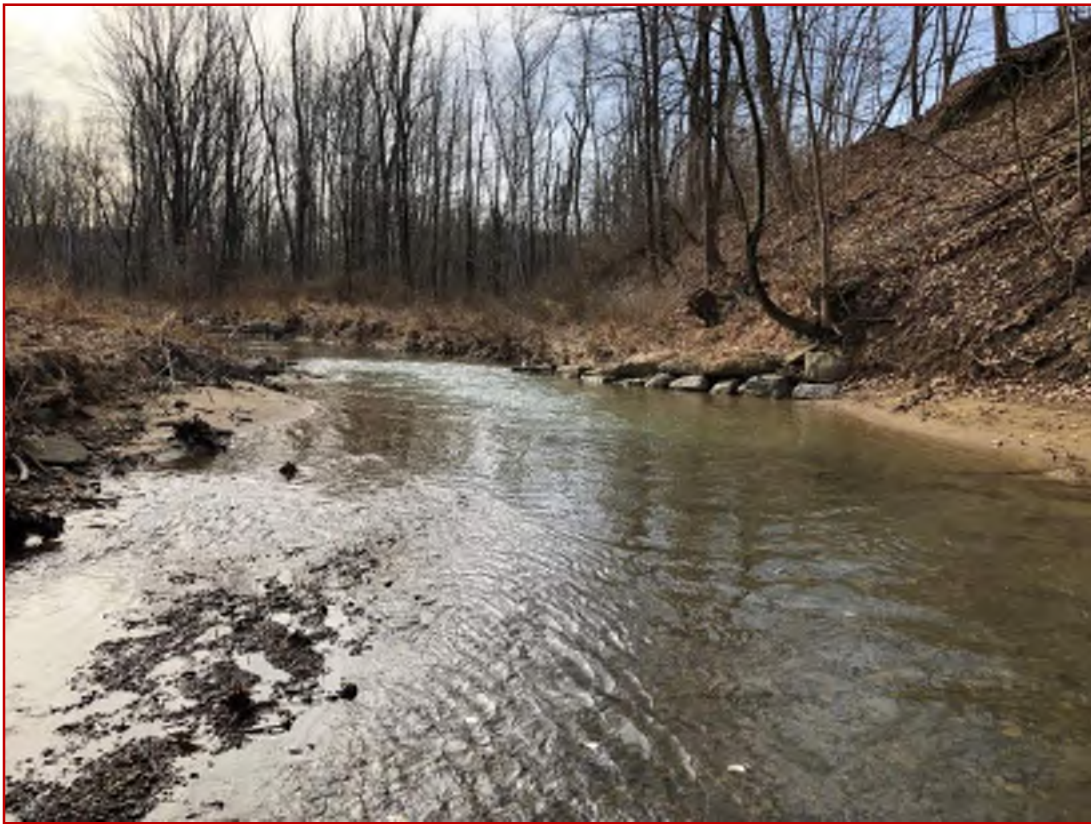
Photo 15: STR 1 (Cobun Creek) – Facing Upstream (3.13.19)

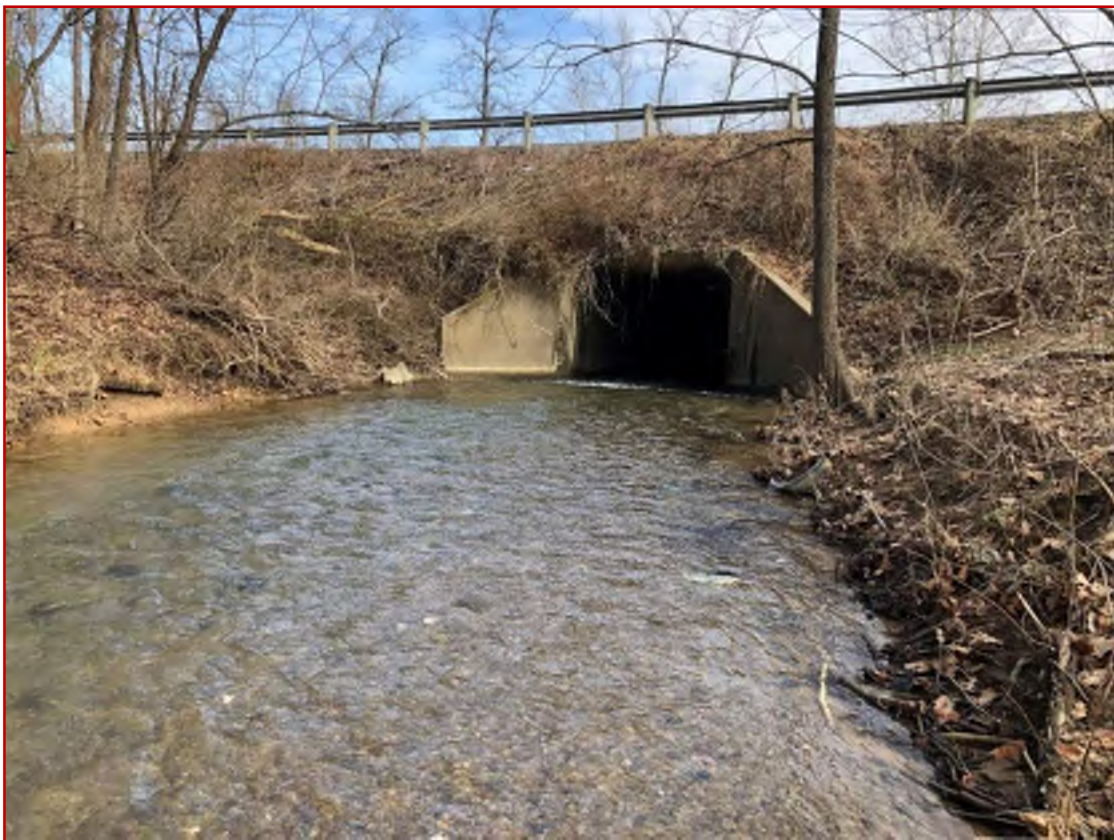
Photo 16: STR 1 (Cobun Creek) - Facing Downstream (3.13.19)

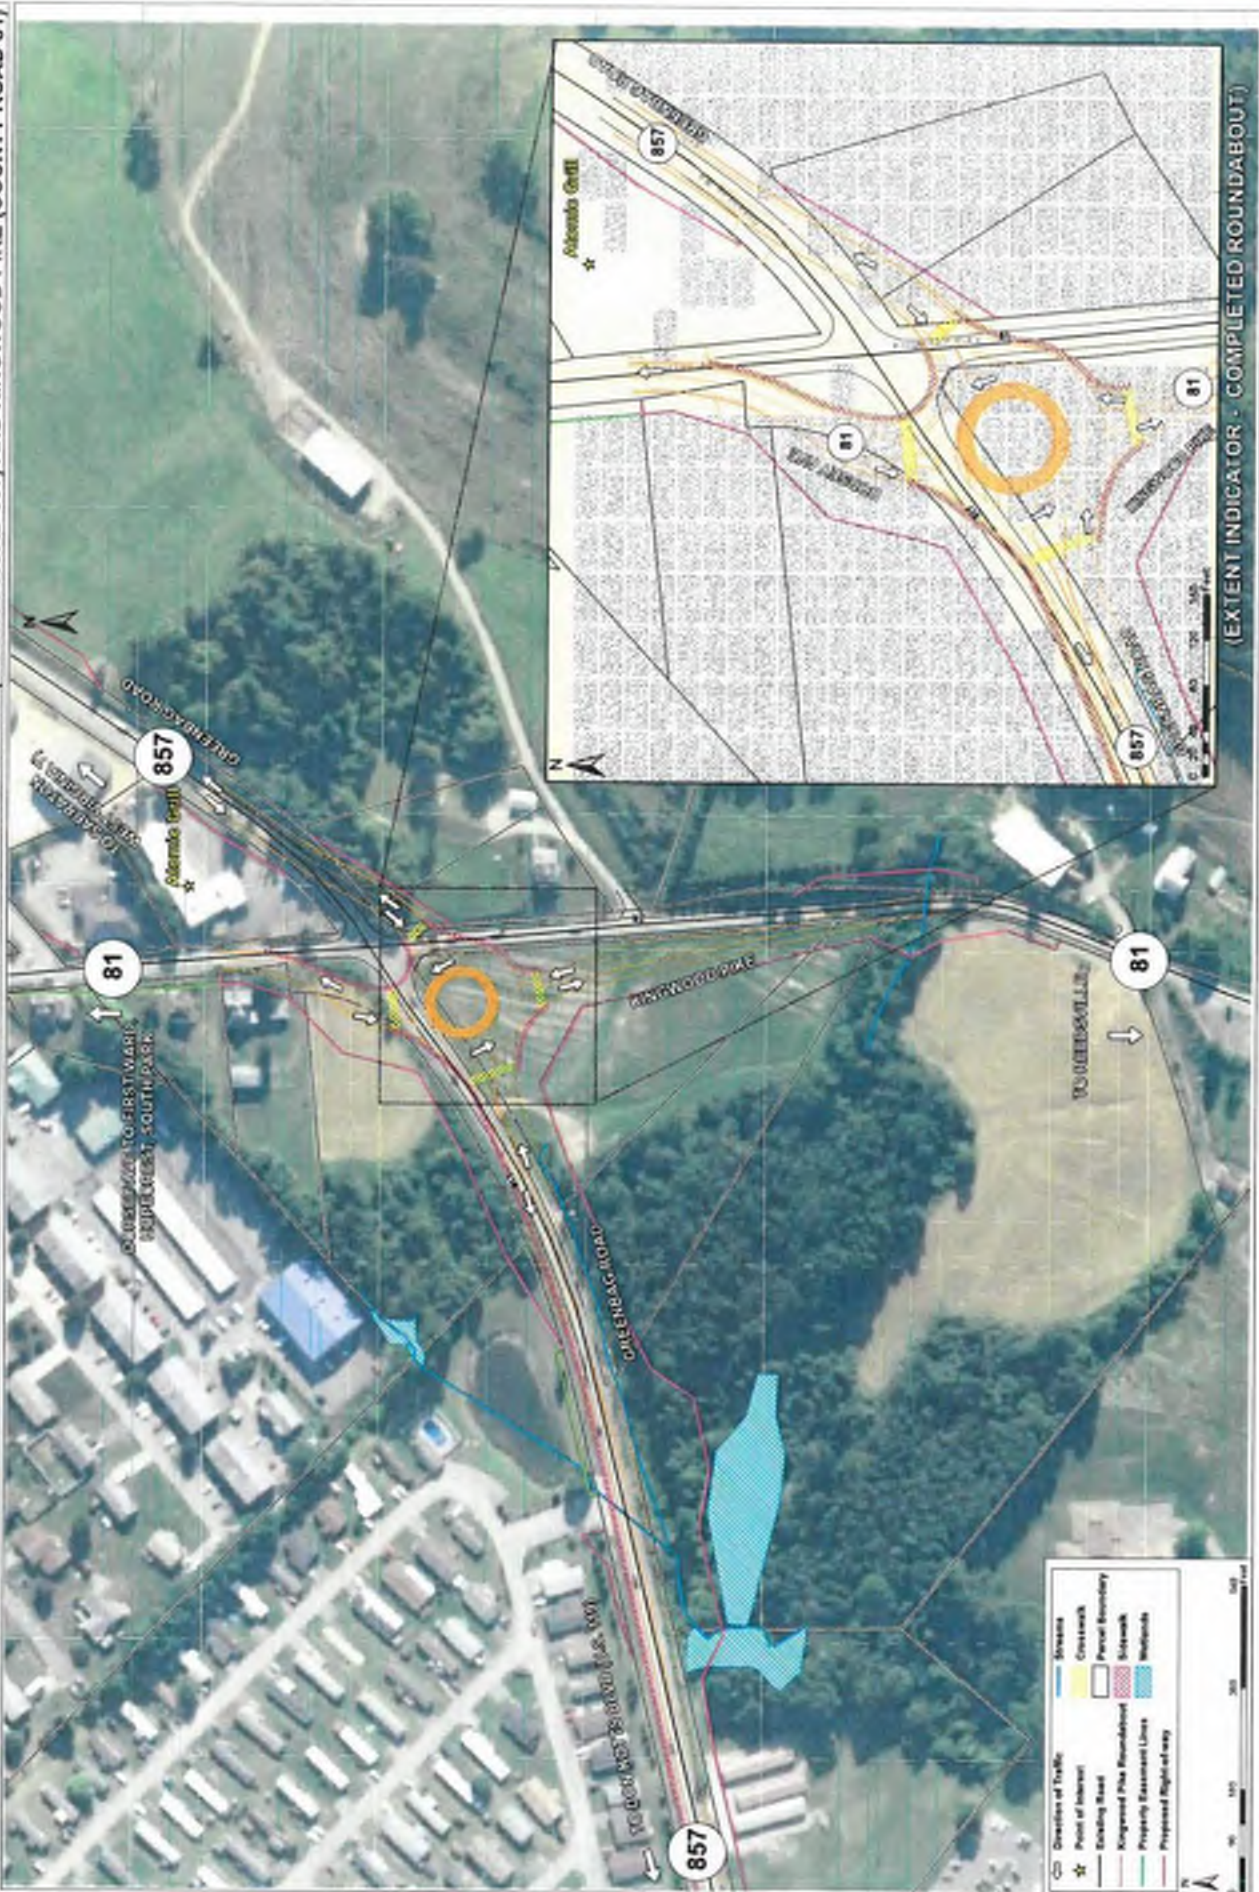
INTERSECTION OF GREENBAG ROAD (COUNTY ROAD 857) AND KINGWOOD PIKE (COUNTY ROAD 81)

(EXTENT INDICATOR - COMPLETED ROUNDABOUT)

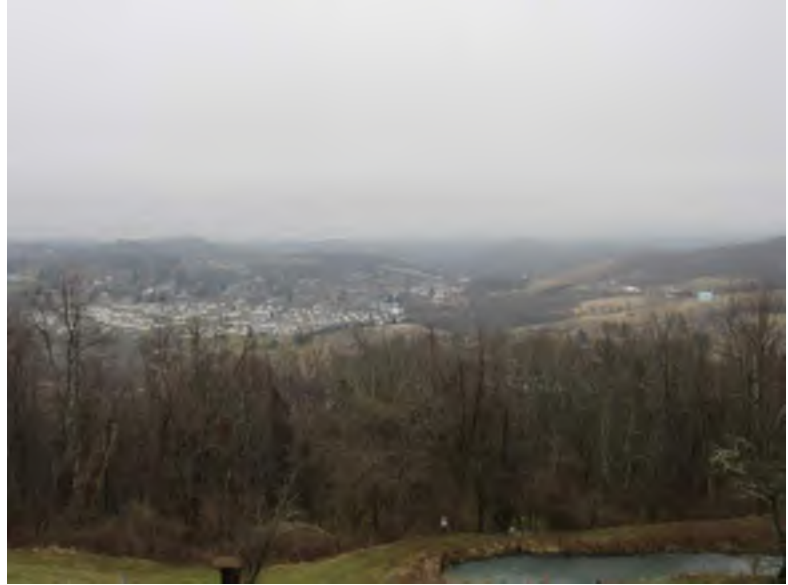
Inset 1. Project area overview from Dorsey Knob, facing northeast (Markosky 2019-02-05)

The West Virginia Division of Highways (WVDOH) is proposing the Greenbag Road Improvement Project (Project) located southeast of the city of Morgantown in Monongalia County (Appendix A: Figures 1-3; Appendix B). The 1.65-mile long Project begins 0.40 miles east of the intersection of Greenbag Road (CR 857) and US 119 and ends where Greenbag Road crosses Aaron Creek (Insets 1-4). The overall roadway improvements include wider lanes and shoulders along with a dedicated center turn lane prior to the Mississippi Street (CR 857/1) intersection. A curb and gutter will be installed along the north side of Greenbag Road to help address drainage issues

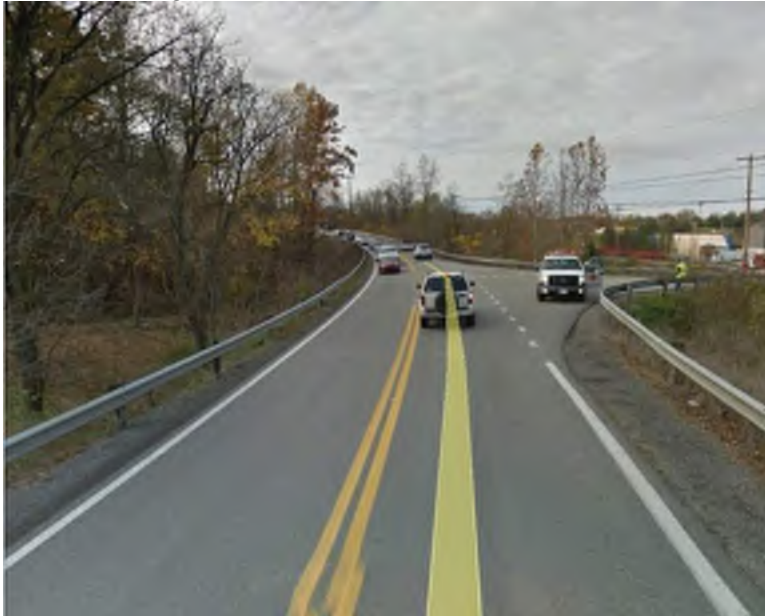
Inset 2. Project overview of Greenbag Road near Mississippi Street (right), facing northwest (Google Earth 2018)

The roadway will be improved to incorporate two 11-foot travel lanes with a 12-foot center turn lane with curb and gutter on each side up from the western terminus of the Project to Mississippi Street. Between Mississippi Street and Dorsey Avenue / Kingwood Pike, the roadway will be improved to two 12-foot travel lanes and a 4-foot paved shoulder on the south side. A 3-foot paved shoulder with a 2-foot curb and gutter will be added on the north side. The 5-foot

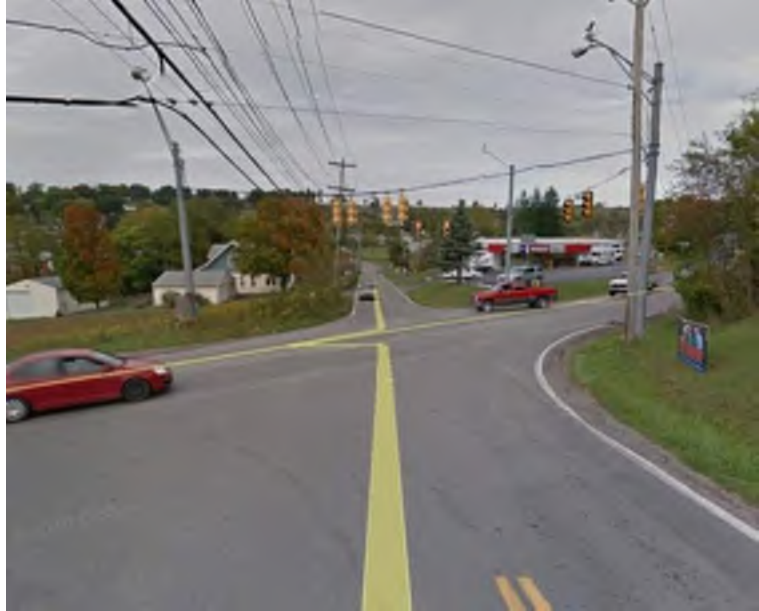
Inset 3. Project overview of the intersection of Greenbag Road (left to right) with Dorsey Avenue / Kingwood Pike, facing north (Google Earth 2018)

concrete sidewalk will be located on the north side of Greenbag Road and will connect with the sidewalk at Mountainview Elementary School. Both the Mississippi Street and Dorsey Avenue / Kingwood Pike intersections with Greenbag Road are proposed to be reconstructed as single-lane roundabouts to provide for continuous traffic flow along the route and to increase the safety of the traveling public as they enter each intersection. The roundabouts will also be developed to allow the safe movement of pedestrians along the sidewalk on the north side of Greenbag Road and will include lighting on each approach to the roundabout. Additional work on

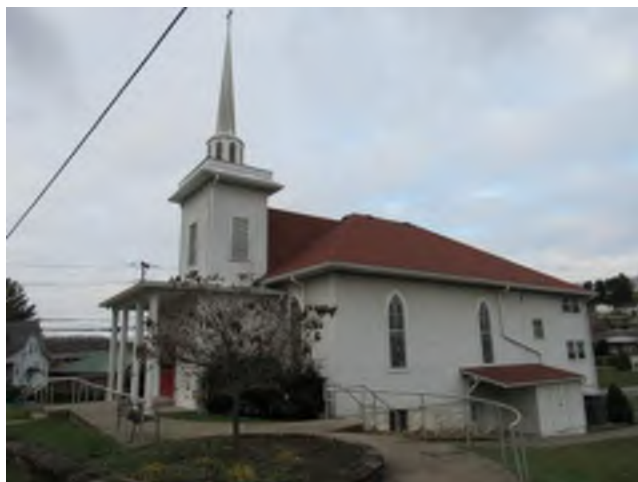
MG-1332 / Harner Chapel is located on the northeast quadrant of the intersection of Luckey Lane and Dorsey Avenue. The chapel is located approximately 1.55 miles southeast of the city of Morgantown and is set within an area of mixed single family and multi-unit residences and commercial development. Harner Chapel was previously surveyed in 1982, but it was not evaluated for NRHP eligibility (Toth 1982). Harner Chapel is a ca.

1914 Carpenter Gothic frame building covered in vinyl siding and capped by a hipped roof covered in asphalt shingle (Appendix C: Photograph 1). The chapel rests on a rock faced concrete block foundation, and its façade features a narthex with a full height bell tower capped by a simple ca. 1990 spire with fixed Gothic arch windows. The fenestration of the chapel consists of Gothic arch windows and paired vinyl sash, one-over-one windows in the ca. 1955 two-story rear addition. A ca. 1990 partial width, shed roof addition has been appended to the northeast elevation. The reconfiguration of the bell tower with a non-historic spire, the large rear addition, and the use of replacement roofing and cladding materials has compromised the historic integrity of the chapel.
