**Greenbag Road Improvement Project
Environmental Assessment
Monongalia County, West Virginia**

State Project: U331-857-0.67
Federal Project: STP-0857(019)D

August 2020

ENVIRONMENTAL ASSESSMENT

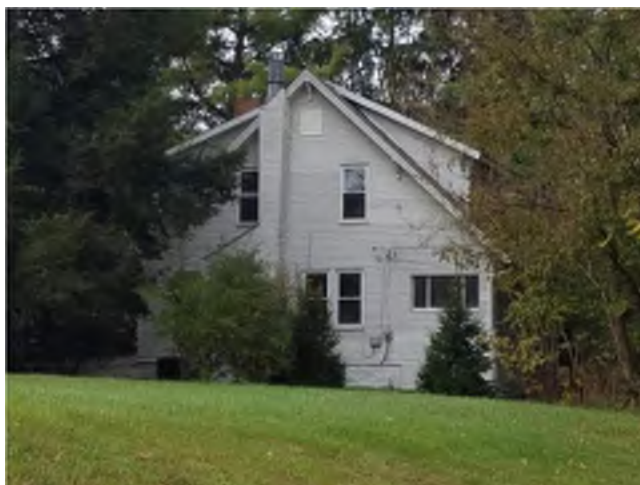
MG-2640 / House at 796 Greenbag Road sits at the top of a steep drive in a heavily wooded lot on former farmland on the south side of Greenbag Road. It is surrounded to the west, south, southeast, and northeast by non-historic churches that have been built to serve the increasingly suburban area.

The altered house appears to be a late (ca. 1940) example of a Craftsman Style bungalow with front and rear shed roof dormers protruding from the steep side gable roof (Appendix C: Photograph 2). It retains knee braces under the gables, but otherwise features replacement siding, roofing, and windows. The formerly open integral front porch has been partially enclosed. An outbuilding--presumed to be a detached garage--was obscured by tree cover.

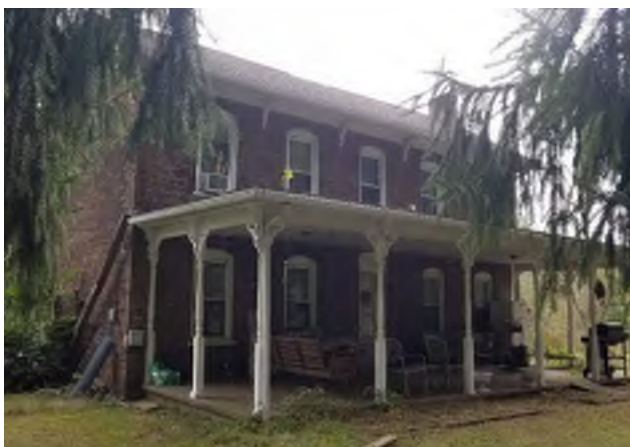
A long gravel driveway leads up a steep embankment from Greenbag Road at the north edge of the farm to the two-story brick Campbell Farmhouse at the heart of the farmstead (Appendix C: Photograph 3). The Italianate farmhouse, which was built ca. 1886, has a T-shaped plan formed by the five bay front section of the farmhouse and a perpendicular two-story rear ell. The farmhouse has a three gable roof with prominent gable returns and replacement asphalt shingle roofing. Two interior end brick chimneys flank the main section of the house and a third brick chimney is located at the center of the rear ell. The brick walls are laid in an American common bond pattern with seventh row headers and feature tall segmental arch window openings on all elevations, although at least one window on the south (side) elevation has been bricked in and one window on the east (rear) elevation has been resized. The current windows are one-over-one metal sash replacements. The farmhouse has a full width front porch with a shallow half hipped roof, turned posts, and scroll sawn brackets. Similar scrolled brackets line the cornice under the eaves. A secondary porch is located on the north elevation of the rear ell. The farmhouse has the characteristic massing, design, and ornamentation of a classic Italianate Style dwelling.

The Campbell Farmhouse retains its integrity. Despite a few alterations to its historic form (replacement windows and roofing as well as minor changes to the fenestration pattern), the farmhouse retains its integrity of design, materials, and workmanship. Its location remains intact, and its immediate setting remains rural and agricultural though the surviving outbuildings date from a later period. Its larger setting has been impacted by the loss of more than 100 acres of farmland and relatively dense highway-oriented suburban development. The Campbell

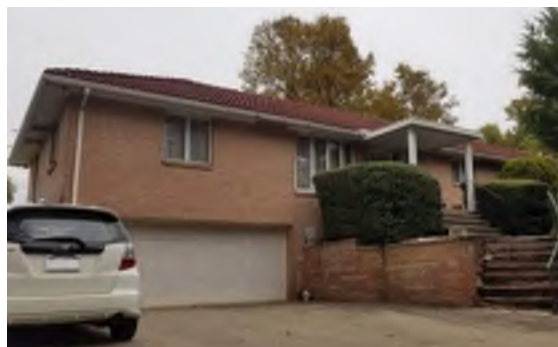
The one-story hipped roof ranch residence has a partially-exposed basement level featuring an integral two-car garage (Appendix C: Photograph 5). A one-bay front porch was added to the house ca. 2010 and a three-season rear enclosed porch was added ca. 2010. A lower level side porch was also added ca. 2010.

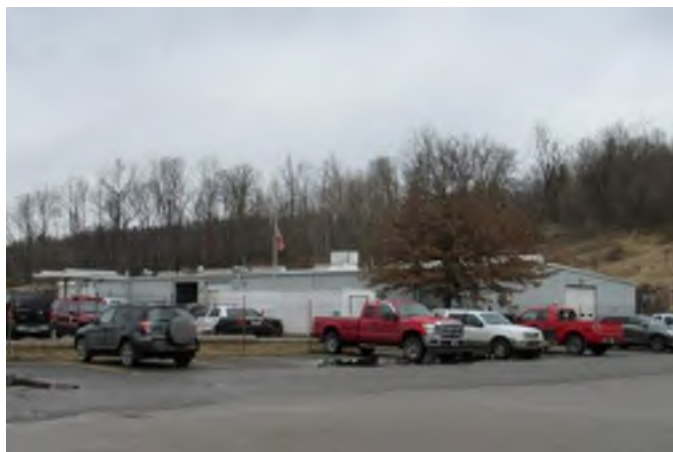
5.6 MG-2644 / Morgantown City Garage 2020 Mississippi Street

The Morgantown City Garage was constructed between 1975 and 1976 by the Mellon-Stuart Company of Pittsburgh, Pennsylvania (Appendix C: Photographs 9-11 [Morgantown Dominion-Post 1975b, 1975c, and 1976]). The steel frame pole barn is covered in ridged metal cladding. The structure is capped by a low-pitched side gable roof covered in standing seam metal roofing. The front (southwest) elevation of the garage features four oversized vehicle-bay openings.

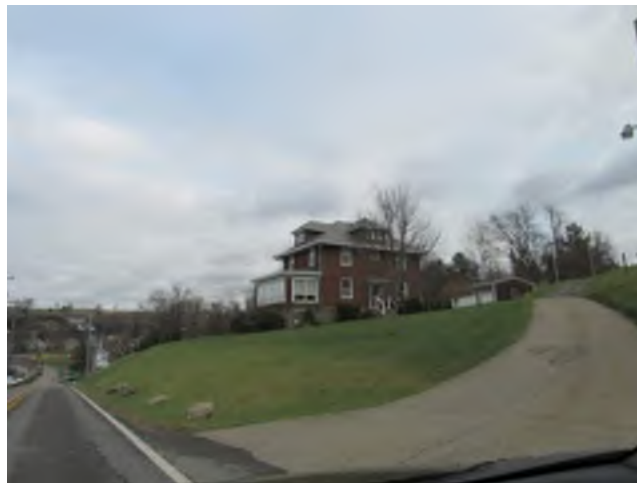
The Anderson House is a ca. 1922, two-and-a-half-story American Four-Square house standing two bays wide and four bays deep (Appendix C: Photographs 20 and 21). The house rests on an ashlar stone foundation and is covered in stretcher bond brick. The hipped roof features overhanging eaves and is covered in asphalt shingle. The roof is pierced by two interior brick chimneys and includes three hipped roof dormer windows clad in vinyl siding. Fenestration consists of replacement one-over-one and vinyl sash windows with simple stone sills. The porch on the façade (west elevation) has been enclosed with vinyl sash hopper windows. The original entrance is located within the porch and an alternate entrance is now located on the south elevation. A one-story, partial width addition has been appended to the rear (east) elevation. A ca. 1980, two-bay detached garage clad in standing seam metal is located east of the house and a ca. 2010 pole barn located farther to the northeast was not visible from the public ROW.

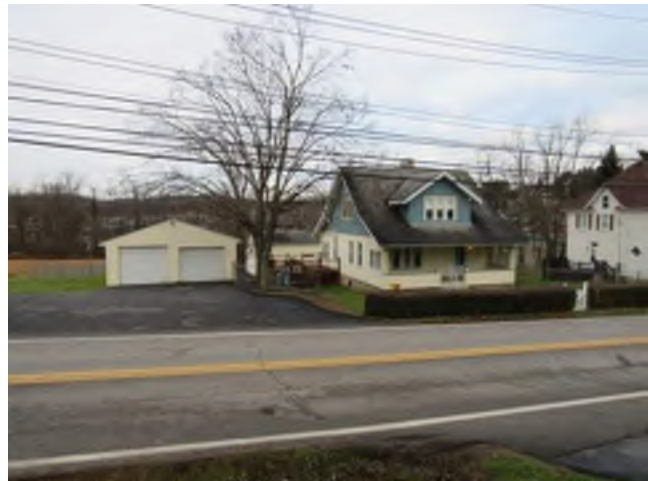
The house at 1440 Dorsey Avenue is a one-and-a-half-story ca. 1915 Bungalow style dwelling partially clad in vinyl siding and wood shingle (Appendix C: Photograph 22). The house rests on a rock faced concrete block foundation and is capped by a side gable roof covered in asphalt shingle. Decorative brackets adorn the overhanging eaves. The roof is pierced by an interior brick chimney and features a front gable dormer on the façade (east elevation). Fenestration consists of replacement one-over-one vinyl sash windows and fixed glass block windows in the basement level. The integral front porch has been partially enclosed with vinyl siding. A ca. 1990 two-bay detached garage covered in vinyl siding and capped by an asphalt shingle front gable roof is located immediately south of the house (Appendix C: Photograph 18). A ca. 2000 combination garage and shed clad in vinyl siding and capped by an asphalt shingle gable roof is located west of the house (Appendix C: Photograph 18).

The house at 1440 Dorsey Avenue lacks integrity because it has undergone alterations including the replacement of siding, windows, and roof materials and the partial enclosure of the front porch. While the house maintains some characteristic architectural elements of the Bungalow house type and Craftsman style, such as the brackets in the eaves, it stands as a common and unexceptional example of its kind and does not possess the architectural merit necessary for listing in the NRHP. Higher style examples of the Bungalow and Craftsman styles can be found in the NRHP listed Chancery Hill and South Park Historic Districts located approximately one mile to the northwest. Therefore, it is not recommended eligible under Criterion C. The house has not been evaluated for significance under Criterion D for its potential to yield information important to the understanding of history or prehistory.

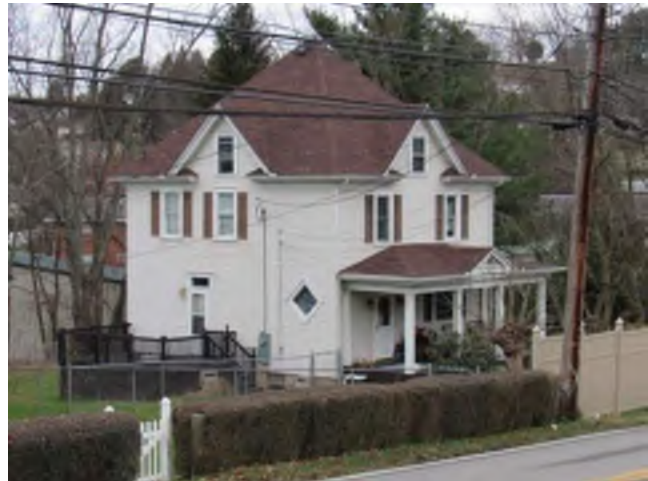
The Smith House is a ca. 1915 two-story modified American Four-Square dwelling clad in vinyl siding and resting on a foundation covered in stucco (Appendix C: Photograph 23). The steeply pitched hipped roof is covered in asphalt shingle and features three cross gable wall dormer windows with gable returns that appear to be variants on the Free-Classic Queen Anne Style. The roof is pierced by one interior brick chimney. Fenestration consists of replacement one-over-one vinyl sash windows, one fixed diamond shaped vinyl sash window, and an altered fixed vinyl sash picture window. The full width hipped roof porch on the façade (east elevation) is supported by simple square columns and features a cross gable pediment.

The Smith House has undergone a loss of integrity due to replacement siding and roof materials, alterations to some original window openings, and the removal of other historic

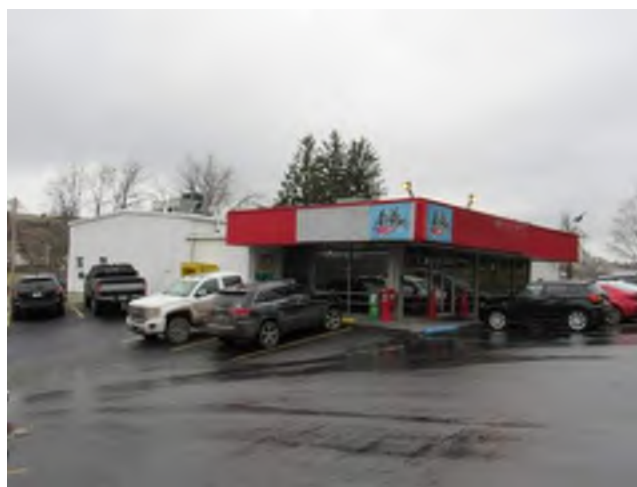
The Atomic Grill, built in 1974, is a steel-frame commercial building clad with standing seam metal panels and resting on a concrete block foundation (Appendix C: Photographs 24 and 25). The main portion of the L-shaped building is a steel frame structure capped by a side gable roof with an eight bay garage for commercial trucks. A storefront entrance projects from the southeast elevation with plate glass walls and a flat roof with covered in standing seam metal. The building is surrounded by a parking lot.

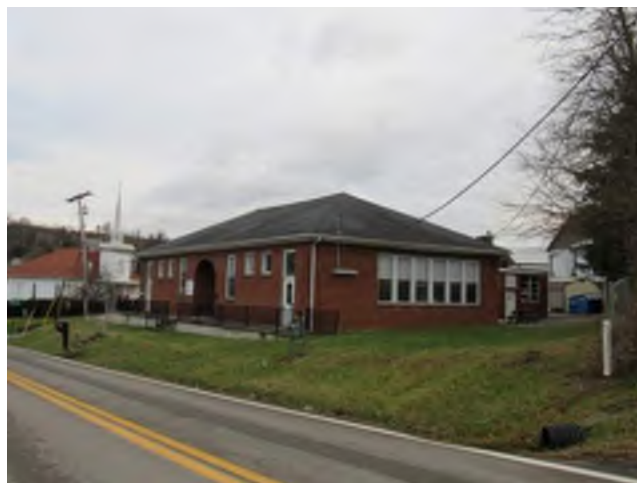
The Dorsey School is a one-story ca. 1920 Classical Revival school house clad with American common bond brick walls (Appendix C: Photographs 26 and 27). The hipped roof is covered in asphalt shingle. Fenestration consists of replacement one-over-one vinyl sash windows, fixed vinyl sash windows, and louvered metal windows. The windows feature simple brick sills. A non-historic one-story concrete block rear addition with a flat roof is appended to the east elevation. A deeply recessed entrance on the façade (west elevation) features a segmental arch entry accented with decorative brickwork. The modern replacement door is surrounded by a modern simple transom and what are likely original sidelights.

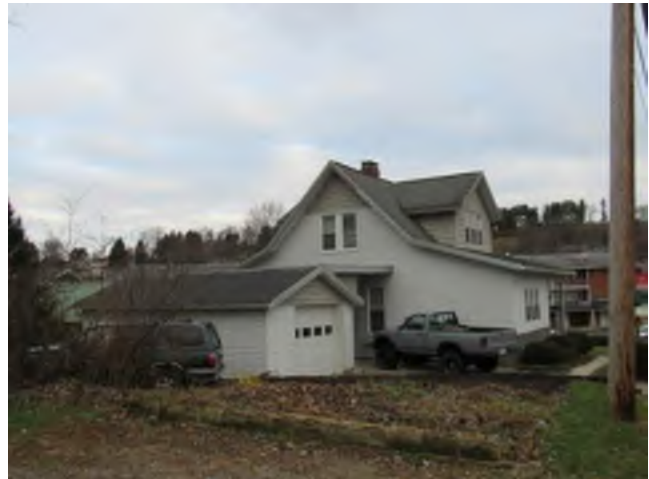
The house at 1432 Dorsey Avenue is a ca. 1915 one-and-a-half-story Bungalow style dwelling covered in vinyl siding and synthetic wood shingle (Appendix C: Photograph 28). The house rests on a rock faced concrete block foundation and is capped by a side gable roof covered in asphalt shingle. The roof is pierced by an interior central chimney and a front gable dormer window is located on the façade (east elevation). The façade features a partially enclosed integral shed roof porch resting on a concrete block foundation. Fenestration consists of simulated three-over-one vinyl sash windows and sliding vinyl sash windows in the basement level. A one-bay garage capped by a front gable asphalt shingle roof and covered in vinyl siding is located immediately south of the house (Appendix C: Photograph 28). A shed roof connects the garage and house.

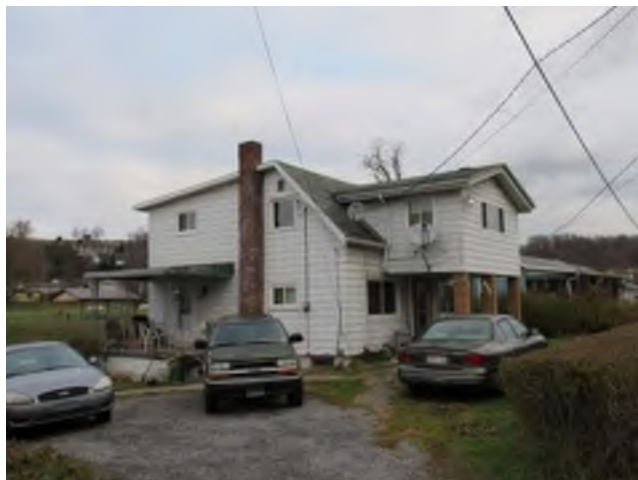
The house at 102 Luckey Lane is a ca. 1940 one-and-a-half story Minimal Traditional style dwelling covered in aluminum siding and capped by a side gable roof covered in asphalt shingle (Appendix C: Photograph 29). The roof is pierced by one exterior brick chimney. The house rests on a concrete block foundation and fenestration consists of fixed and sliding vinyl sash windows. A partial width, second story addition supported by brick piers has been appended to the façade (southeast elevation). The addition is capped by a front gable roof covered in asphalt shingle. A two-story, full width addition has been appended to the rear (northwest) elevation. Two shed roof porch additions resting on concrete block foundations are appended to the northeast and southwest elevations.

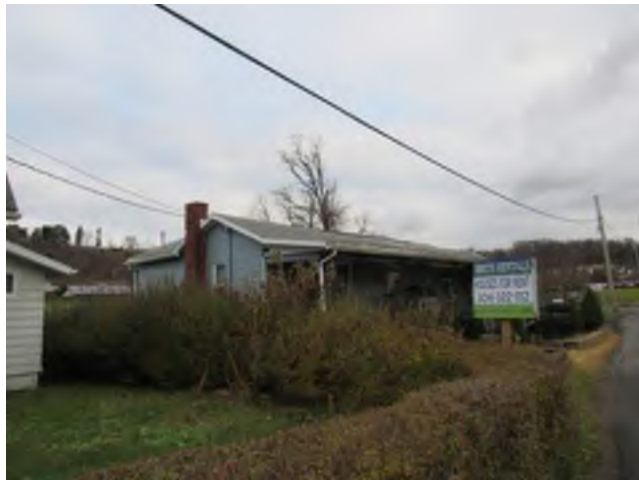
The house at 104 Luckey Lane is a ca. 1940 one-story Minimal Traditional style dwelling clad in vinyl siding and resting on a concrete block foundation (Appendix C: Photograph 30). The house is capped by a side gable roof covered in asphalt shingle and pierced by an exterior brick chimney. Fenestration consists of replacement one-over-one and fixed vinyl sash windows. A shed roof porch supported by metal posts has been appended to the façade (southeast

elevation), while a one-bay garage capped by a side gable roof has been appended to the northeast elevation.

Lane lacks integrity because it has undergone alterations and additions including replacement siding and roof materials, alterations or original window openings, and a one-bay garage addition. For these reasons it is not eligible for listing under Criterion C. The house has not been evaluated for significance under Criterion D for its potential to yield information important to the understanding of history or prehistory.

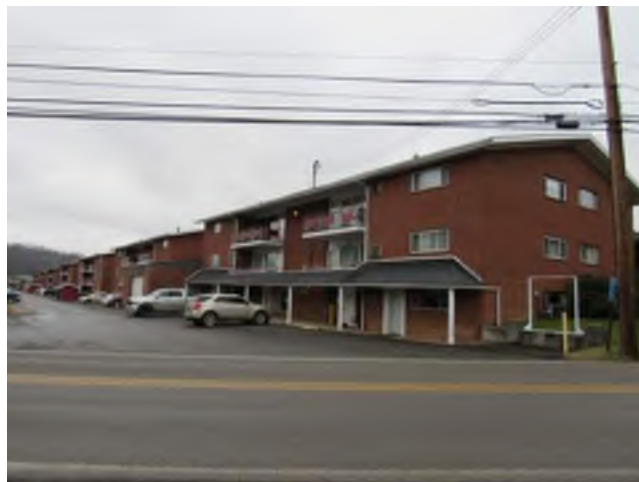
Mountain View Manor is a three-story, multi-unit housing complex constructed ca. 1970 comprising seven rectangular buildings, each with 10 units. In each building, four units face the northwest elevation, four units face the southeast elevation, and two additional units are included on the ground level of the southeast elevation (Appendix C: Photograph 31). Each building features a one-bay, central entrance with segmented plate glass panels from the floor to ceiling on their northwest elevations. Entrances on the southeast elevations are simple doors with one plain side light. The three-story buildings with exposed basements are covered in applied stretcher bond brick and capped by side gable

roofs covered in asphalt shingle. The roofs feature a slight overhang in the gable ends and eaves. Fenestration consists of tripartite metal sash sliding glass windows. Each unit features an integrated porch, either on the northwest or southeast elevation, with a simple metal balustrade, floor to ceiling plate glass windows, and a door for access. Unit 1, located at the northeast end of the complex, contains offices on the ground floor while the remaining units are residential.

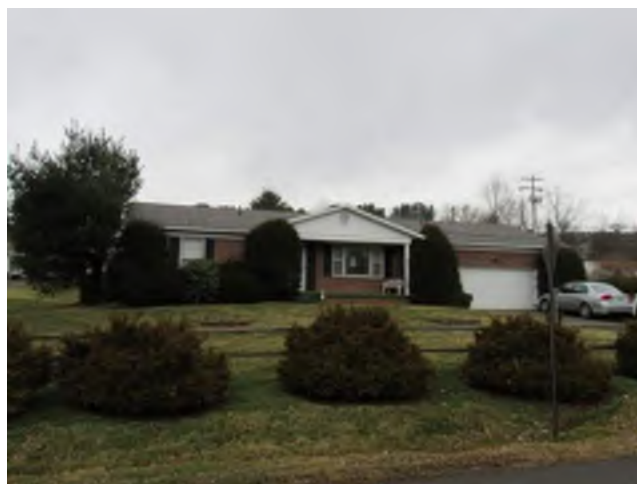
The house at 500 Parkway Drive is a ca. 1970, one-story Ranch style dwelling covered in applied stretcher bond brick and vinyl siding and capped by a side gable roof covered in asphalt shingle (Appendix C: Photograph 32). The one-story dwelling rests on a concrete block foundation. Fenestration consists of one-over-one vinyl sash windows and a tripartite picture window on the façade (southeast elevation). The façade features a pedimented porch supported by simple columns. A partial width porch projects from the rear (northwest) elevation.

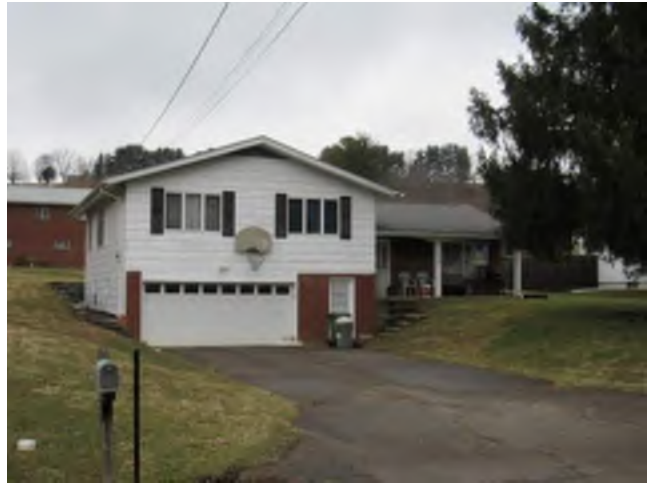
The house at 502 Parkway Drive is a ca. 1970, one-and-a-half story Modern Split-Level dwelling covered in applied stretcher bond brick and aluminum siding (Appendix C: Photograph 33). The house rests on a concrete block foundation and is capped by a gable roof covered in asphalt shingle. The L-shaped house features a two-story, projecting front gable with a garage on the ground level. A one-story ell projects from the northeast elevation of the front gable section of the house. An integral porch supported by simple square posts is located within the ell. The entry door within the porch is flanked by simple sidelights. Fenestration consists of double hung aluminum sash, simulated six-over-six windows and tripartite sliding windows.

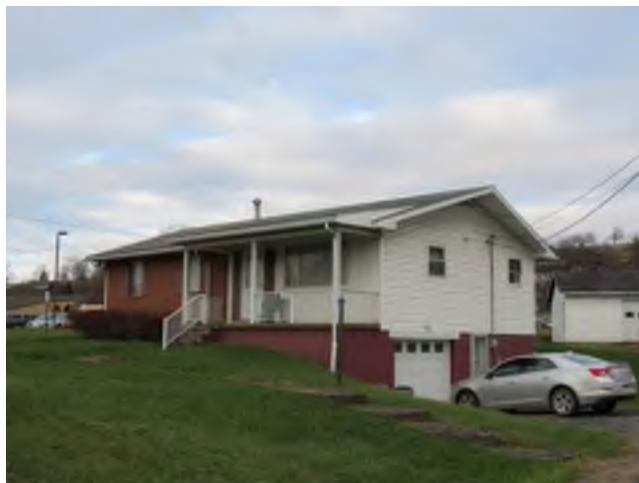
The house at 693 Greenbag Road is a ca. 1955 frame Ranch style building clad in applied stretcher bond brick and vinyl siding (Appendix C: Photograph 34). The side gable roof is covered in asphalt shingle and features overhanging eaves in the gable ends. Fenestration consists of sliding, fixed, and one-over-one metal sash windows. A partial width shed roof porch is appended to the façade (southeast elevation). An integral garage is located on the side (northeast elevation). A ca. 1980 two-bay detached garage clad in vinyl siding and capped by a side gable roof covered in asphalt shingle is located north of the house (Appendix C: Photograph 35).

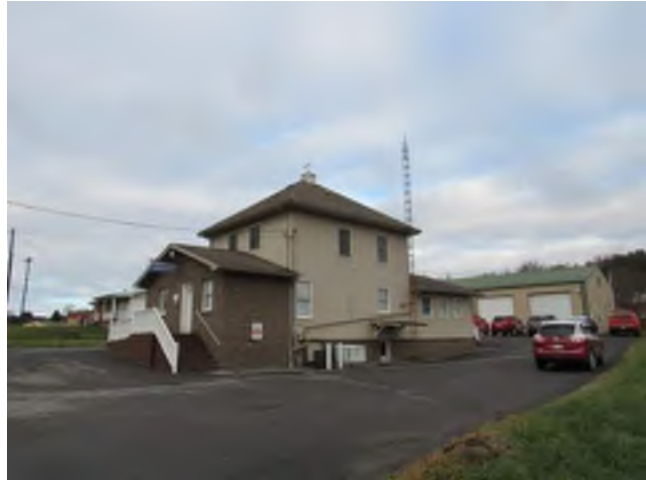
non-historic one-story addition covered in vinyl siding has been appended to the rear (northwest) elevation. A ca. 1990 three-bay detached commercial-scale garage covered in standing seam metal is located immediately northwest of the house (Appendix C: Photograph 37).

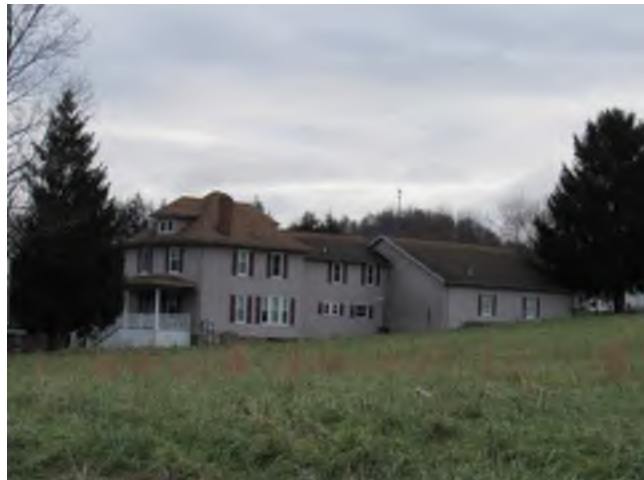
The house at 710 Greenbag Road is a ca. 1930 two-and-a-half-story American Four-Square type dwelling resting on a coursed rubble stone foundation (Appendix C: Photograph 38). The house is clad in vinyl siding and is capped by a steeply pitched hipped roof covered in asphalt shingle. The roof is pierced by an interior chimney and includes hipped roof dormer windows on the façade (northwest) and rear (southeast) elevations. An altered hipped roof porch supported by simple Doric columns with a balustrade decorates to the façade. Three non-historic additions have been added to the rear of the house to quadruple the area of the building's footprint. A two-story non-historic living space addition, a patio partially covered by a

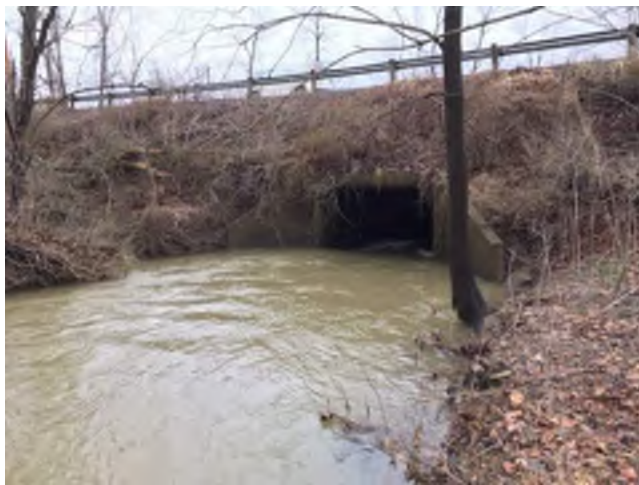
The ca. 1965 culvert is a single span, reinforced concrete box culvert that carries Greenbag Road and fill over Cobun Creek (Appendix C: Photograph 39). The culvert is 71 feet in overall length with a span that measures 14 feet wide. The culvert includes tapered reinforced concrete wingwalls on its north and south elevations.

The box culvert carrying Greenbag Road over Cobun Creek will be replaced by a wider box culvert.

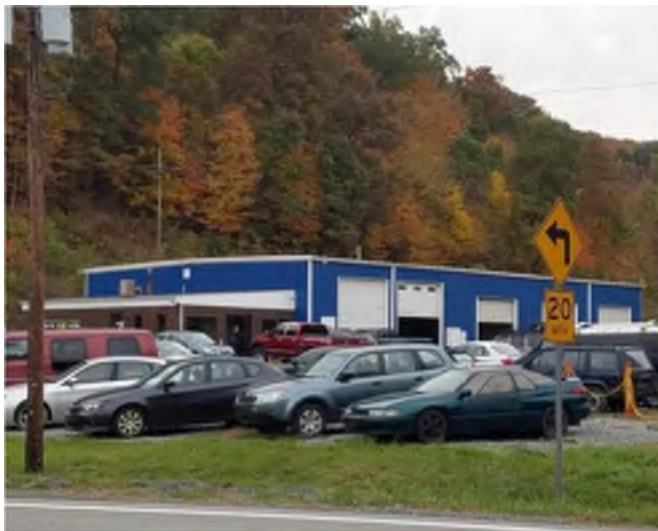
The tall, one-story, rectangular plan service building, built ca. 1970, is prefabricated with a standing seam metal roof and wall cladding (Appendix C: Photograph 40). A one-story shed-roof office area clad with brick veneer is attached to the north (front) elevation. Five oversize vehicle bays line the west (side) elevation. Parking lots frame the building to the north and west.

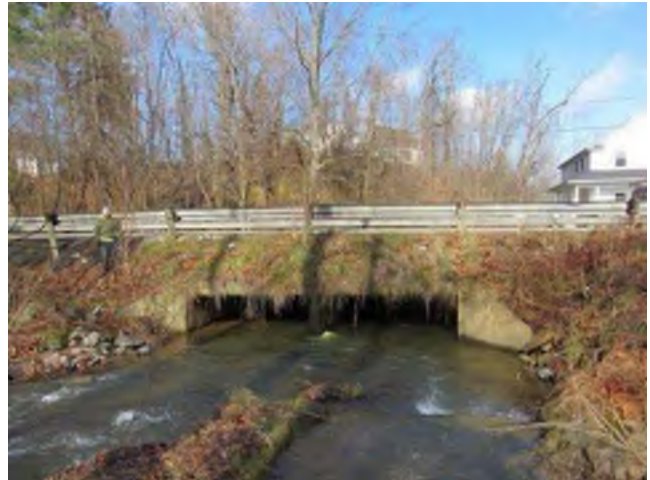
The MG-2666 / Aaron Creek Box Culvert (Structure No. 31A203) is a two-span continuous concrete culvert that was built ca. 1966 by the Greer Limestone Co. (WVDOH 1990) (Appendix C: Photograph 41). It is a cast in place structure consisting of two sidewalls, a center wall, a floor slab, and a roof slab, with two ten-foot span openings and a total length of 20.8 feet. A 2018 inspection of the culvert found that the structure was in fair condition (WVDOH 2018). The culvert retains integrity despite regular repairs to the structure and the addition of safety guardrails ca. 1996 (WVDOH 1990).

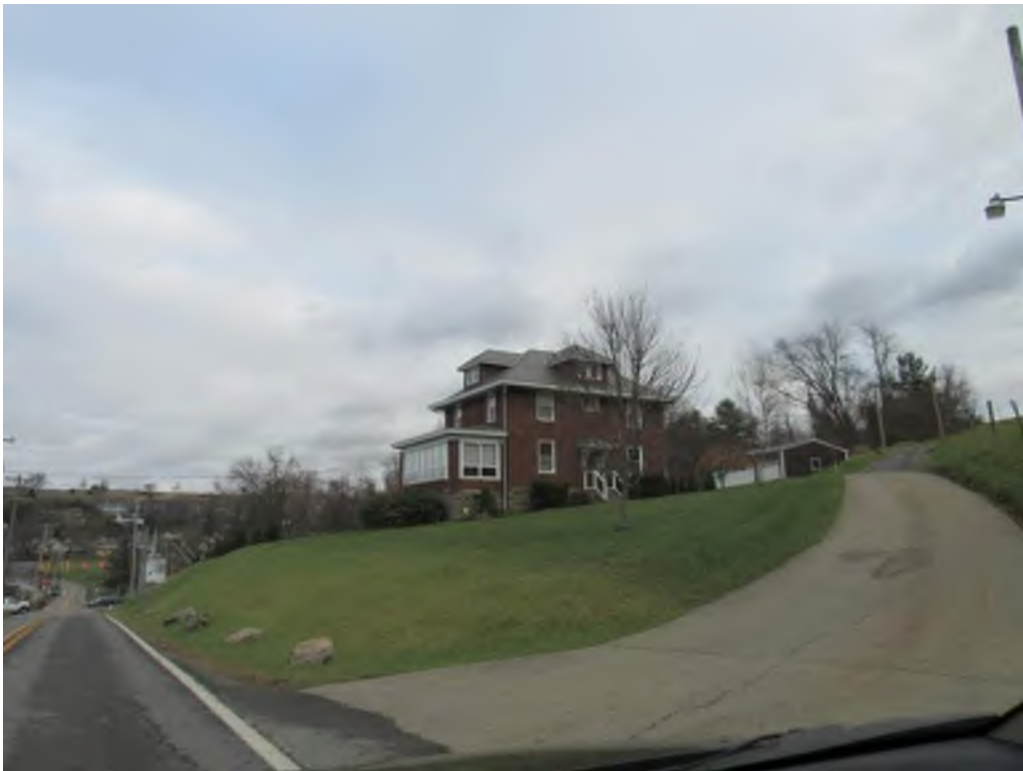
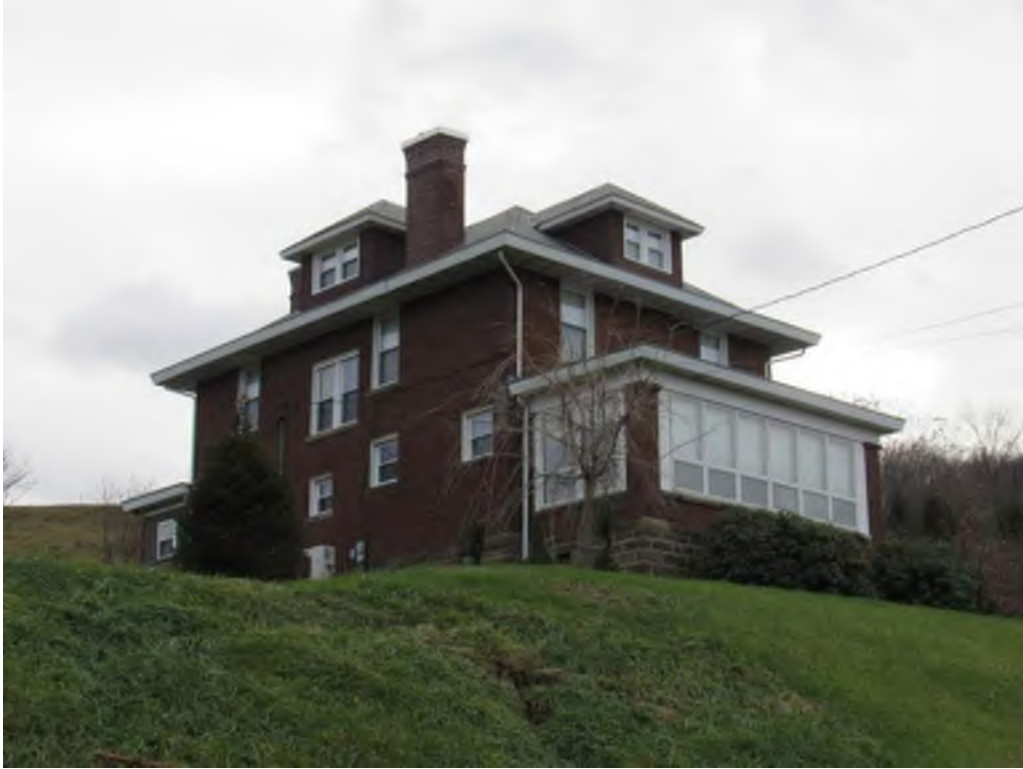
Photograph 20. MG-2647 / Anderson House, Morgantown, Monongalia County
Overview showing house and non-historic garage, facing northeast

Photograph 21. MG-2647 / Anderson House, Morgantown, Monongalia County
House showing enclosed front porch, facing southeast

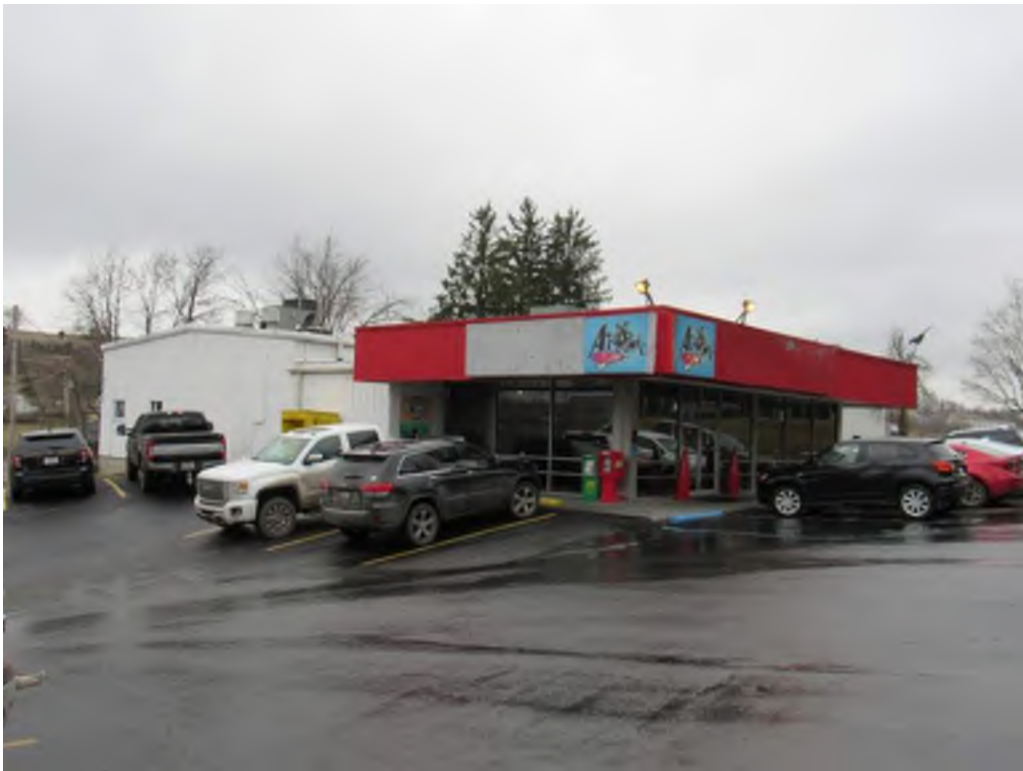
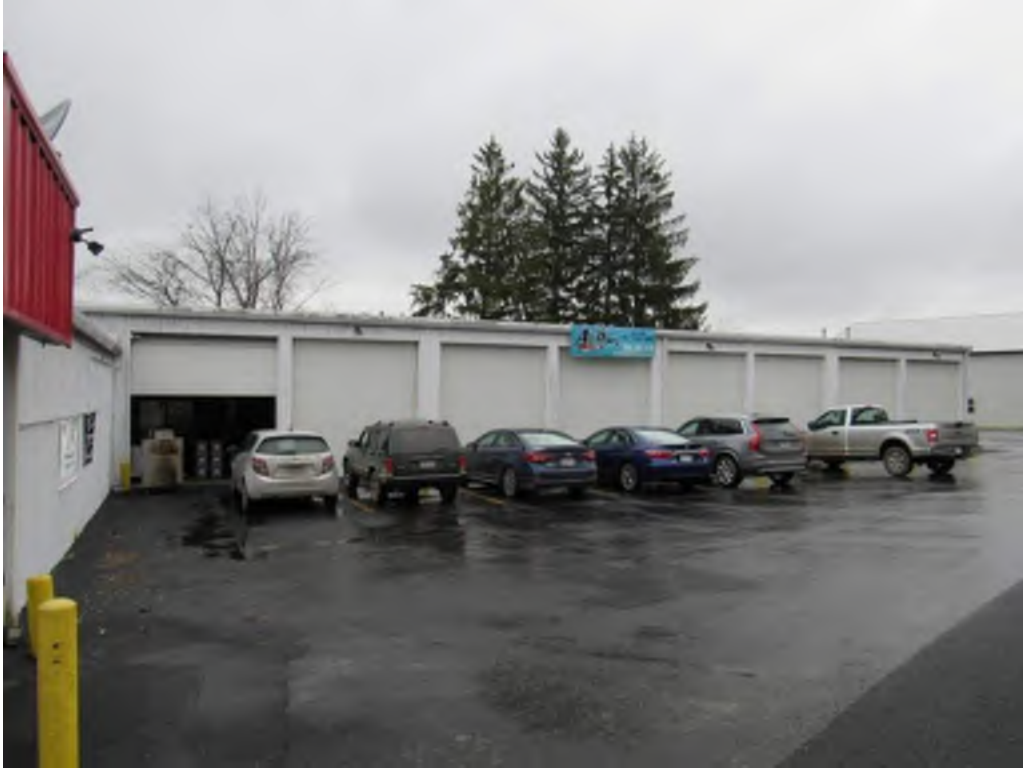
Photograph 24. MG-2650 / Atomic Grill, Morgantown, Monongalia County
Main entrance, facing northeast

Photograph 25. MG-2650 / Atomic Grill, Morgantown, Monongalia County
Garage bays, facing north

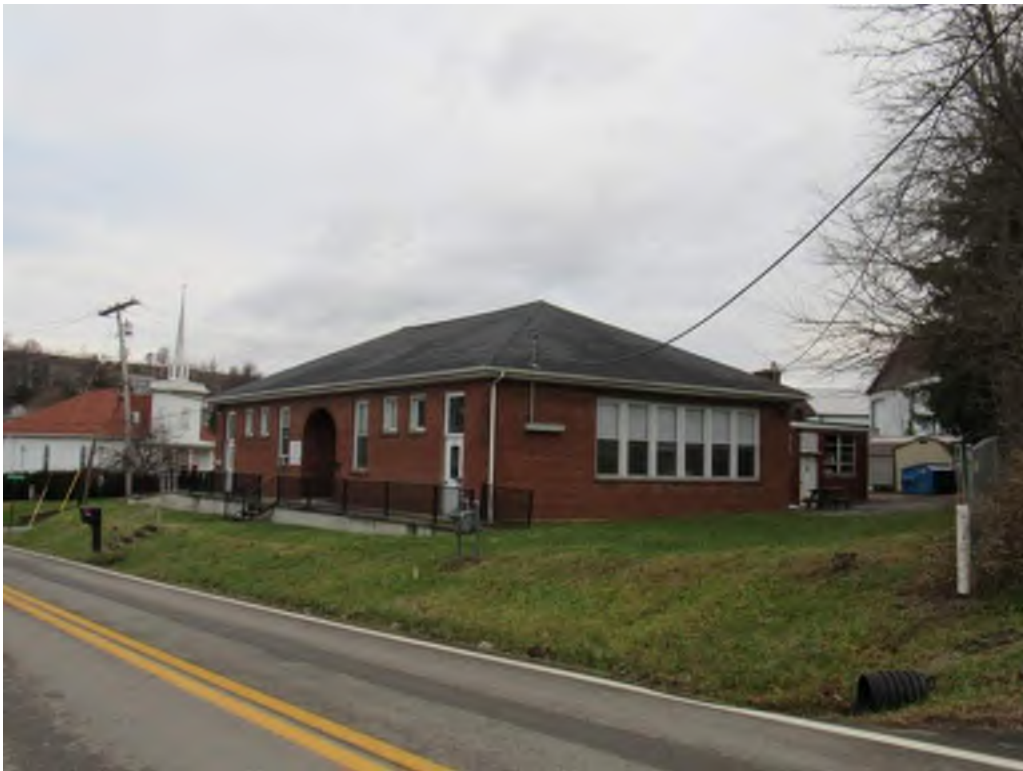
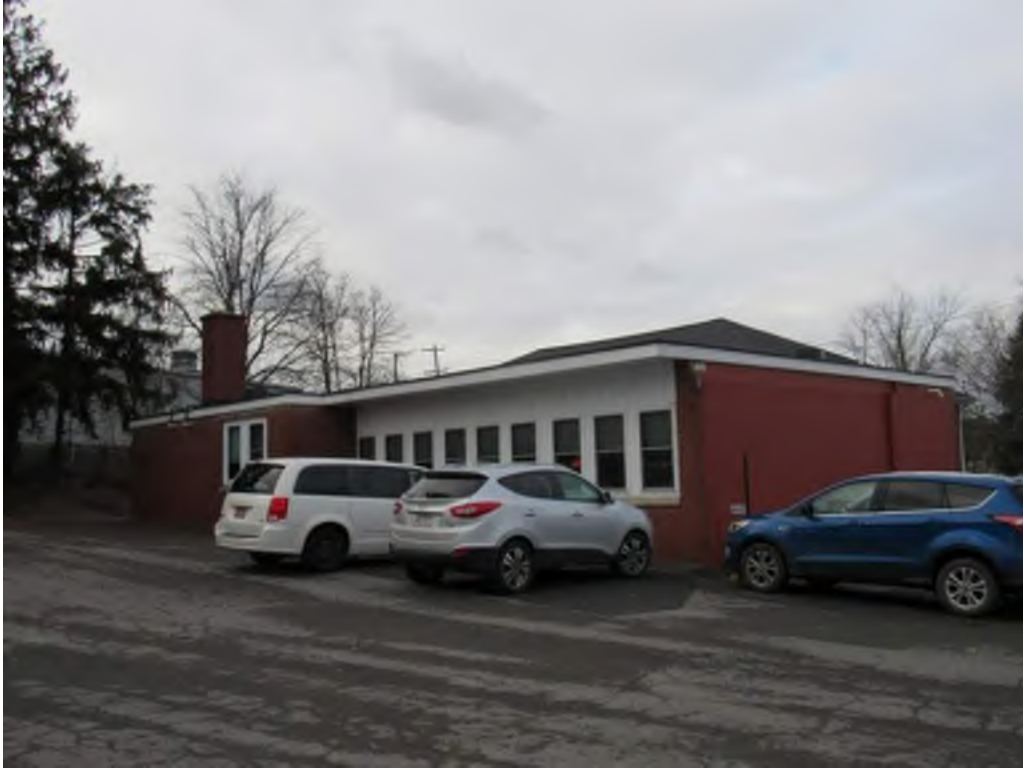
Photograph 26. MG-2651 / Dorsey School, Morgantown, Monongalia County
Façade and south elevation, facing northeast

Photograph 27. MG-2651 / Dorsey School, Morgantown, Monongalia County
Rear addition, facing southwest

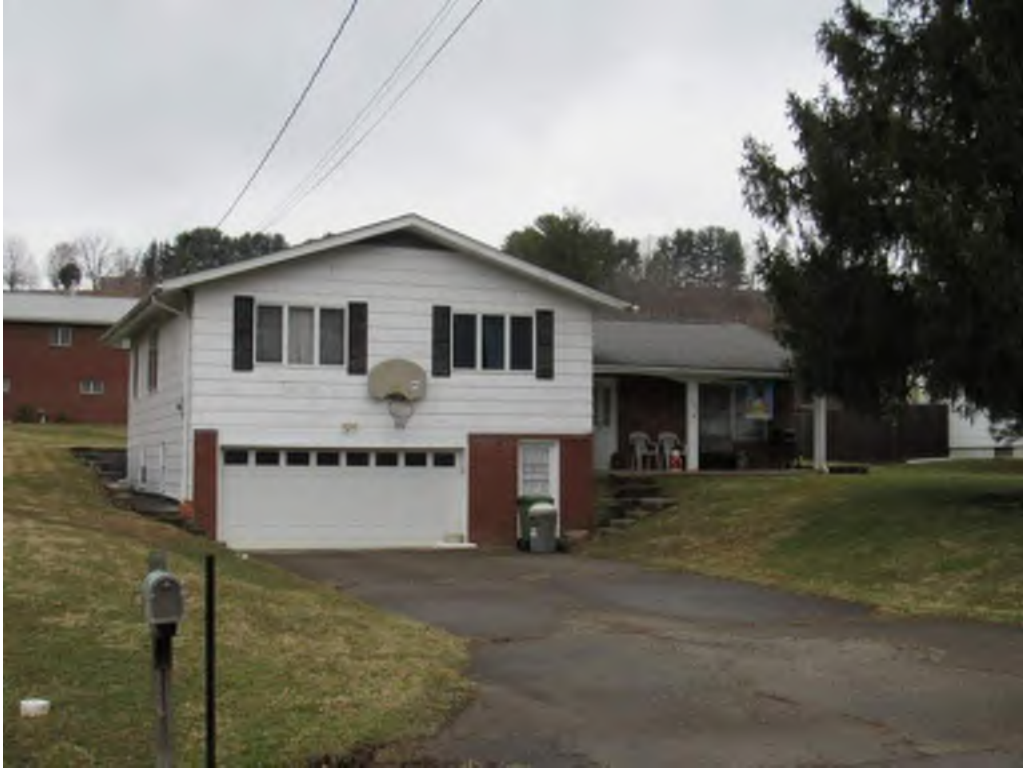
Photograph 32. MG-2656 / House at 500 Parkway Drive, Morgantown, Monongalia County
House and garage, facing north

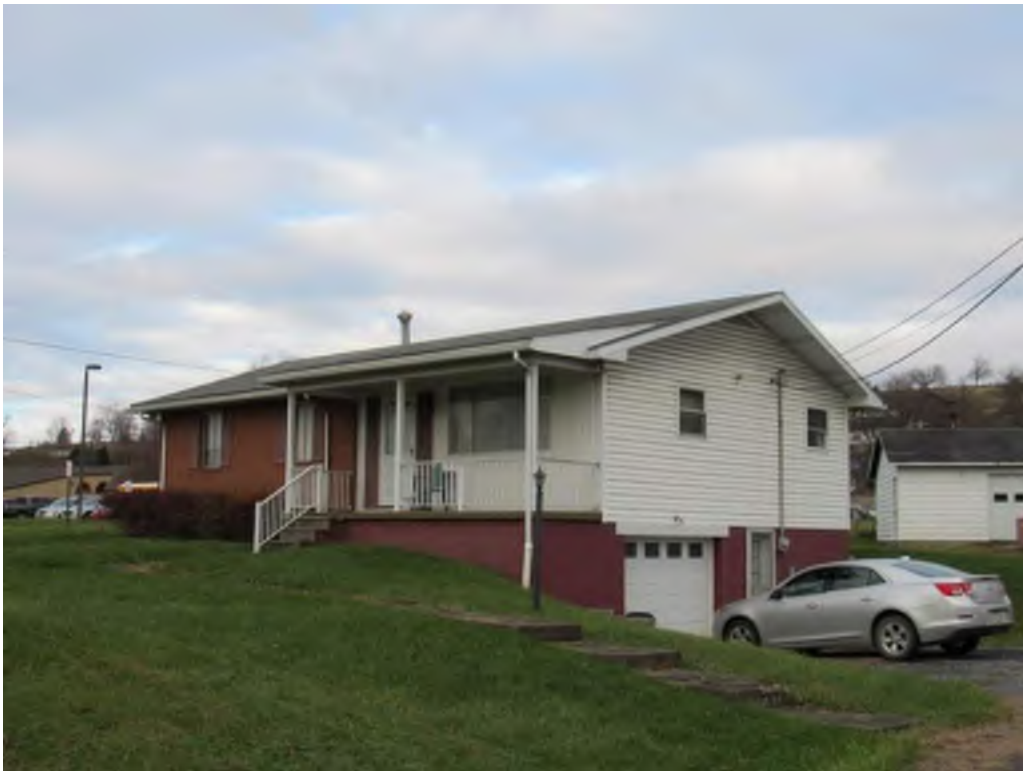
Photograph 33. MG-2657 / House at 502 Parkway Drive, Morgantown, Monongalia County
Garage and ell, facing northwest

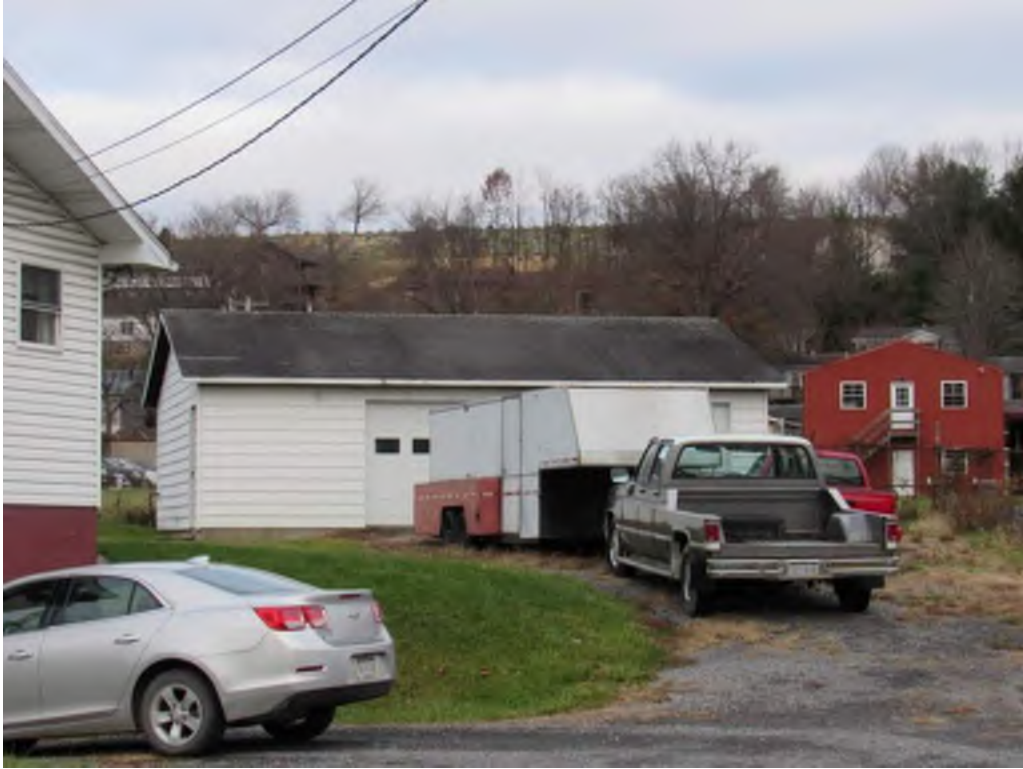
Photograph 34. MG-2658 / House at 693 Greenbag Road, Morgantown, Monongalia County
House with integral garage, facing northwest

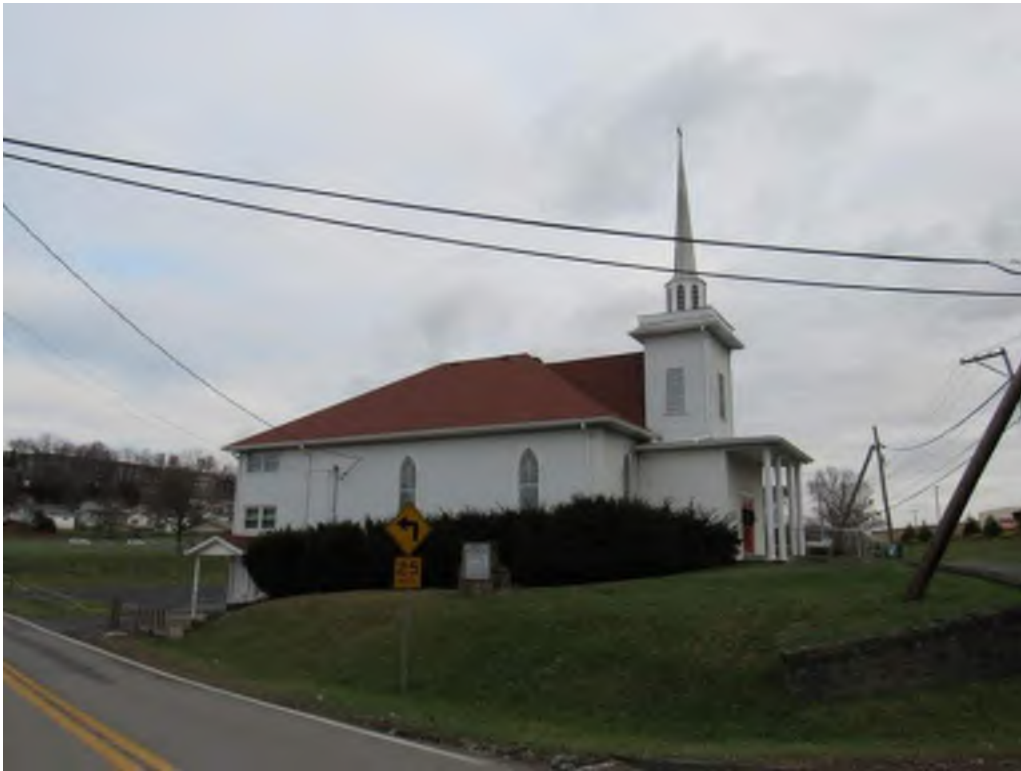
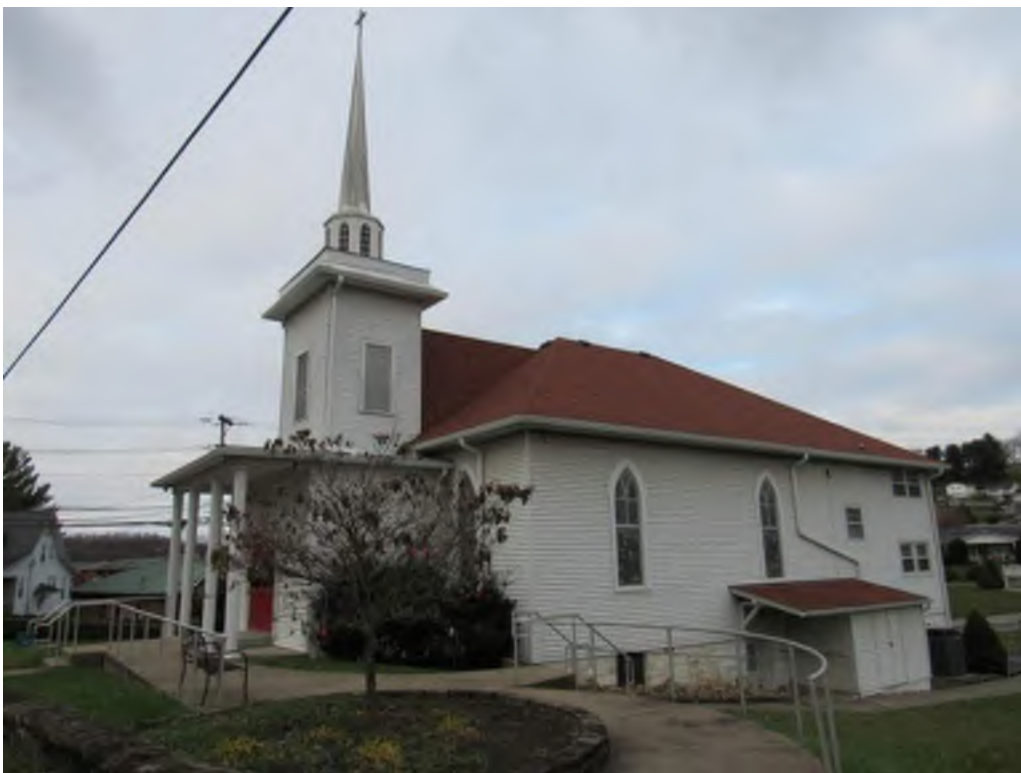
Harner Chapel is a ca. 1914 Carpenter Gothic frame building covered in vinyl siding and capped by a hipped roof covered in asphalt shingle (Photographs 1-2). The chapel rests on a rock faced concrete block foundation, and its façade features a narthex with a full height bell tower capped by a simple ca. 1990 spire with fixed Gothic arch windows. The fenestration of the chapel consists of Gothic arch windows and paired vinyl sash, one-over-one windows in the ca. 1955 two-story rear addition. A ca. 1990 partial width, shed roof addition has been appended to the northeast elevation. The reconfiguration of the bell tower with a non-historic spire, the large rear addition, and the use of replacement roofing and cladding materials has compromised the historic integrity of the chapel.

Photograph 1. Façade and rear addition (left), facing northeast (2018-12-04)

Photograph 2. Northeast elevation, facing northwest (2018-12-04)
