**Greenbag Road Improvement Project
Environmental Assessment
Monongalia County, West Virginia**

State Project: U331-857-0.67
Federal Project: STP-0857(019)D

August 2020

ENVIRONMENTAL ASSESSMENT

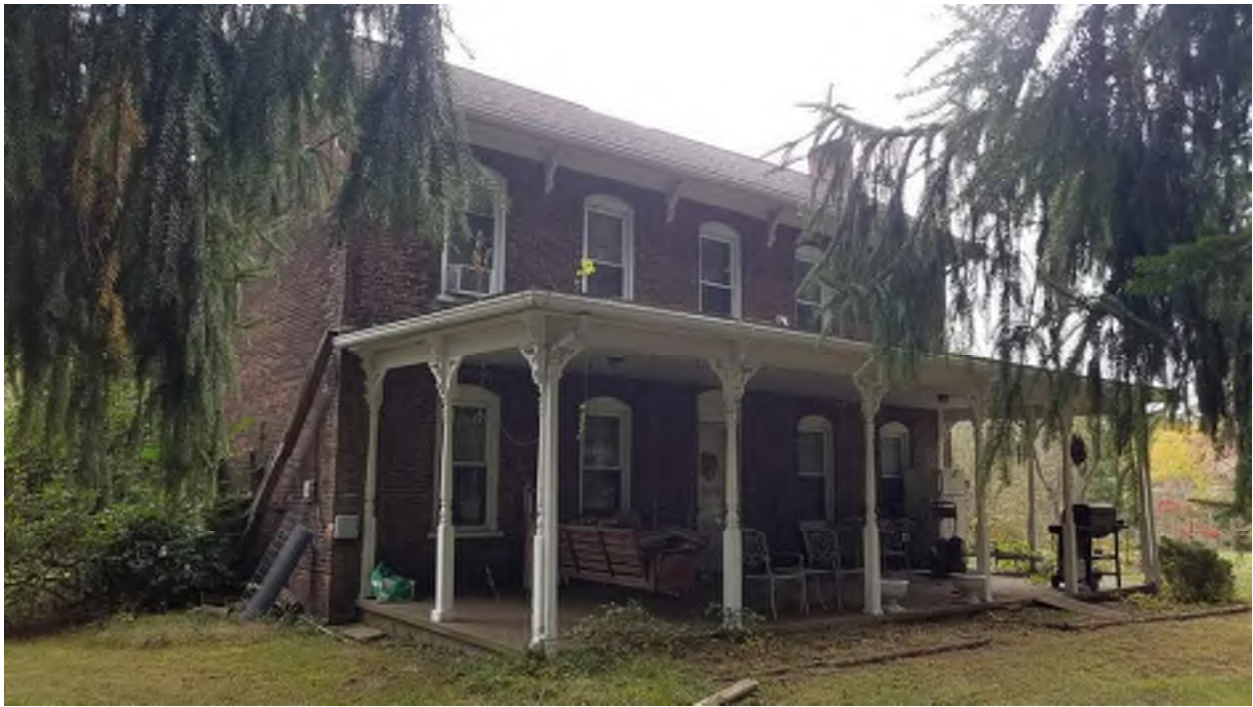
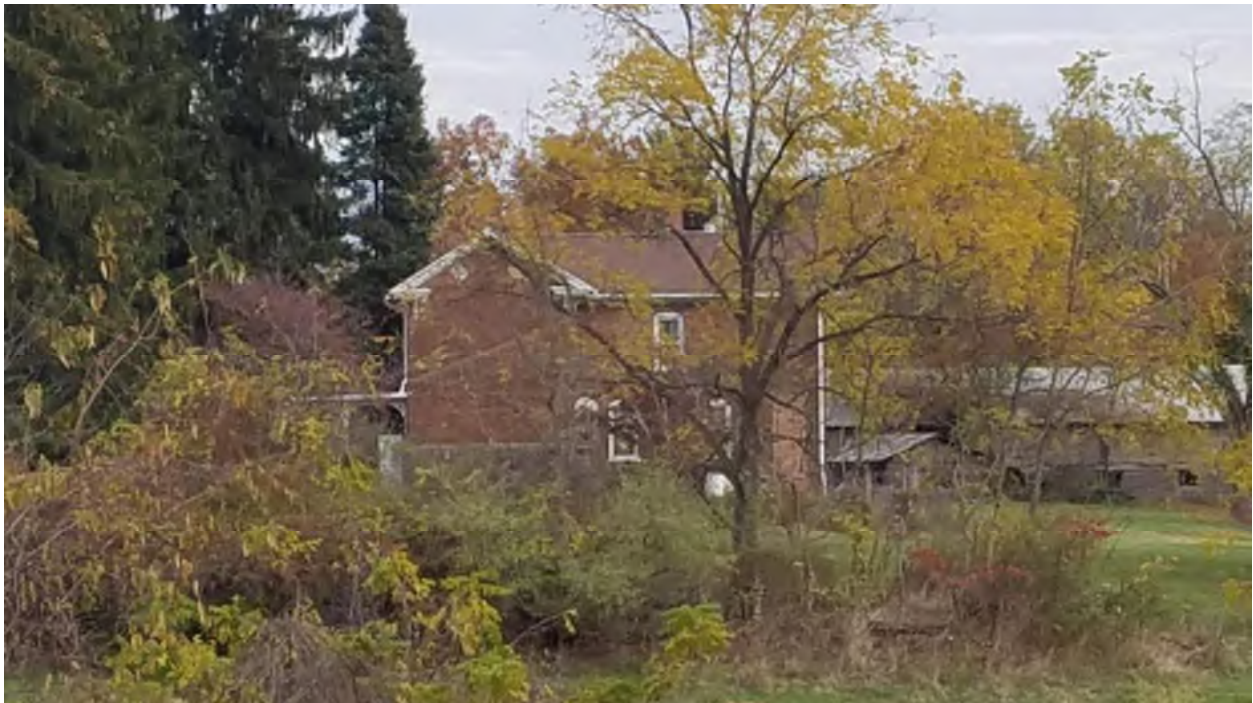
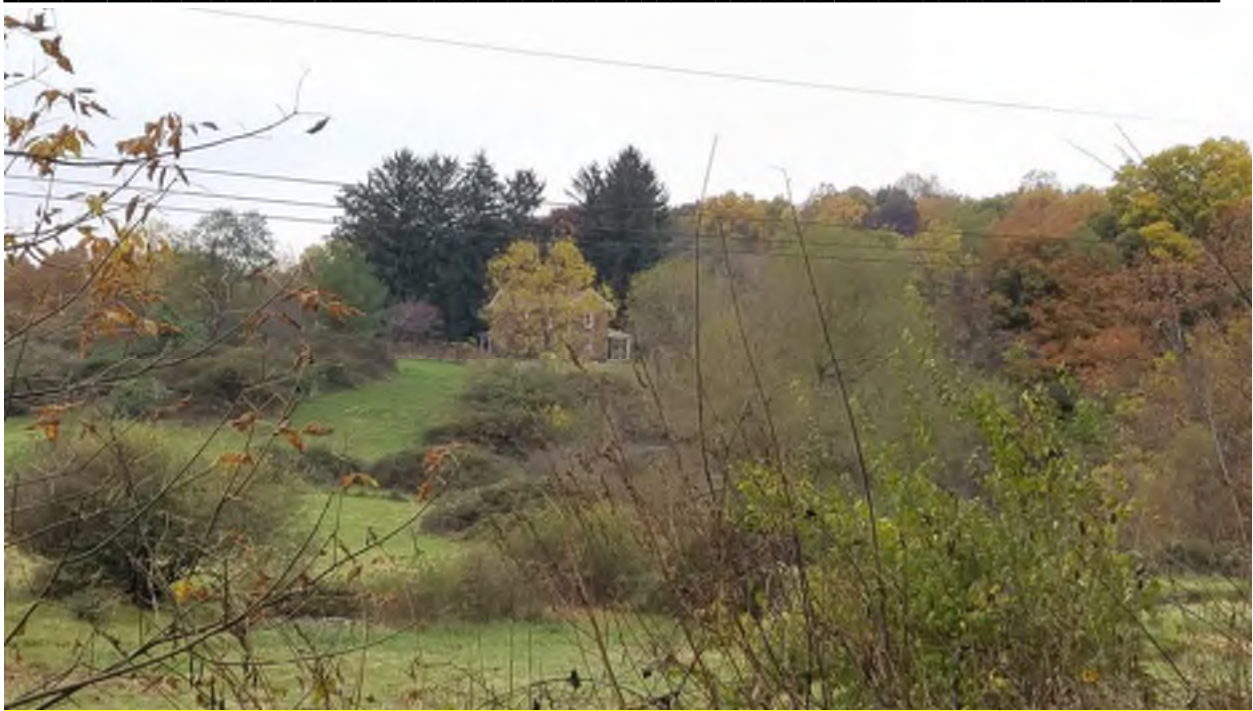
A long gravel driveway leads up a steep embankment from Greenbag Road at the north edge of the farm to the two-story brick Campbell Farmhouse at the heart of the farmstead (Photographs 1-3). The Italianate farmhouse, which was built ca. 1886, has a T-shaped plan formed by the five bay front section of the farmhouse and a perpendicular two-story rear ell. The farmhouse has a three gable roof with prominent gable returns and replacement asphalt shingle roofing. Two interior end brick chimneys flank the main section of the house and a third brick chimney is located at the center of the rear ell. The brick walls are laid in an American common bond pattern with seventh row headers and feature tall segmental arch window openings on all elevations, although at least one window on the south (side) elevation has been bricked in and one window on the east (rear) elevation has been resized. The current windows are one-over-one metal sash replacements. The farmhouse has a full width front porch with a shallow half hipped roof, turned posts, and scroll sawn brackets. Similar scrolled brackets line the cornice under the eaves. A secondary porch is located on the north elevation of the rear ell. The farmhouse has the characteristic massing, design, and ornamentation of a classic Italianate Style dwelling.

Photograph 1. North and west (front) elevations of the Campbell Farmhouse, facing southeast.

Photograph 2. South (side) elevation of the farmhouse, facing north.

Photograph 3. View of Campbell Farmhouse rear elevation in the distance, facing northwest.

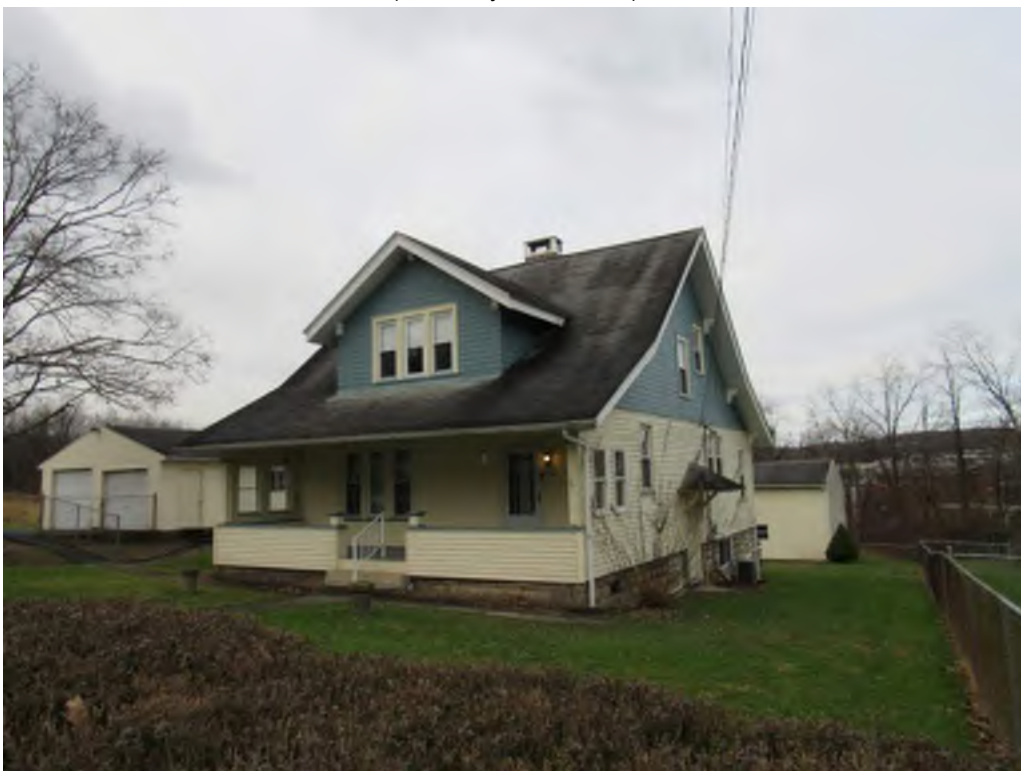
The house at 1440 Dorsey Avenue is a one-and-a-half-story ca. 1915 Bungalow style dwelling partially clad in vinyl siding and wood shingle (Photograph 1). The house rests on a rock faced concrete block foundation and is capped by a side gable roof covered in asphalt shingle. Decorative brackets adorn the overhanging eaves. The roof is pierced by an interior brick chimney and features a front gable dormer on the façade (east elevation). Fenestration consists of replacement one-over-one vinyl sash windows and fixed glass block windows in the basement level. The integral front porch has been partially enclosed with vinyl siding. A ca. 1990 two-bay detached garage covered in vinyl siding and capped by an asphalt shingle front gable roof is located immediately south of the house (Photograph 2). A ca. 2000 combination garage and shed clad in vinyl siding and capped by an asphalt shingle gable roof is located west of the house (Photographs 1 and 2).

Photograph 2. House and non-historic garage (left), facing southwest (Markosky 2018-12-04)

The house at 1440 Dorsey Avenue lacks integrity because it has undergone alterations including the replacement of siding, windows, and roof materials and the partial enclosure of the front porch. While the house maintains some characteristic architectural elements of the Bungalow house type and Craftsman style, such as the brackets in the eaves, it stands as a common and unexceptional example of its kind and does not possess the architectural merit necessary for listing in the NRHP. Higher style examples of the Bungalow and Craftsman styles can be found in the NRHP listed Chancery Hill and South Park Historic Districts located approximately one mile to the northwest. Therefore, it is not recommended eligible under Criterion C. The house has not been evaluated for significance under Criterion D for its potential to yield information important to the understanding of history or prehistory.

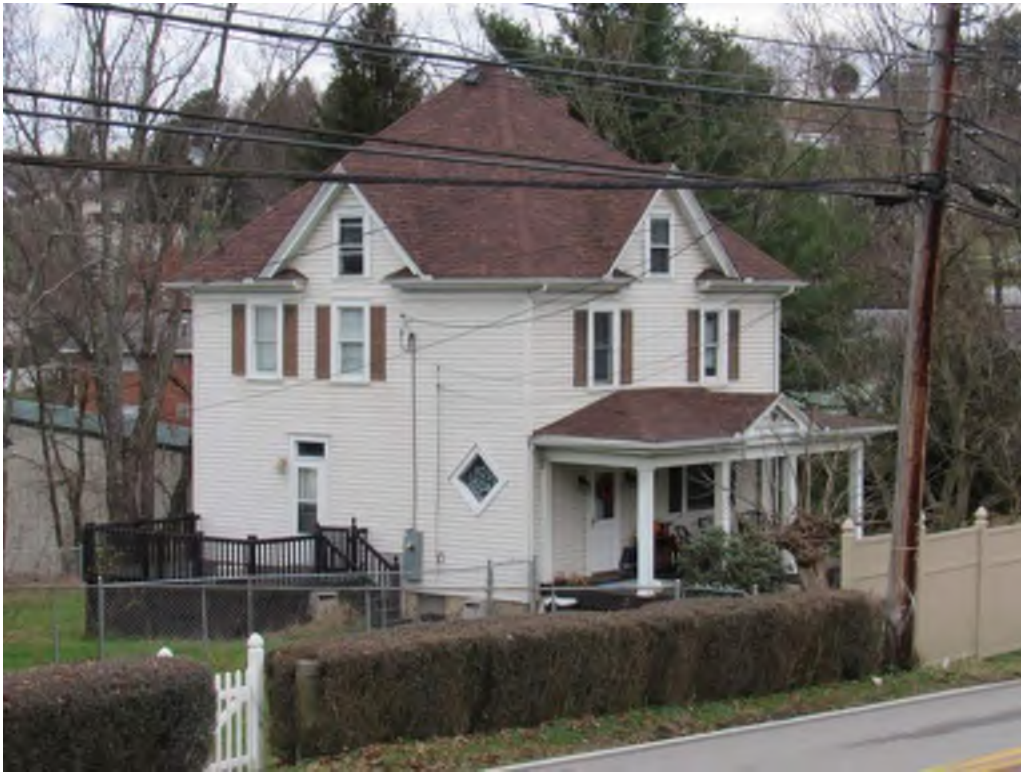
The Smith House is a ca. 1915 two-story modified Four-Square dwelling clad in vinyl siding and resting on a foundation covered in stucco (Photographs 1 and 2). The steeply pitched hipped roof is covered in asphalt shingle and features three cross gable wall dormer windows with gable returns that appear to be variants on the Free-Classic Queen Anne Style. The roof is pierced by one interior brick chimney. Fenestration consists of replacement one-over-one vinyl sash windows, one fixed diamond shaped vinyl sash window, and an altered fixed vinyl sash picture window. The full width hipped roof porch on the façade (east elevation) is supported by simple square columns and features a cross gable pediment.

Photograph 1. East and south elevations, facing northwest (Markosky 2018-12-04)

The Smith House has undergone a loss of integrity due to replacement siding and roof materials, alterations to some original window openings, and the removal of other historic materials. It stands as a common and unexceptional example of its style. Higher style examples of the Four-square type can be found in the NRHP listed Chancery Hill Historic District and South Park Historic District located approximately one mile to the northwest. The Smith House is therefore not eligible for listing under Criterion C. The house has not been evaluated for significance under Criterion D for its potential to yield information important to the understanding of history or prehistory.

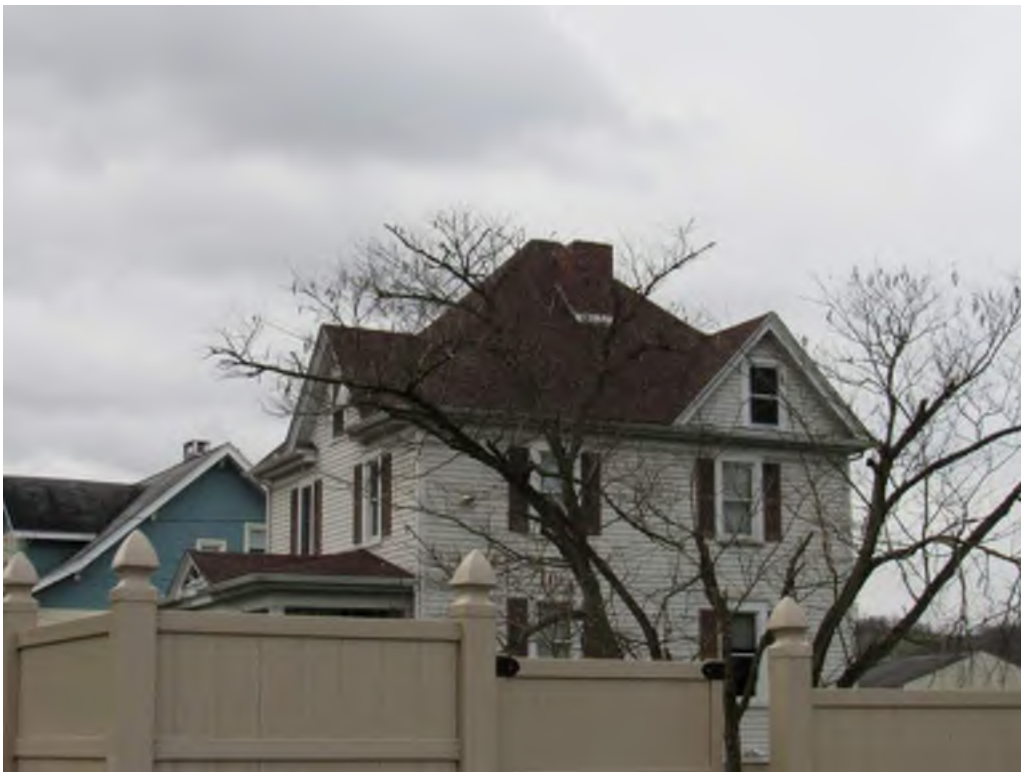
Photograph 2. East and north elevations, facing southwest (Markosky 2018-12-04)

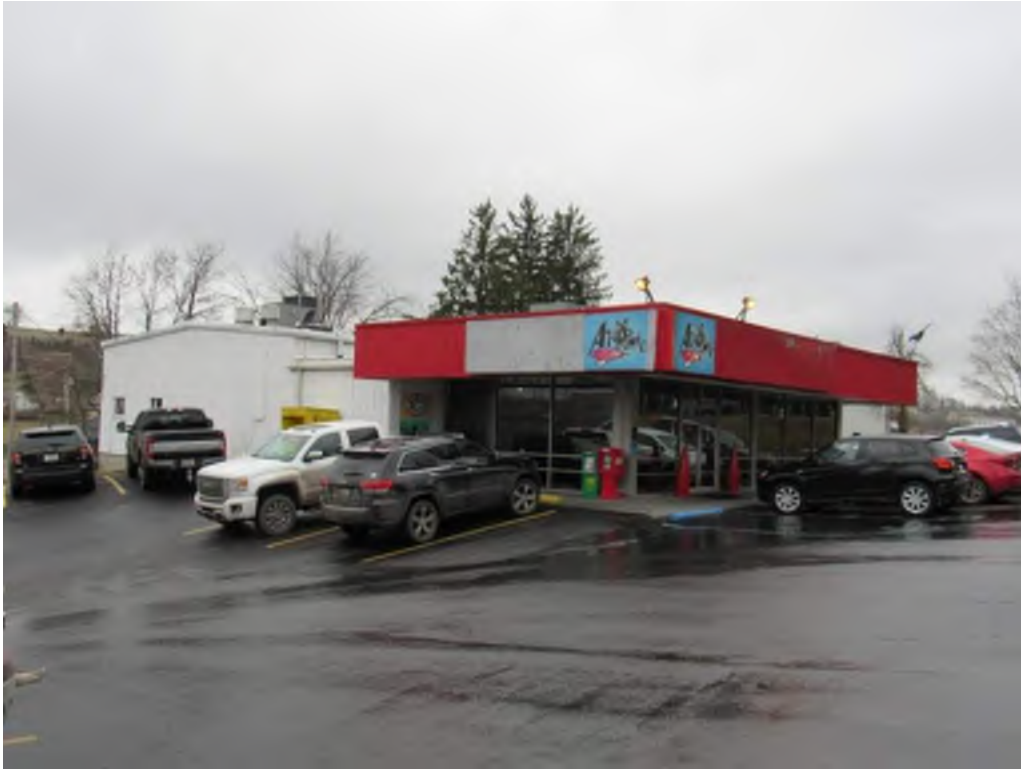
The Atomic Grill is a 1974 steel-frame commercial building clad with standing seam metal panels and resting on a concrete block foundation (Photographs 1 and 2). The main portion of the L-shaped building is a steel frame structure capped by a side gable roof with an eight bay garage for commercial trucks. A storefront entrance projects from the southeast elevation with plate glass walls and a flat roof with covered in standing seam metal. The building is surrounded by a parking lot.

Photograph 1. Main entrance, facing northeast (Markosky 2019-02-05)

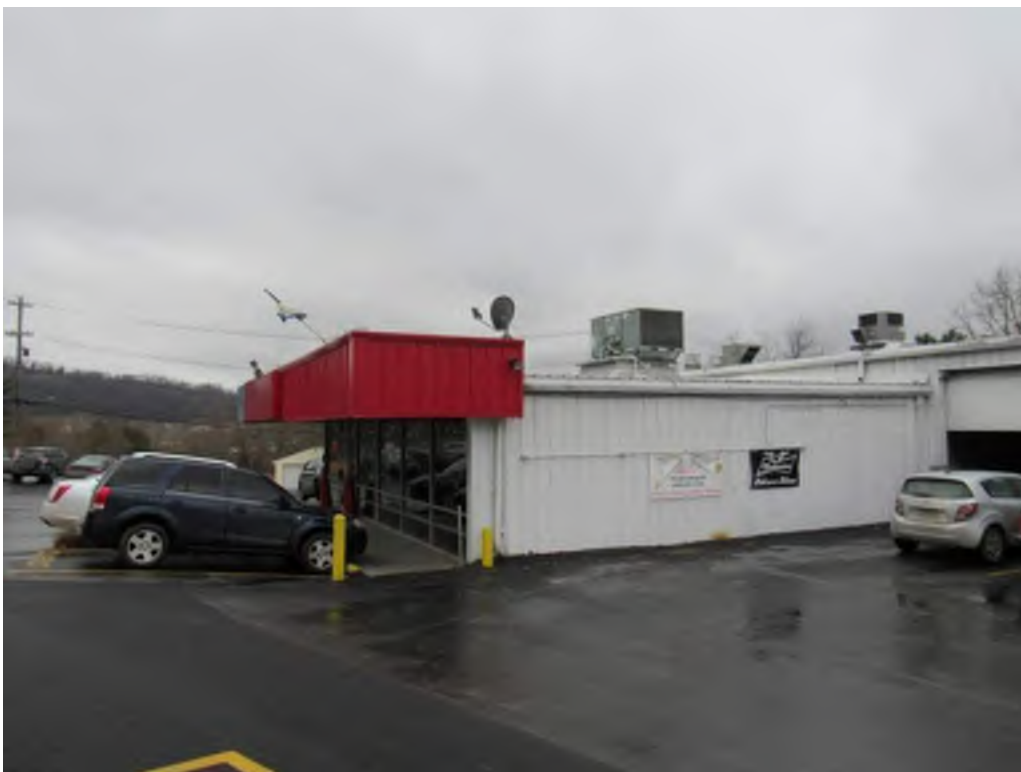
Photograph 2. Dining area, facing west (Markosky 2019-02-05)

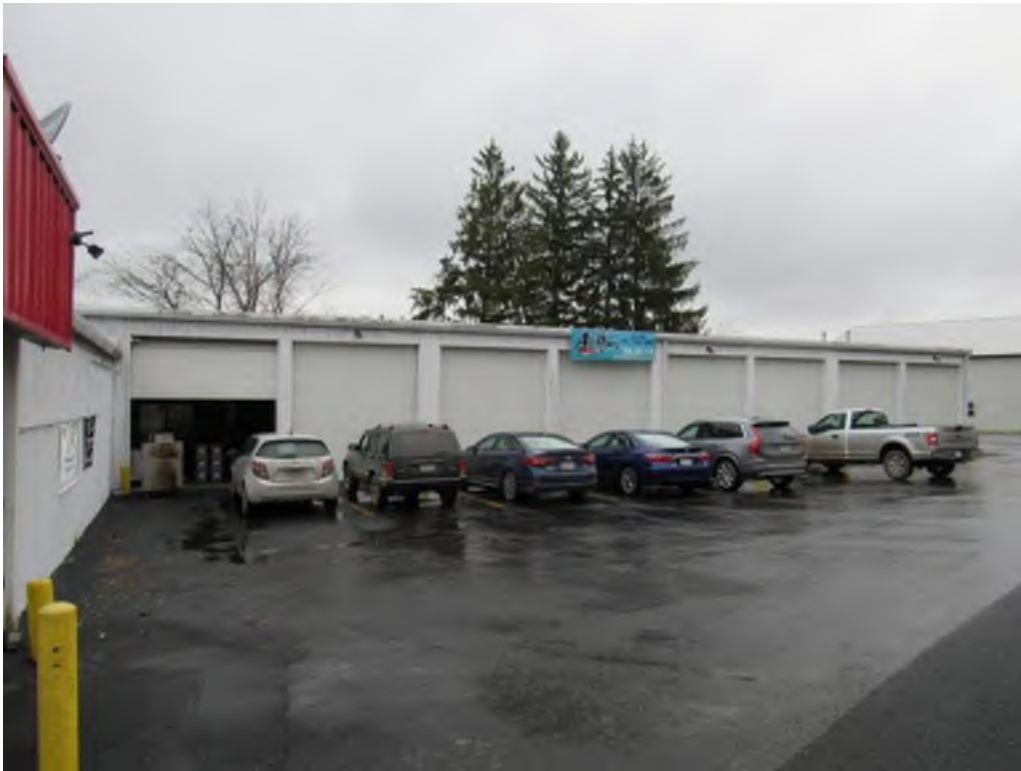
Photograph 3. Garage bays, facing north (Markosky 2019-02-05)

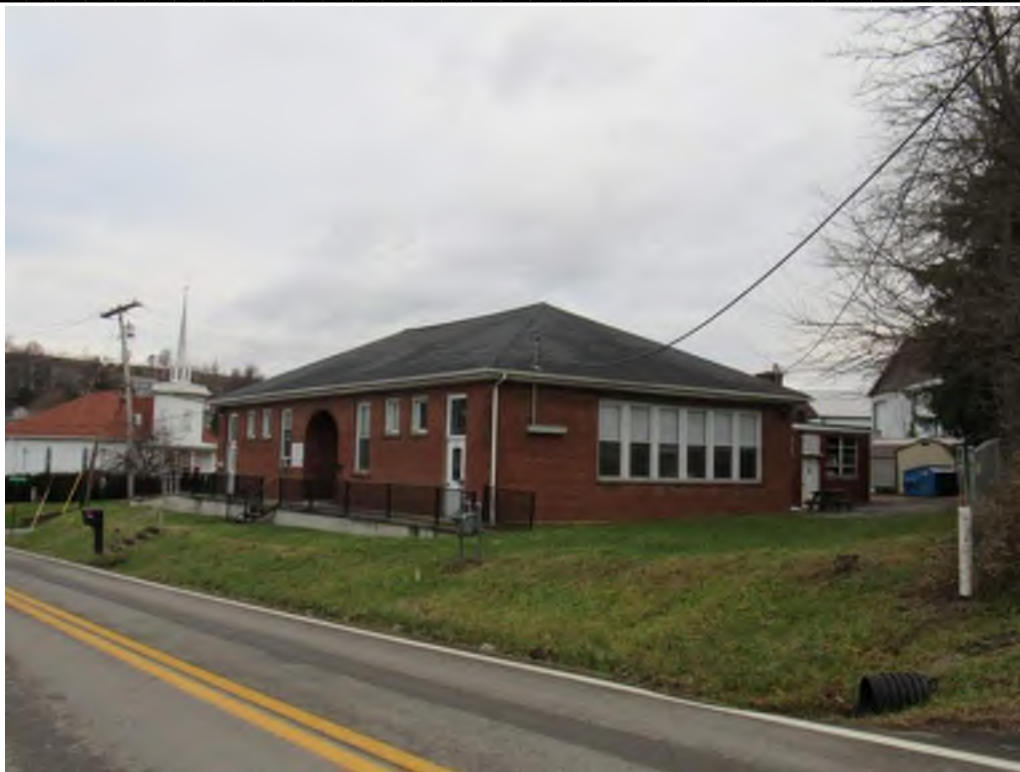
The Dorsey School is a one-story ca. 1920 Classical Revival school house clad with American common bond brick walls (Photographs 1-3). The hipped roof is covered in asphalt shingle. Fenestration consists of replacement one-over-one vinyl sash windows, fixed vinyl sash windows, and louvered metal windows. The windows feature simple brick sills. A non-historic one-story concrete block rear addition with a flat roof is appended to the east elevation. A deeply recessed entrance on the façade (west elevation) features a segmental arch entry accented with decorative brickwork. The modern replacement door is surrounded by a modern simple transom and what are likely original sidelights.

Photograph 1. Façade and south elevation, facing northeast (2018-12-05)

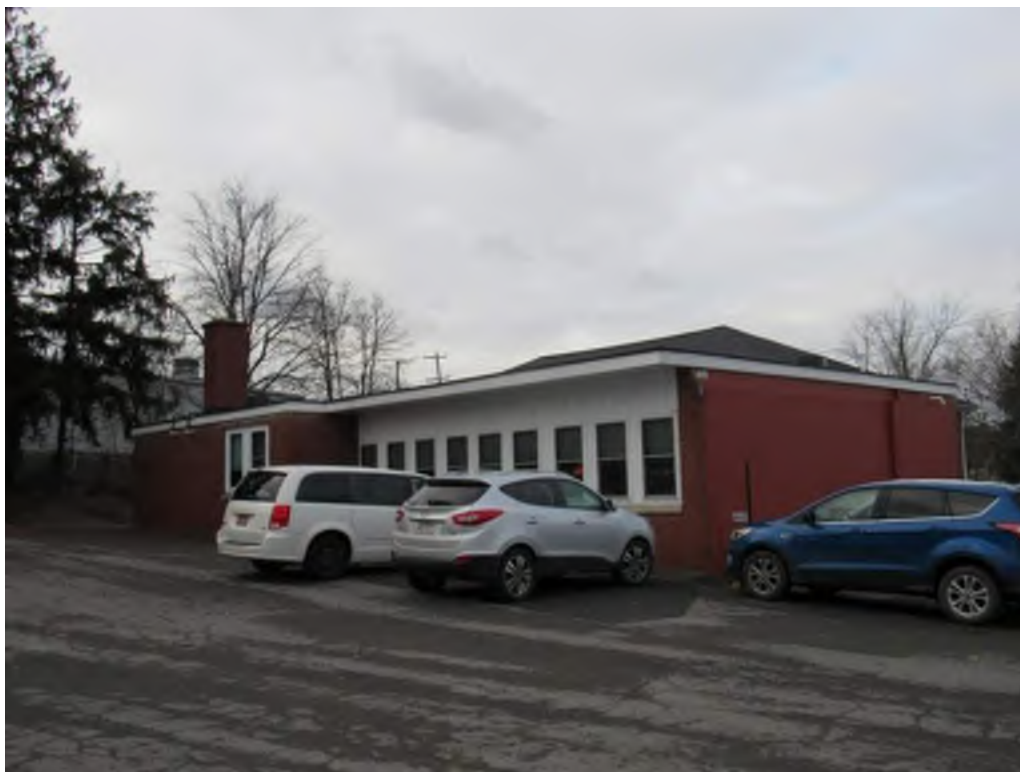
Photograph 2. Rear addition, facing southwest (2018-12-05)

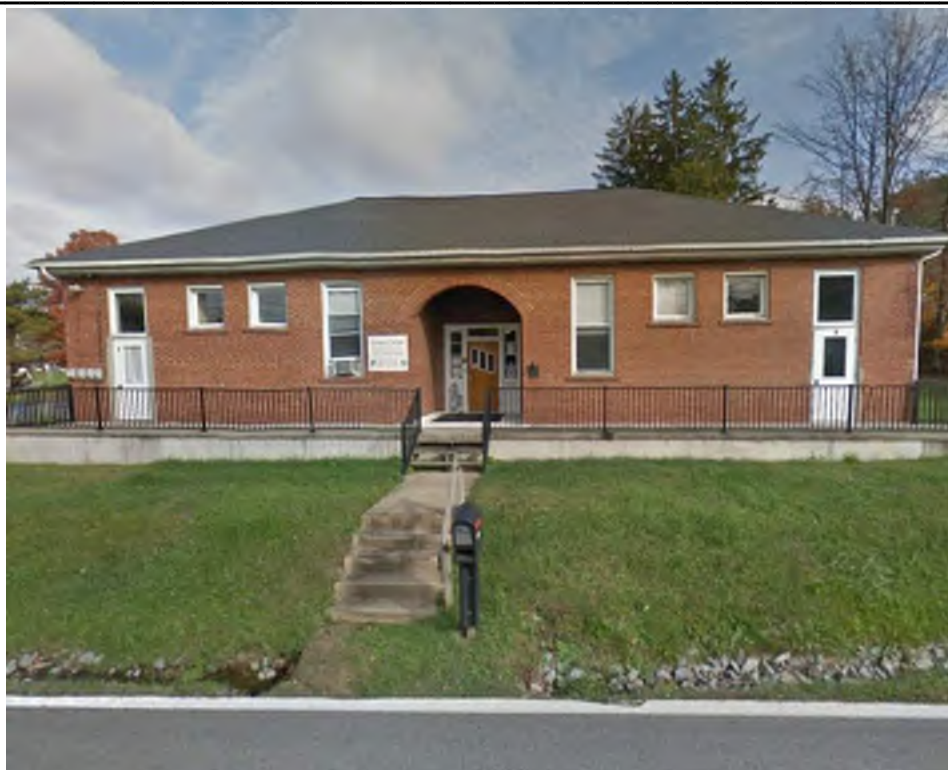
Photograph 3. Recessed entrance fronting Dorsey Avenue, facing east (Google Earth 2018)

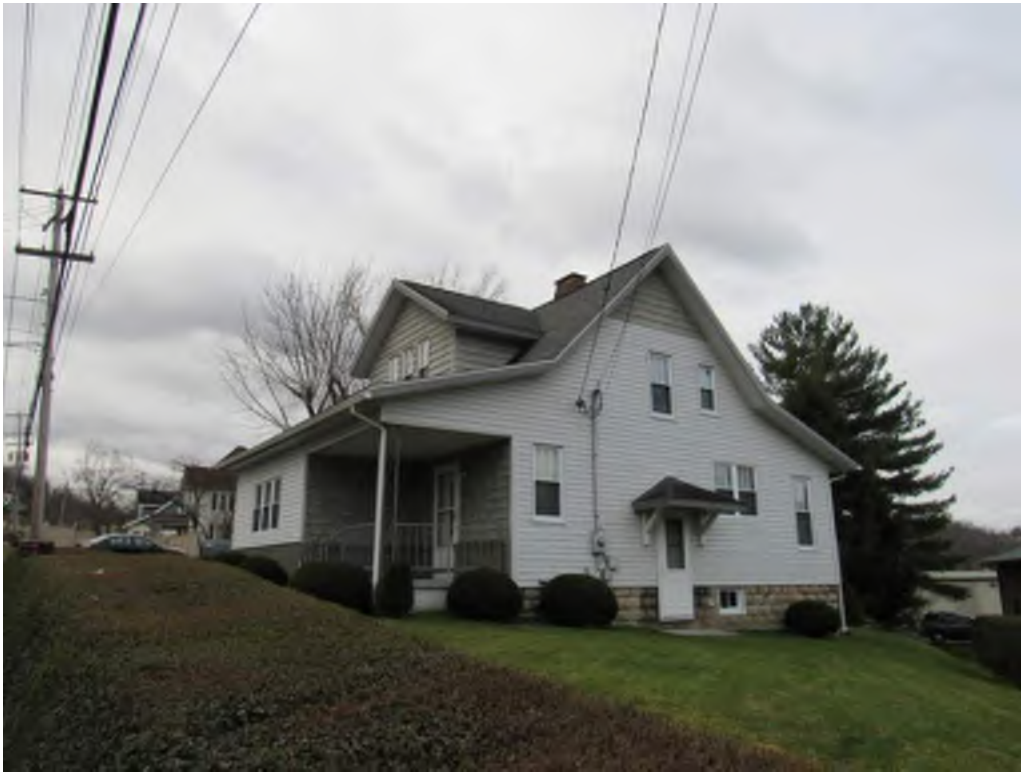
The house at 1432 Dorsey Avenue is a ca. 1915 one-and-a-half-story Bungalow style dwelling covered in vinyl siding and synthetic wood shingle (Photograph 1). The house rests on a rock faced concrete block foundation and is capped by a side gable roof covered in asphalt shingle. The roof is pierced by an interior central chimney and a front gable dormer window is located on the façade (east elevation). The façade features a partially enclosed integral shed roof porch resting on a concrete block foundation. Fenestration consists of simulated three-over-one vinyl sash windows and sliding vinyl sash windows in the basement level.

Photograph 1. House showing enclosed porch, facing southwest (Markosky 2018-12-05)

No information was recovered linking the house at 1432 Dorsey Avenue to events significant on the local, state, or national level. Therefore, it is not eligible for listing on the NRHP under Criterion A. No information was recovered to suggest the house was historically associated with individuals significant on the local, state, or national level. Therefore, it is not eligible for listing under Criterion B. The house at 1432 Dorsey Avenue lacks integrity because it has undergone alterations with replacement siding, windows, and roofing as well as a partially enclosed front porch. For these reasons it is not eligible for listing under Criterion C. The house has not been evaluated for significance under Criterion D for its potential to yield information important to the understanding of history or prehistory.

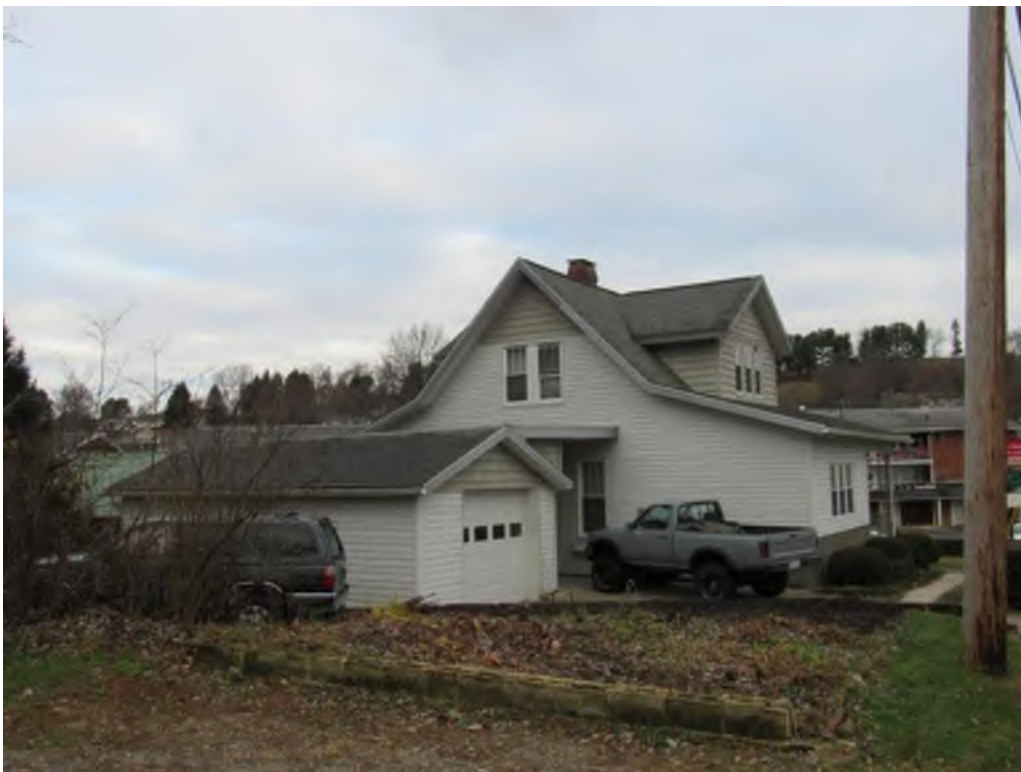
Photograph 2. House and garage, facing northwest (Markosky 2018-12-05)

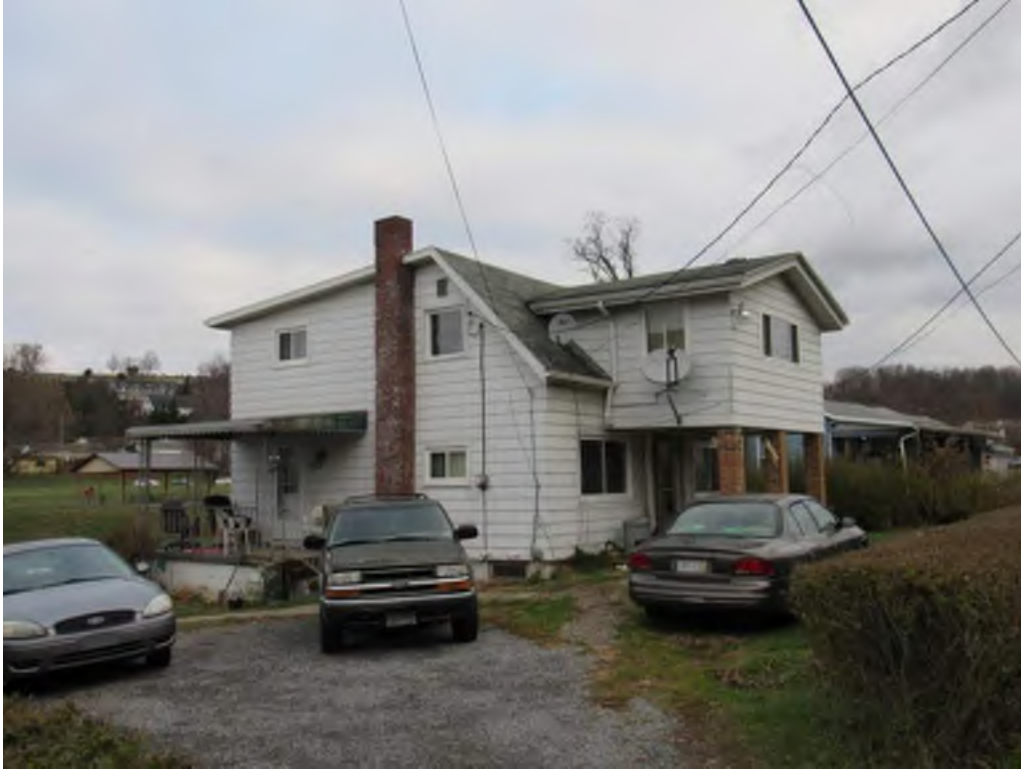
The house at 102 Luckey Lane is a ca. 1940 one-and-a-half story Minimal Traditional style dwelling covered in aluminum siding and capped by a side gable roof covered in asphalt shingle. The roof is pierced by one exterior brick chimney. The house rests on a concrete block foundation and fenestration consists of fixed and sliding vinyl sash windows. A partial width, second story addition supported by brick piers has been appended to the façade (southeast elevation). The addition is capped by a front gable roof covered in asphalt shingle. A two-story, full width addition has been appended to the rear (northwest) elevation. Two shed roof porch additions resting on concrete block foundations are appended to the northeast and southwest elevations.

Photograph 1. House with second story enclosed addition, facing northeast (Markosky 2018-12-05)

No information was recovered linking the house at 102 Luckey Lane to events significant on the local, state, or national level. Therefore, it is not eligible for listing on the NRHP under Criterion A. No information was recovered to suggest the house was historically associated with individuals significant on the local, state, or national level. Therefore, it is not eligible for listing under Criterion B. The house at 102 Luckey Lane lacks integrity because it has undergone alterations (including replacement siding, roofing, and windows) and multiple additions (including a second story addition on the façade). For these reasons it is not eligible for listing under Criterion C. The house has not been evaluated for significance under Criterion D for its potential to yield information important to the understanding of history or prehistory.

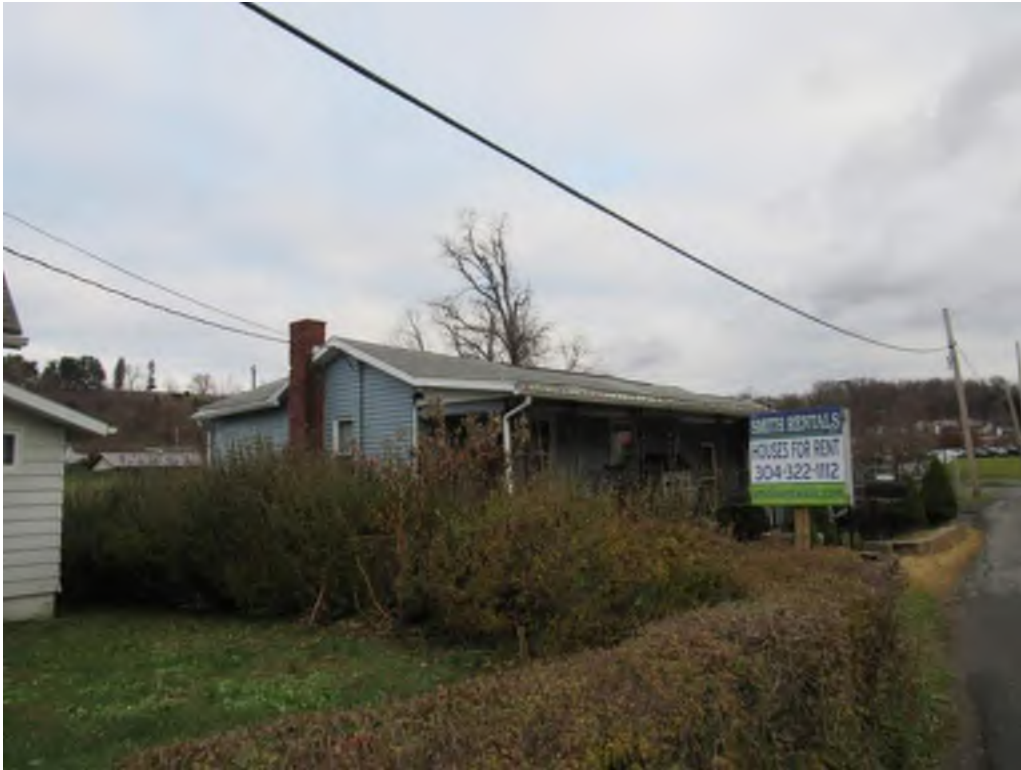
The house at 104 Luckey Lane is a ca. 1940 one-story Minimal Traditional style dwelling clad in vinyl siding and resting on a concrete block foundation. The house is capped by a side gable roof covered in asphalt shingle and pierced by an exterior brick chimney. Fenestration consists of replacement one-over-one and fixed vinyl sash windows. A shed roof porch supported by metal posts has been appended to the façade (southeast elevation), while a one-bay garage capped by a side gable roof has been appended to the northeast elevation.

Photograph 1. Façade and southwest elevation, facing northeast (Markosky 2018-12-05)

No information was recovered linking the house at 104 Luckey Lane to events significant on the local, state, or national level. Therefore, it is not eligible for listing on the NRHP under Criterion A. No information was recovered to suggest the house was historically associated with individuals significant on the local, state, or national level. Therefore, it is not eligible for listing under Criterion B. The house at 104 Luckey Lane lacks integrity because it has undergone alterations and additions including replacement siding and roof materials, alterations or original window openings, and a one-bay garage addition. For these reasons it is not eligible for listing under Criterion C. The house has not been evaluated for significance under Criterion D for its potential to yield information important to the understanding of history or prehistory.

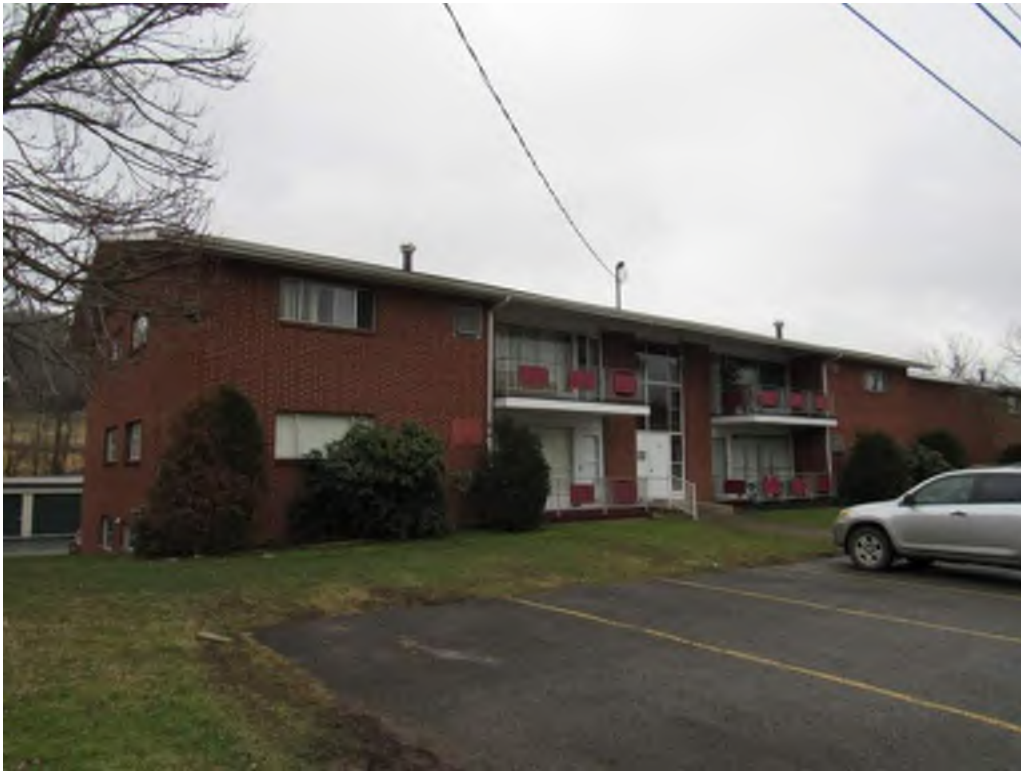
Photograph 1. Representative building, northwest elevation, facing southwest (Markosky 2019-02-05)

No information was recovered linking Mountain View Manor to events significant on the local, state, or national level. Therefore, it is not eligible for listing in the NRHP under Criterion A. No information was recovered to suggest the housing units were historically associated with individuals significant on the local, state, or national level. Therefore, it is not recommended eligible for listing under Criterion B. Mountain View Manor stands as a common and unexceptional example of late mid-century multi-unit residential architecture. It does not possess the architectural merit necessary to be considered eligible under Criterion C. The housing development has not been evaluated for significance under Criterion D for its potential to yield information important to the understanding of history or prehistory.

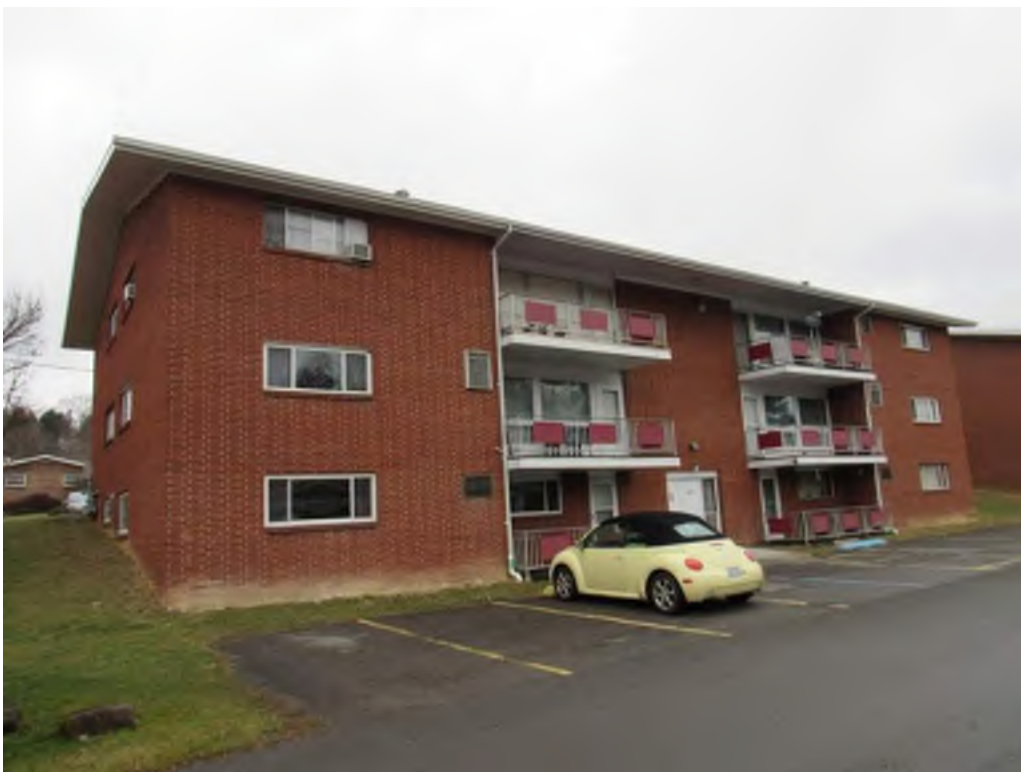
Photograph 2. Representative building, southeast elevation, facing north (Markosky 2019-02-05)

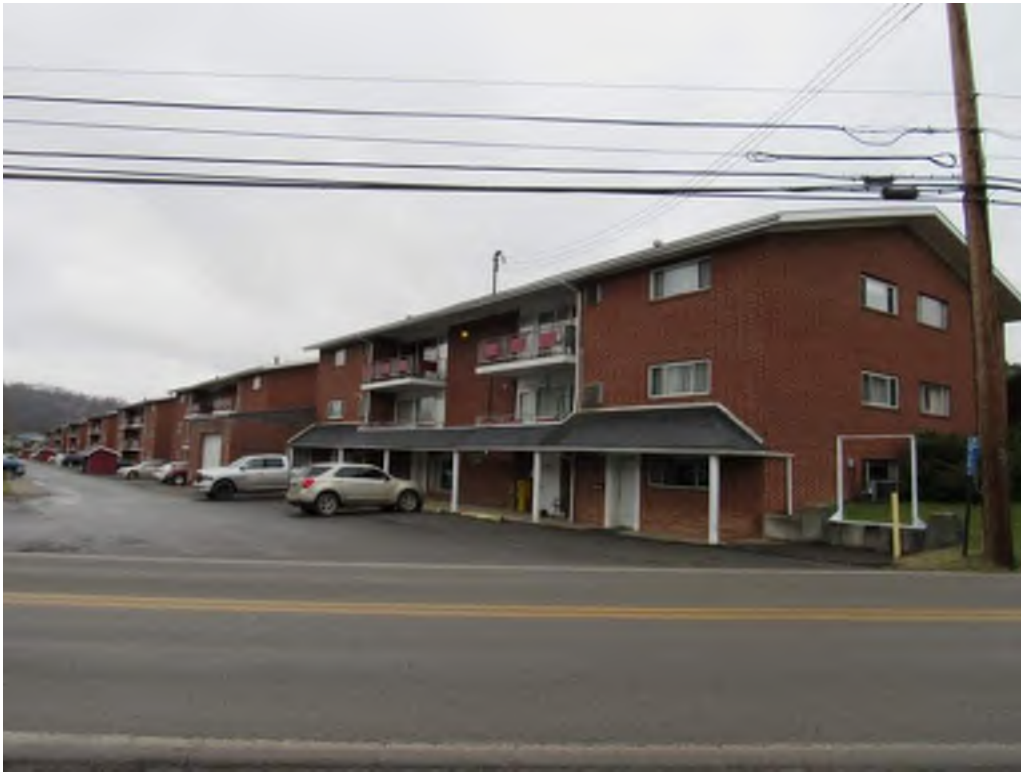
Photograph 3. Overview of buildings, facing west (Markosky 2019-02-05)

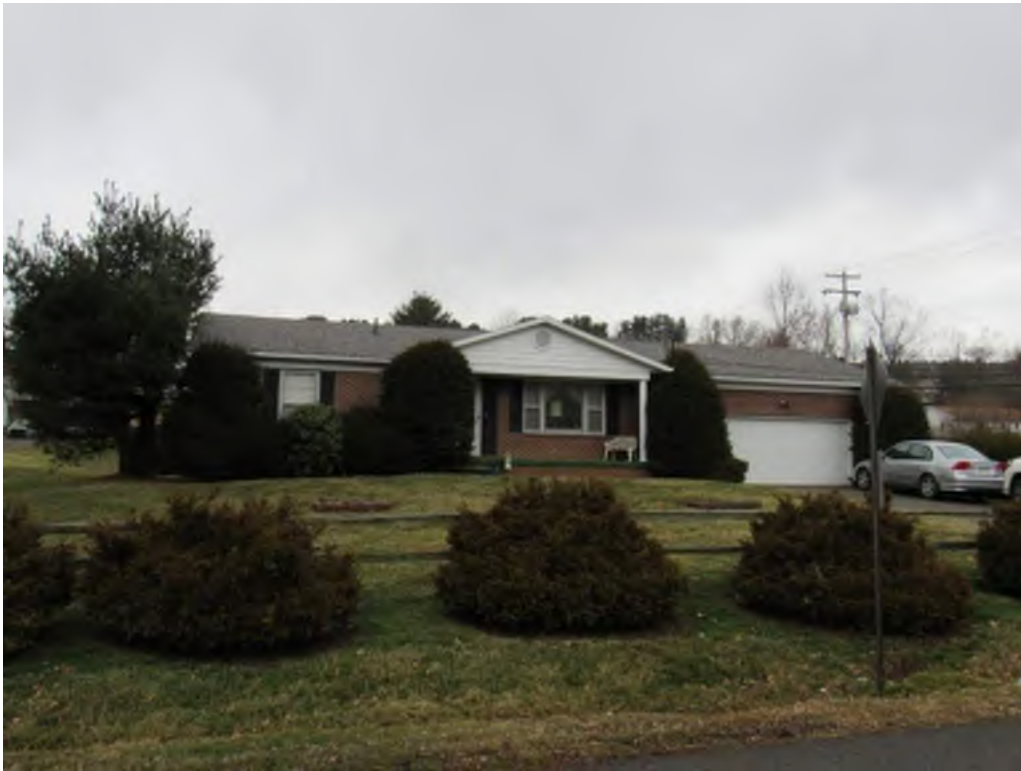
The house at 500 Parkway Drive is a ca. 1970, one-story Ranch style dwelling covered in applied stretcher bond brick and vinyl siding and capped by a side gable roof covered in asphalt shingle (Photographs 1 and 2). The one-story dwelling rests on a concrete block foundation. Fenestration consists of one-over-one vinyl sash windows and a tripartite picture window on the façade (southeast elevation). The façade features a pedimented porch supported by simple columns. A partial width porch projects from the rear (northwest) elevation.

Photograph 1. House and garage, facing north (Markosky 2019-02-05)

No information was recovered linking the house at 500 Parkway Drive to events significant on the local, state, or national level. Therefore, it is not eligible for listing in the NRHP under Criterion A. No information was recovered to suggest the house was historically associated with individuals significant on the local, state, or national level. Therefore, it is not recommended eligible for listing under Criterion B. The house stands as a common and unexceptional example of postwar residential architecture. It is not a part of a significant postwar residential subdivision and does not possess the architectural merit necessary to be considered eligible under Criterion C. The house has not been evaluated for significance under Criterion D for its potential to yield information important to the understanding of history or prehistory.

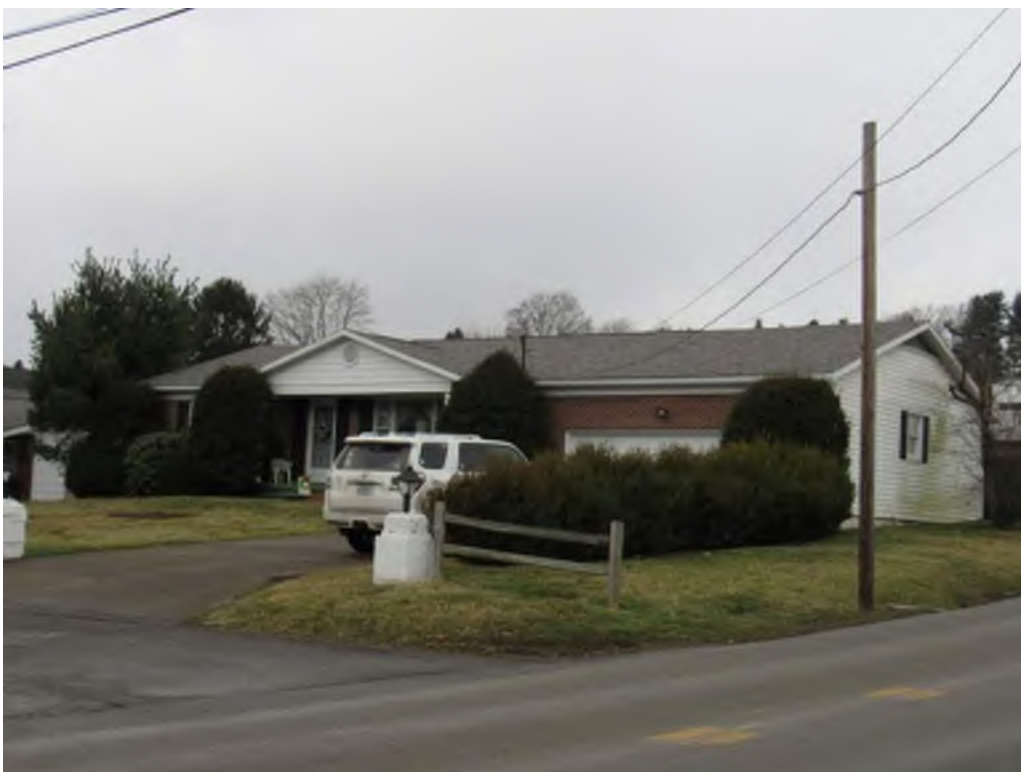
Photograph 2. Façade and northeast elevation, facing northwest (Markosky 2019-02-05)

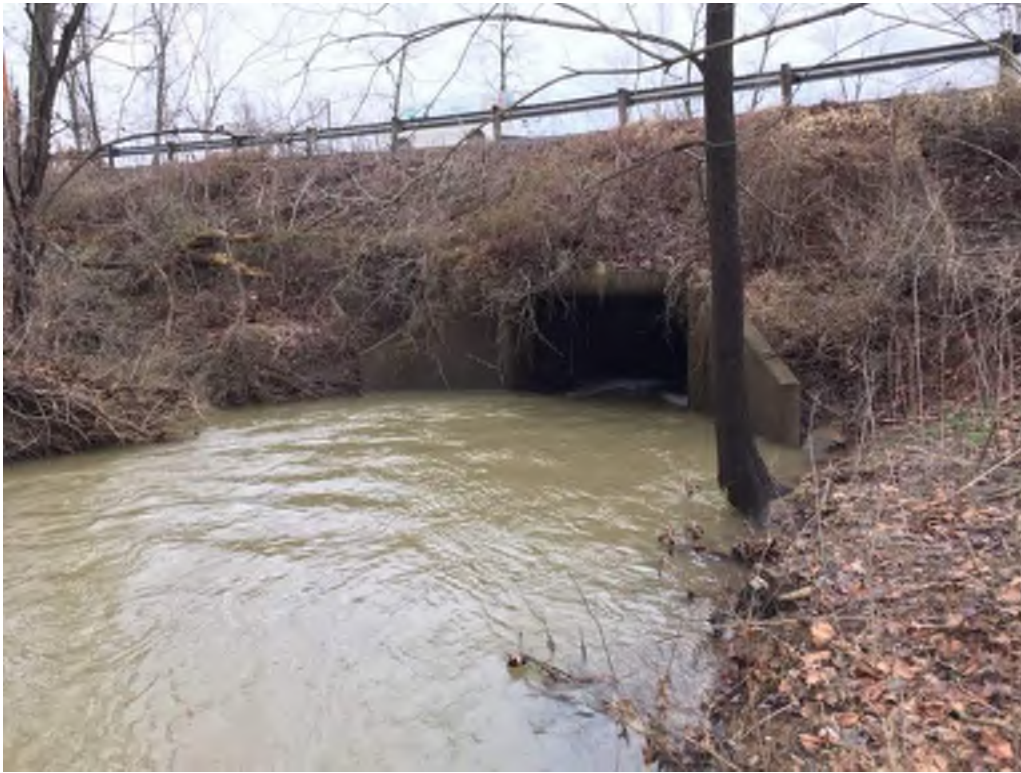
Photograph 1. From flood plain south of Greenbag Road, facing north (Markosky 2019-02-12)

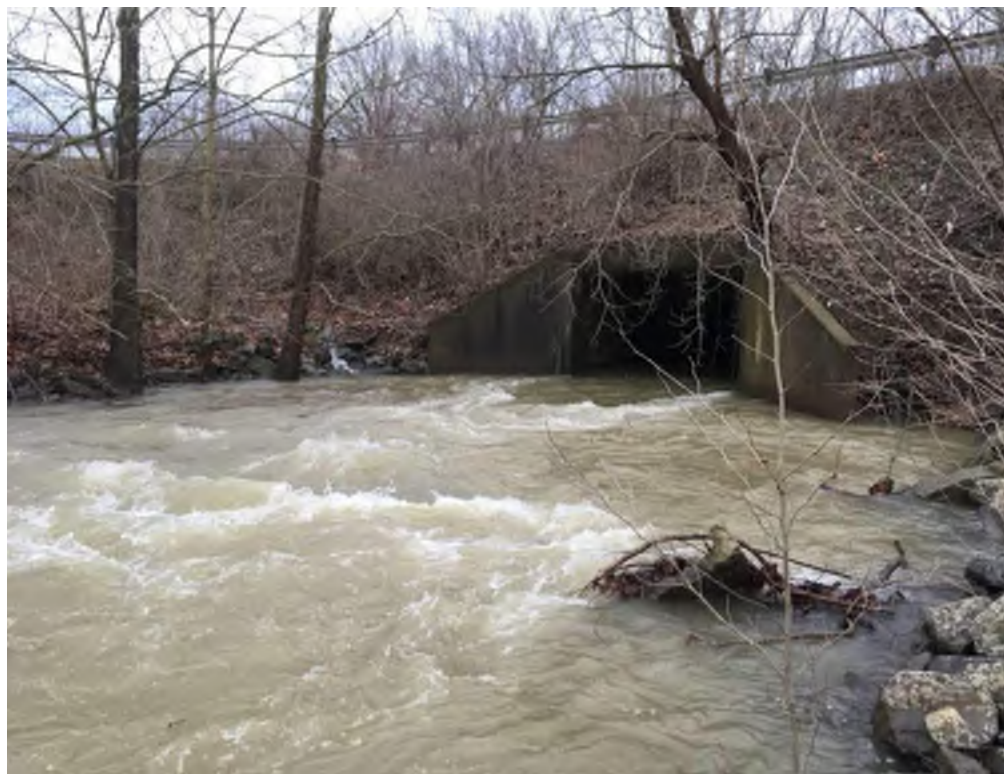
Photograph 2. View from north of Greenbag Road, facing south (Markosky 2019-02-12)
