**Greenbag Road Improvement Project
Environmental Assessment
Monongalia County, West Virginia**

State Project: U331-857-0.67
Federal Project: STP-0857(019)D

August 2020

ENVIRONMENTAL ASSESSMENT

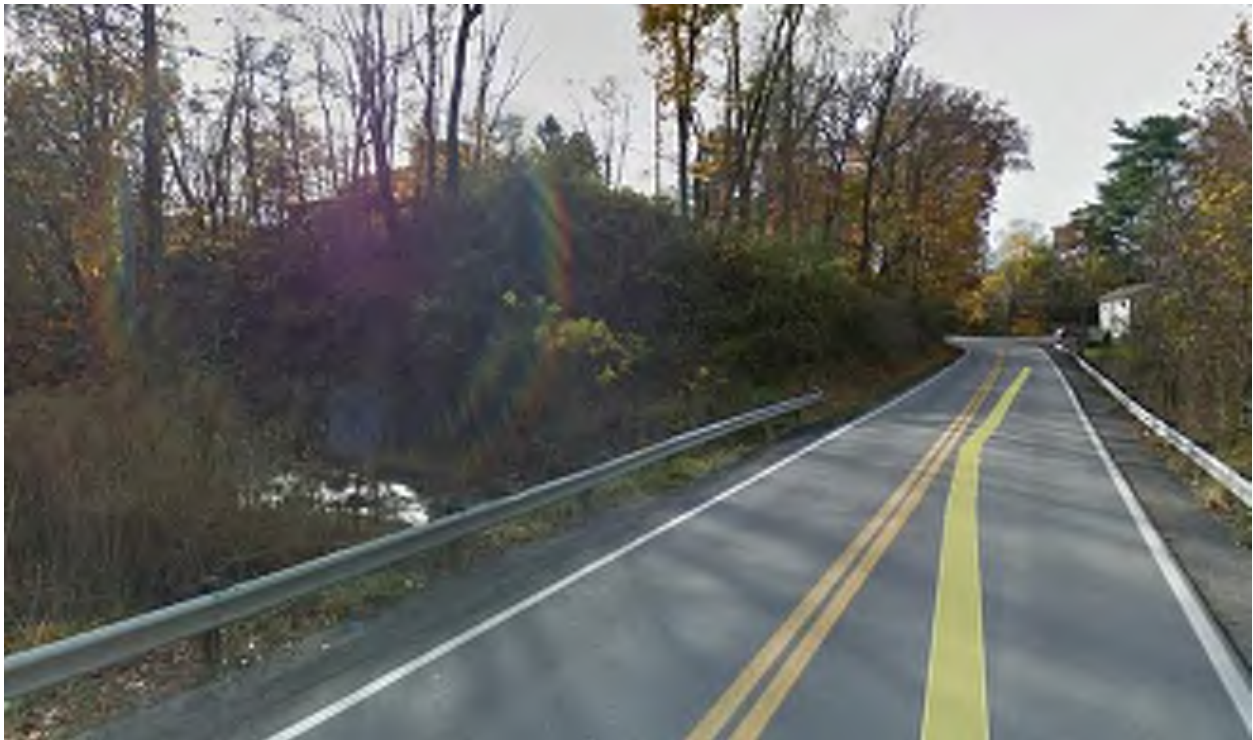
Photograph 1. Through view of culvert, facing southwest (Google Earth 2019)

The MG-2666 / Aaron Creek Box Culvert (Structure No. 31A203) is a two-span continuous concrete culvert constructed ca. 1966 that was built by the Greer Limestone Co. (WVDOH 1990). It is a cast in place structure consisting of two sidewalls, a center wall, a floor slab, and a roof slab, with two ten-foot span openings and a total length of 20.8 feet. A 2018 inspection of the culvert found that the structure was in fair condition (WVDOH 2018).

The culvert retains integrity despite regular repairs to the structure and the addition of safety guardrails ca. 1996 (WVDOH 1990).

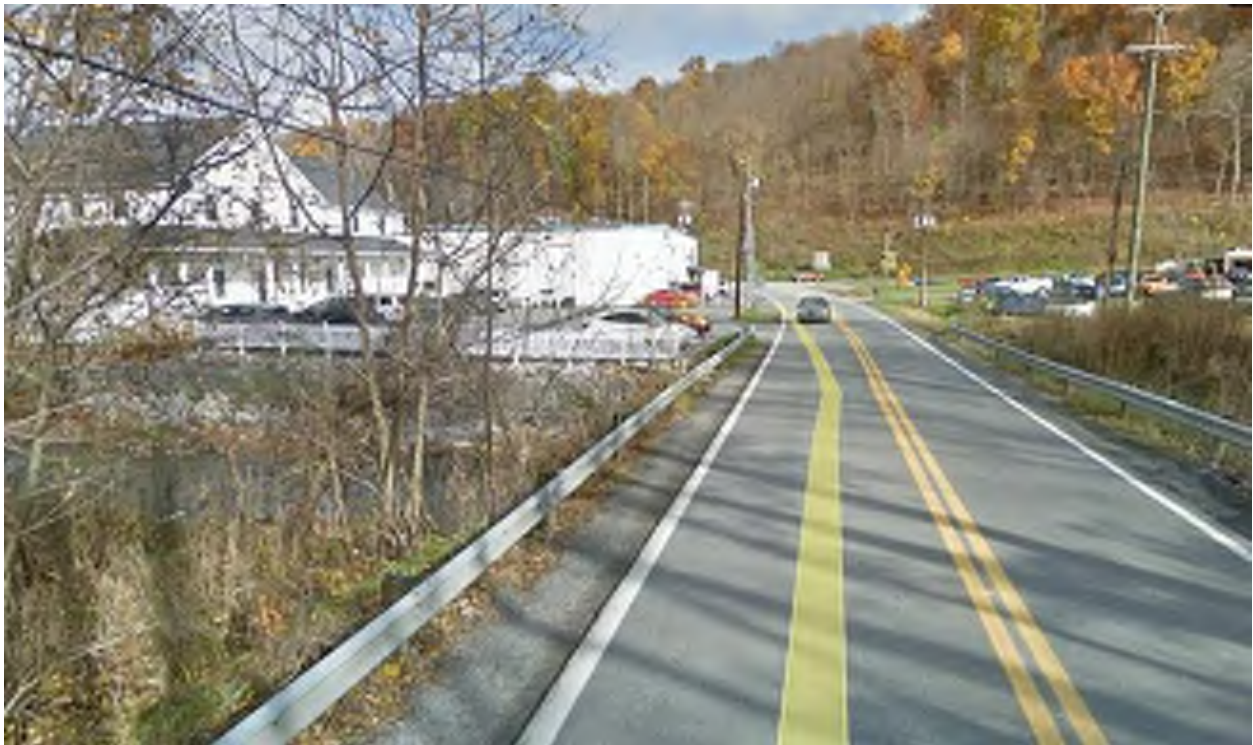
Photograph 2. Through view of culvert, facing northeast (Google Earth 2019)

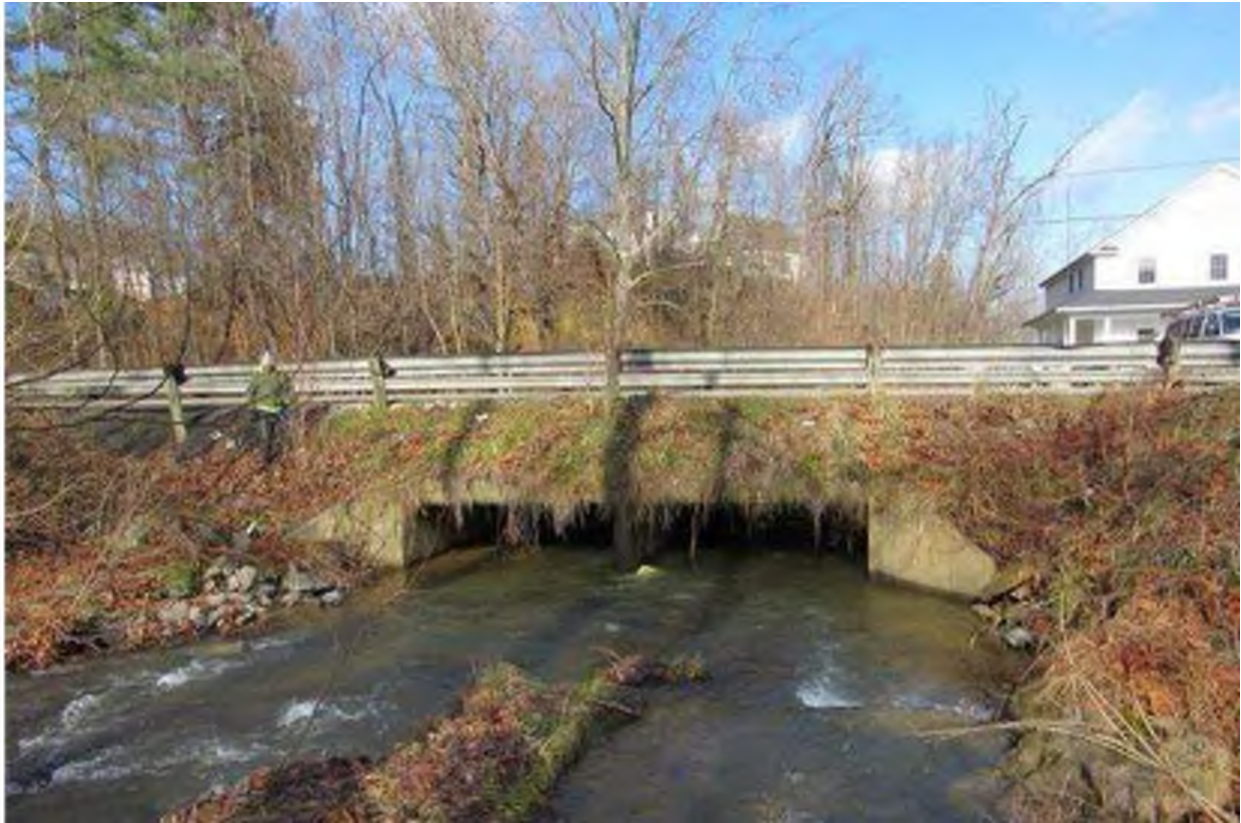
Photograph 3. South elevation of culvert, facing northeast (WVDOH 2018)

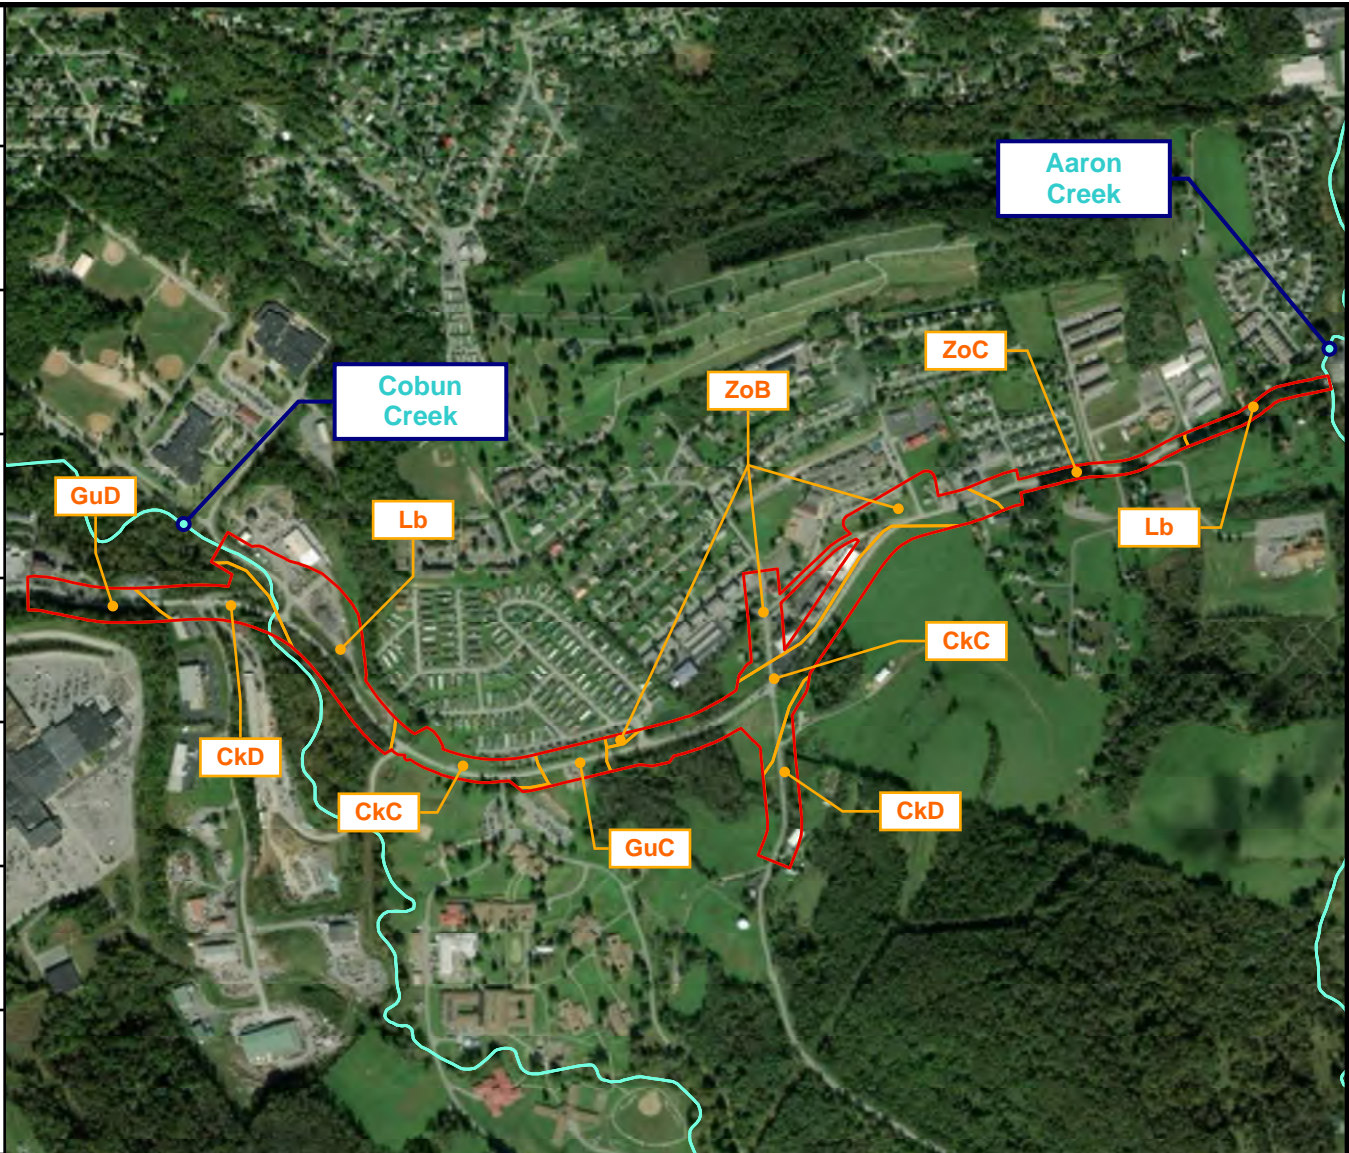
Figure 3
Soils in the Study Area

- Archaeological Study Area
- Soil Type Boundary
- Stream

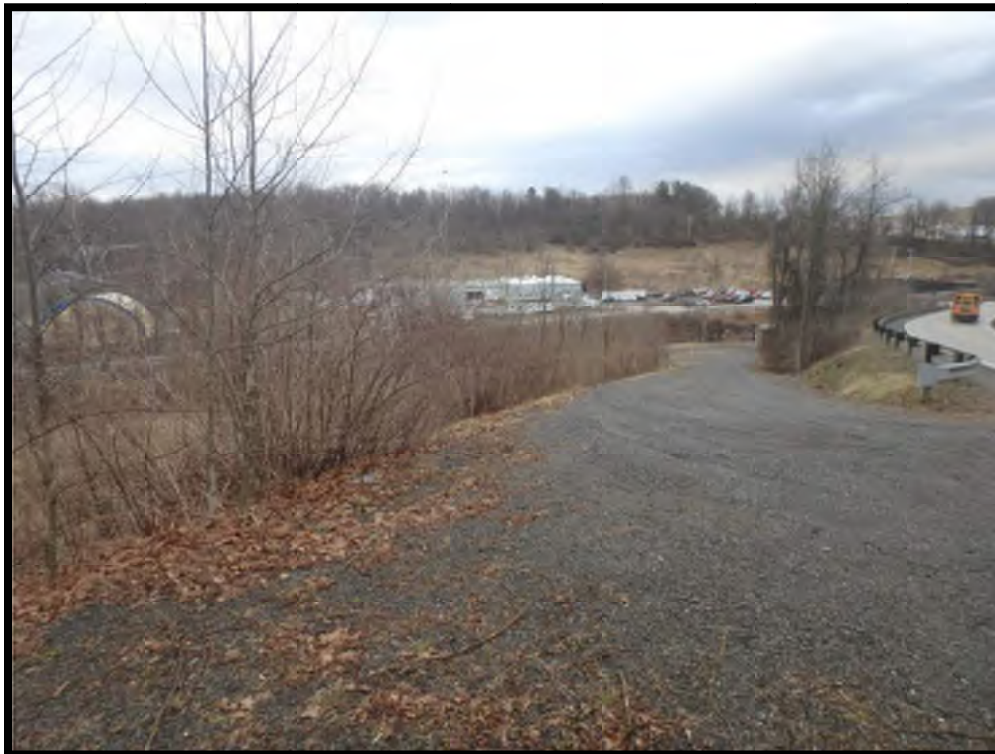
Photograph 9. General view of the study area, facing east. Note disturbance from grading and a sewer line (evidenced by a manhole cover) parallel to Greenbag Road.

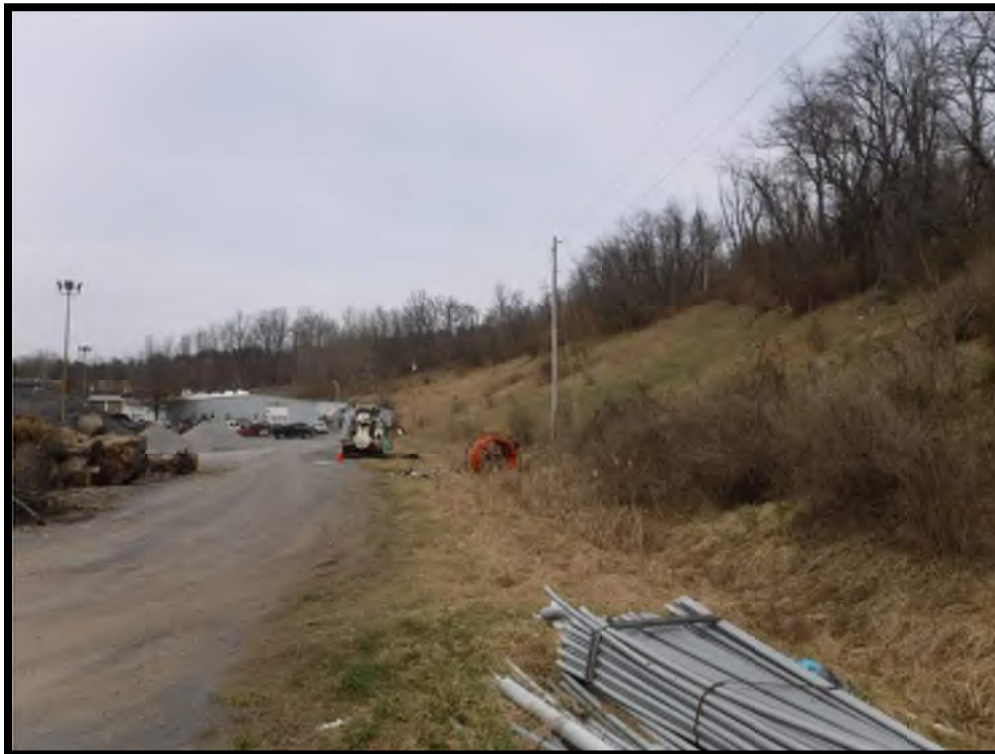
Photograph 21. General view of steep slope and disturbance in the study area, facing south-southeast.

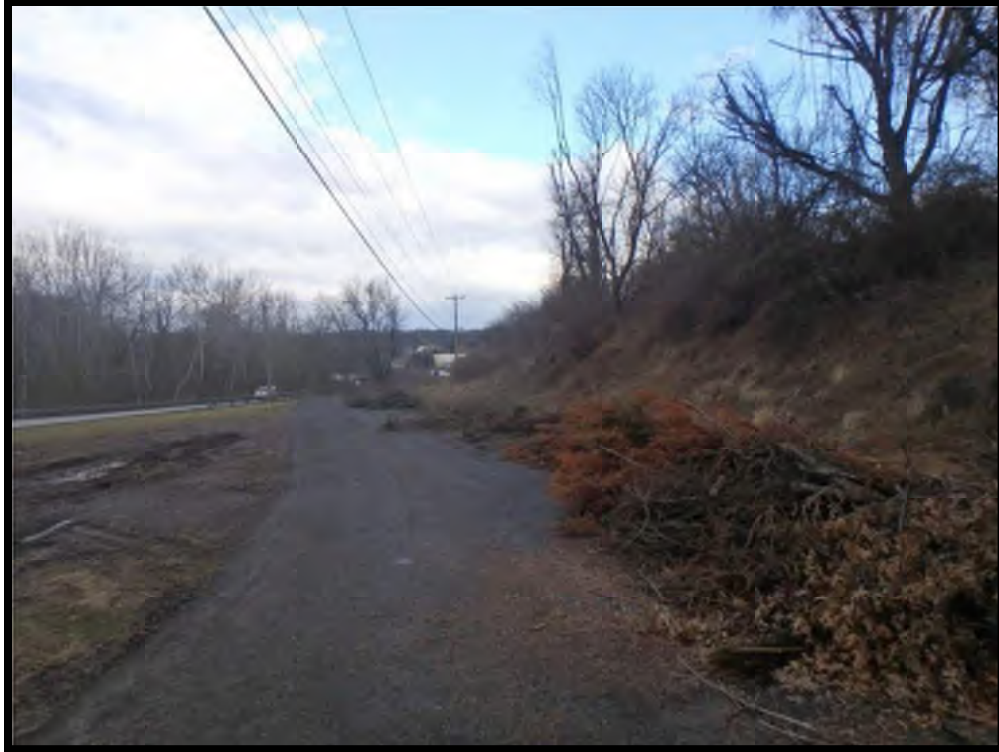
Photograph 22. General view of steep slope and disturbance in the study area, facing north.

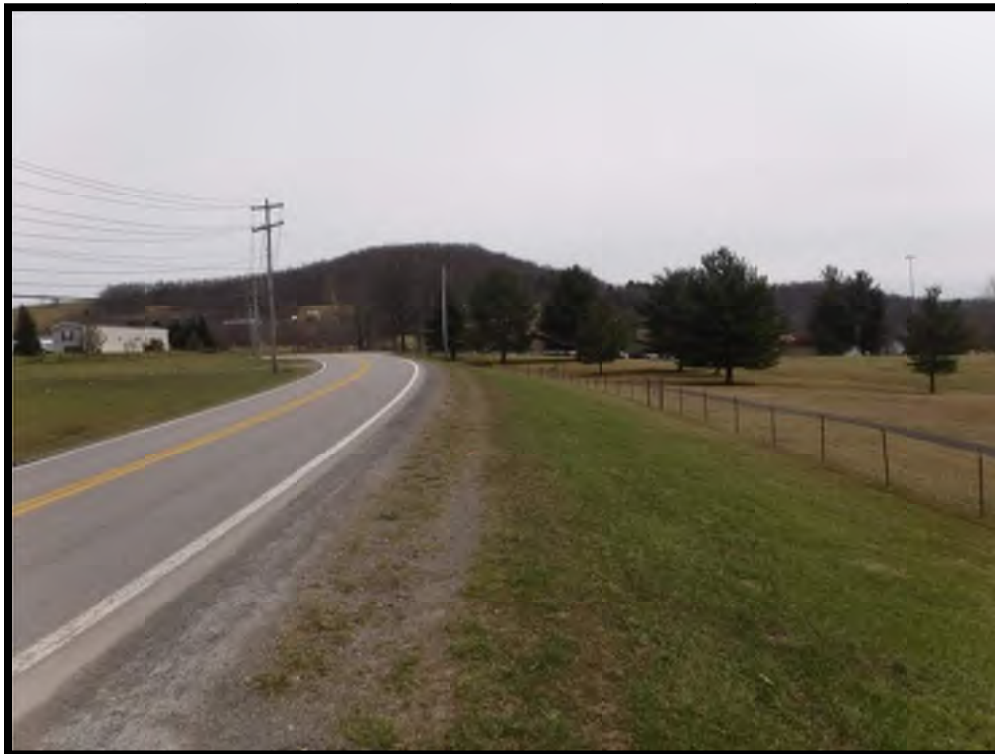
Photograph 25. General view of the study area, facing northeast. Note that the grassy area is disturbed from grading.

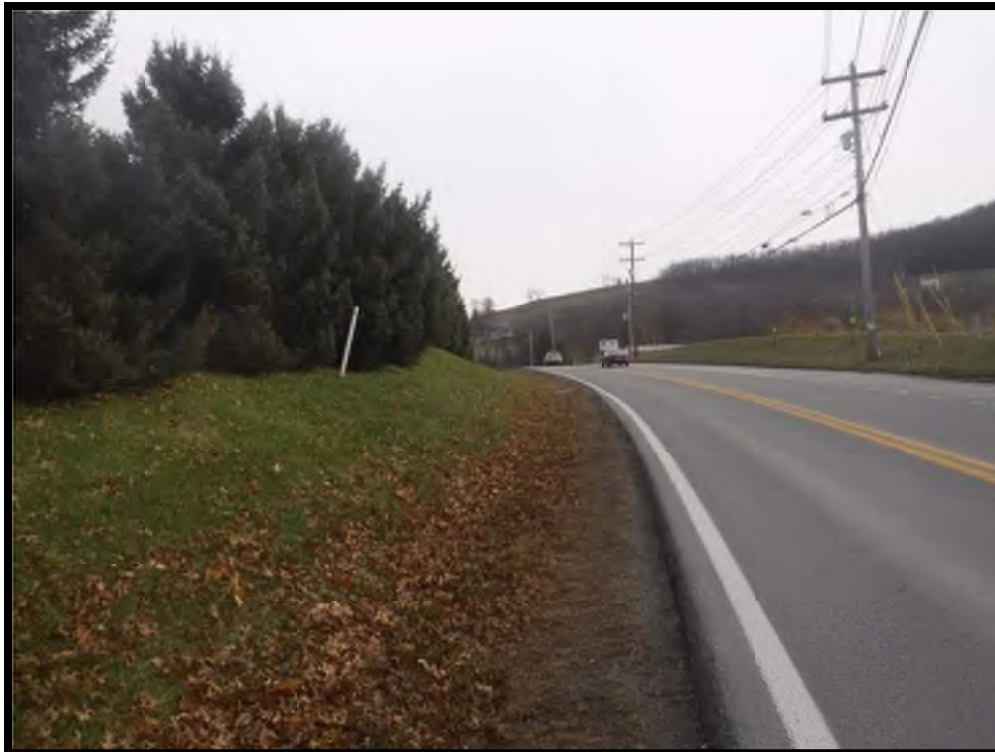
Photograph 27. View of buried utility lines (marked by white pin flags) adjacent to Test Area 5, facing southeast.

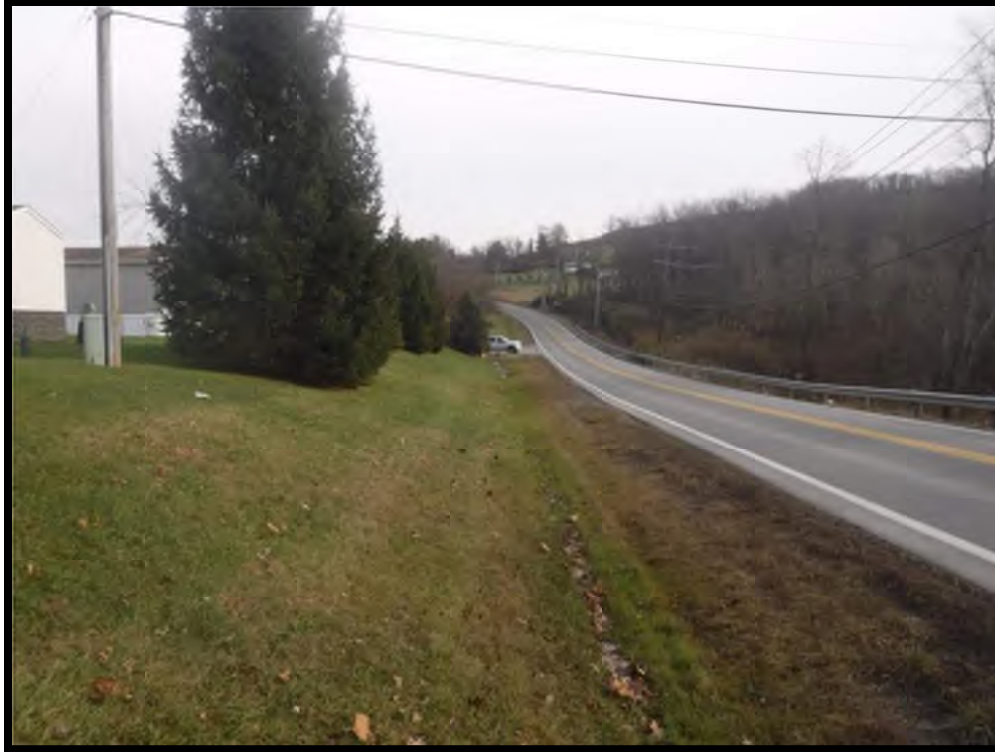
Photograph 28. View of cut slope in the study area, facing east.

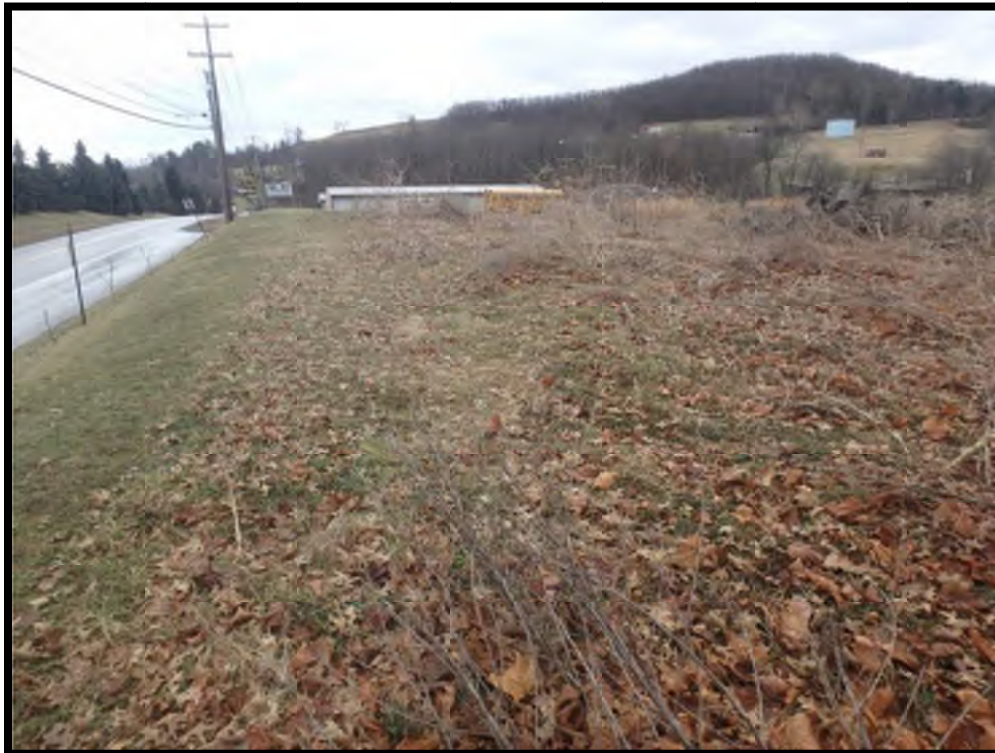
Photograph 29. View of cut slope in the study area, facing east.

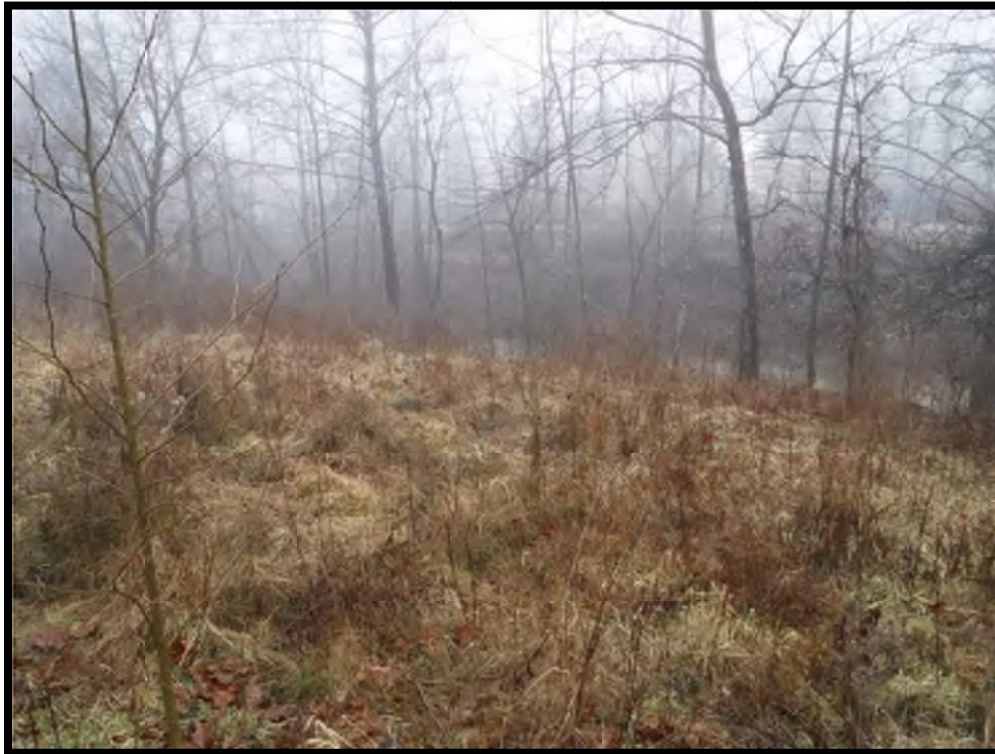
Photograph 61. View of Test Area 2, facing north.

Test Area 2 is located on the north side of Greenbag Road just west of the intersection with Mississippi Street (see **Figure 16: Sheet 1 and Sheet 3**). The test area is on a stream bench landform with elevations ranging from 272.2 to 274.3 m (893.0 to 900.0 ft) above mean sea level. At the time of the survey, vegetation consisted of a tall weeds and brush (**Photograph 61**). Soils in the test area are mapped as Clarksburg silt loam, 15 to 25 percent slopes (CkD). The test area is 0.05 ha (0.13 ac) in size. One (1) STP was excavated in Test Area 2. The soil profile consisted of Ap-Bw-Bt (**Figure 18**). No pre-contact or historic period cultural materials were identified in Test Area 2.

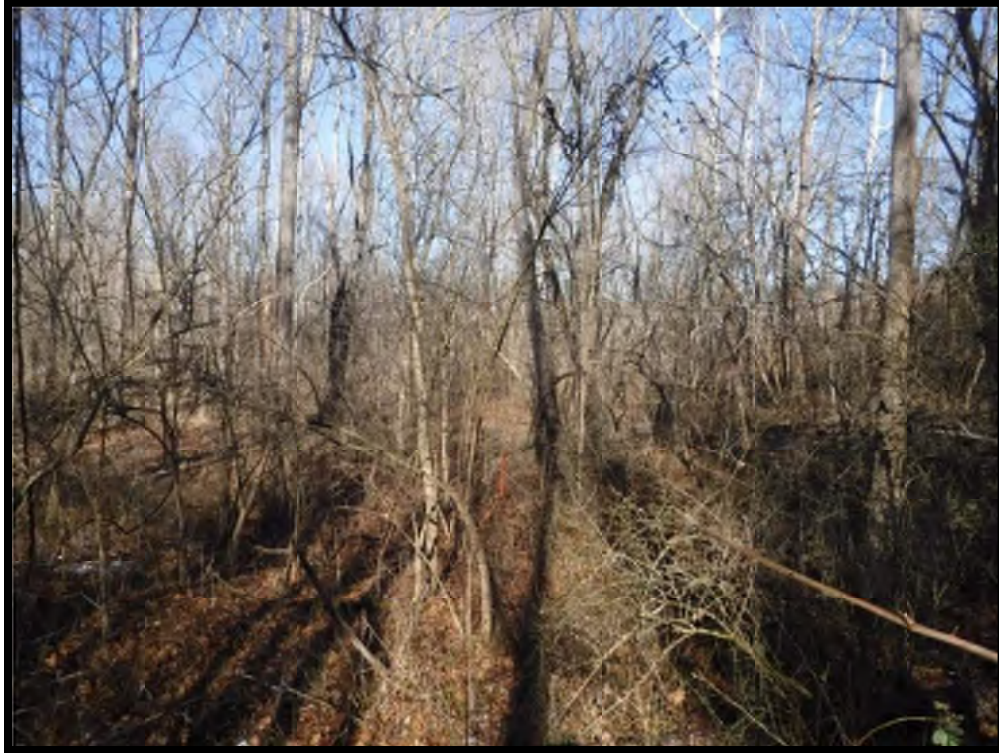
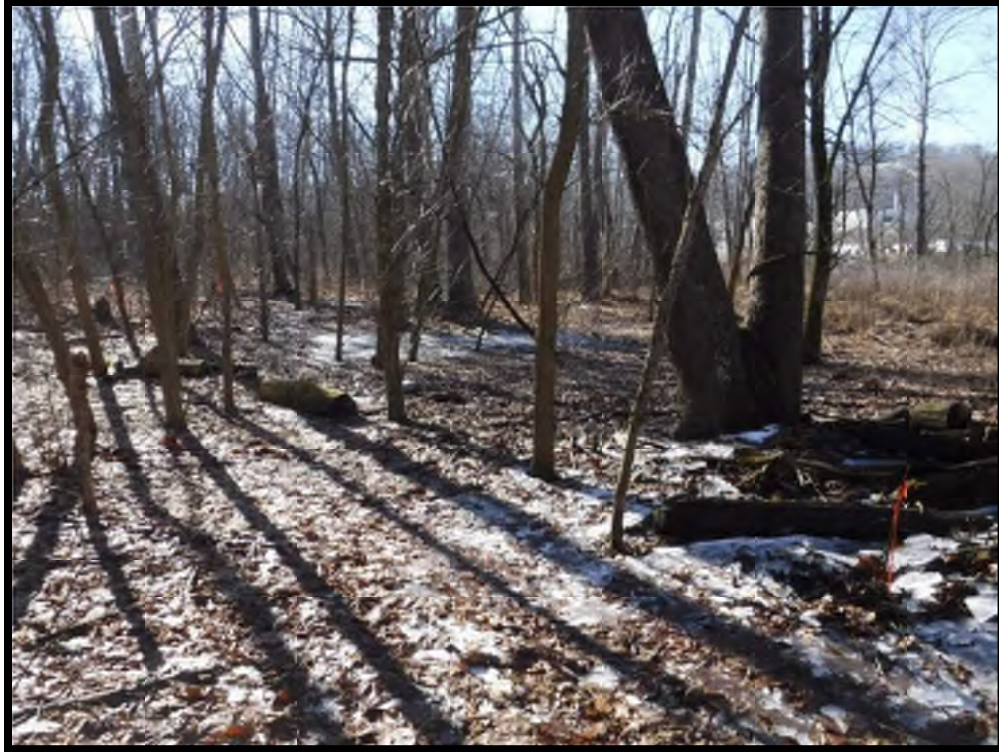
Test Area 3 is located on the south side of Greenbag Road opposite the intersection with Mississippi Street (see **Figure 16: Sheet 2**). The test area is on a floodplain landform along Cobun Creek with elevations ranging from 270.4 to 278.3 m (887.0 to 913.0 ft) above mean sea level. At the time of the survey, vegetation consisted of mixed hardwood trees with underbrush (**Photographs 62 and 63**). Soils in the test area are mapped primarily as Lobdell silt loam, 0 to 3 percent slopes, occasionally flooded (Lb), with Clarksburg silt loam, 15 to 25 percent slopes in the western end of the test area. The test area is 0.42 ha (1.04 ac) in size. In total, sixteen (16) STPs were excavated in Test Area 3. The soil profile varied, generally consisting of A-BA-Bw-C, AC-C-Cg, or AC-BC-Bg soil profiles. The soils reflect shifting of the stream, areas that have

been scoured, and recent alluvial deposits, as well as some pockets of older, more developed soils (**Figure 19**). No pre-contact or historic period cultural materials were identified in Test Area 3.

Photograph 62. View of Test Area 3, facing northwest.

Photograph 63. View of Test Area 3, facing southeast.

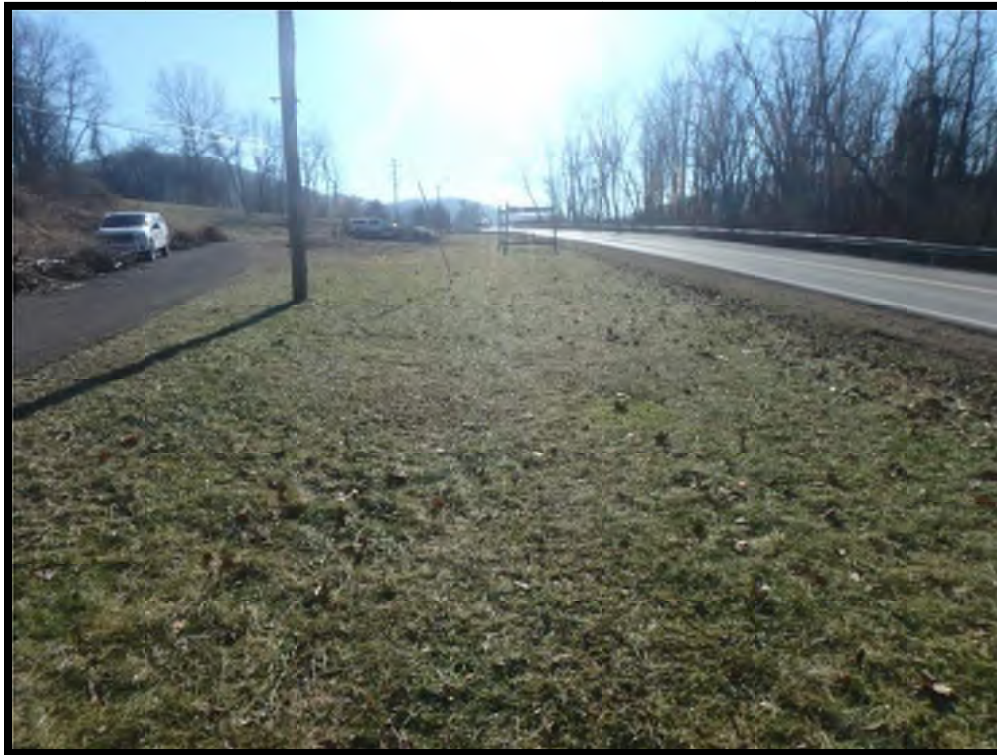
Photograph 64. View of Test Area 4, facing southeast.

Test Area 4 is located on the north side of Greenbag Road, opposite Test Area 3, and south of an access road for the City of Morgantown Public Works Garage (see **Figure 16: Sheet 2**). The test area is on an upland landform with elevations ranging from 278.9 to 282.6 m (915.0 to 927.0 ft) above mean sea level. At the time of the survey, vegetation consisted of a maintained grassy lawn (**Photograph 64**). Soils in the test area are mapped as Lobdell silt loam, 0 to 3 percent slopes, occasionally flooded (Lb), but given the upland landform, are more likely to be the Clarksburg silt loam, 8 to 15 percent slopes soils, which are mapped nearby. The test area is 0.13 ha (0.32 ac) in size. In total, five (5) STPs were excavated in Test Area 4. The soil profile generally consisted of Fill 1-Btx-Cr (**Figure 20**). Excavations determined that the area was previously graded and filled. No pre-contact or historic period cultural materials of any kind were identified in Test Area 4.

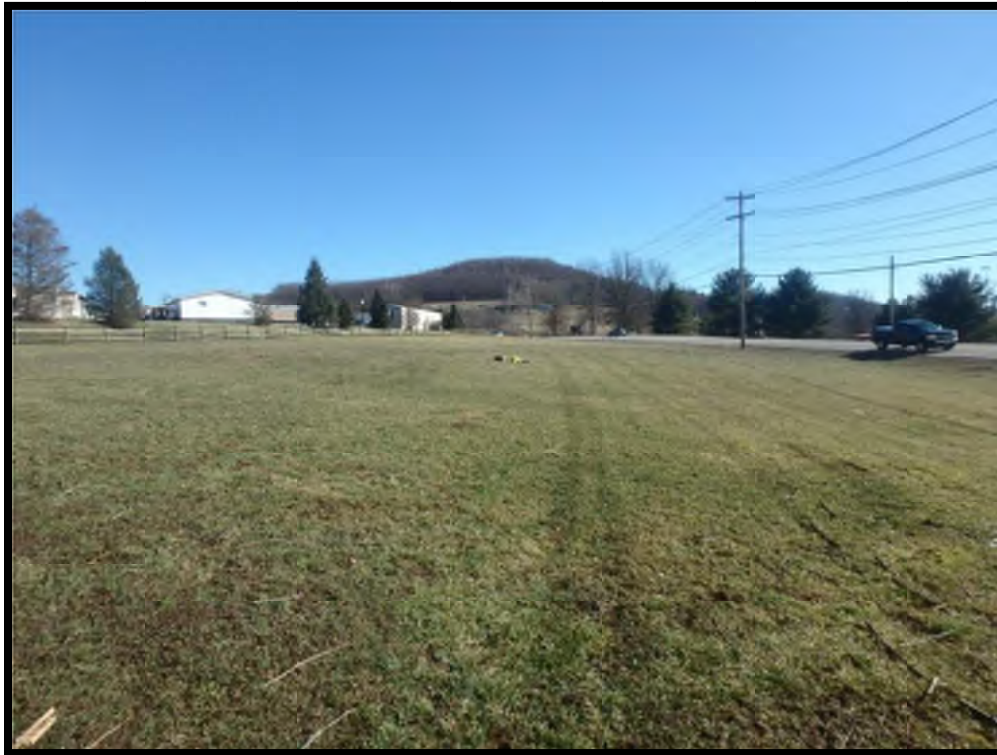
Test Area 5 is located on the north side of Greenbag Road opposite a baseball field associated with the Federal Correctional Institute (see **Figure 16: Sheet 4**). The test area is on an upland landform with elevations ranging from 285.0 to 290.5 m (935.0 to 953.0 ft) above mean sea level. At the time of the survey, vegetation consisted of a maintained grassy lawn (**Photograph 65**). Soils in the test area are mapped as Clarksburg silt loam, 8 to 15 percent slopes (CkC). The test area is 0.22 ha (0.54 ac) in size. In total, nine (9) STPs were excavated in Test Area 5. The natural soil profile underlying two layers of fill consisted of A-Bt1-Bt2-Btx (**Figure 21**). Some STPs exhibited fill over the natural soils and some areas had been graded and filled. The portion of Test Area 5 that is adjacent and parallel to the existing roadway was determined to have been disturbed by buried utility lines, precluding the need for STPs in that location. No pre-contact or historic period cultural materials were identified in Test Area 5.

Photograph 65. View of Test Area 5, facing southeast. White pin flags are marking a sewer line that is parallel to Greenbag Road (right).

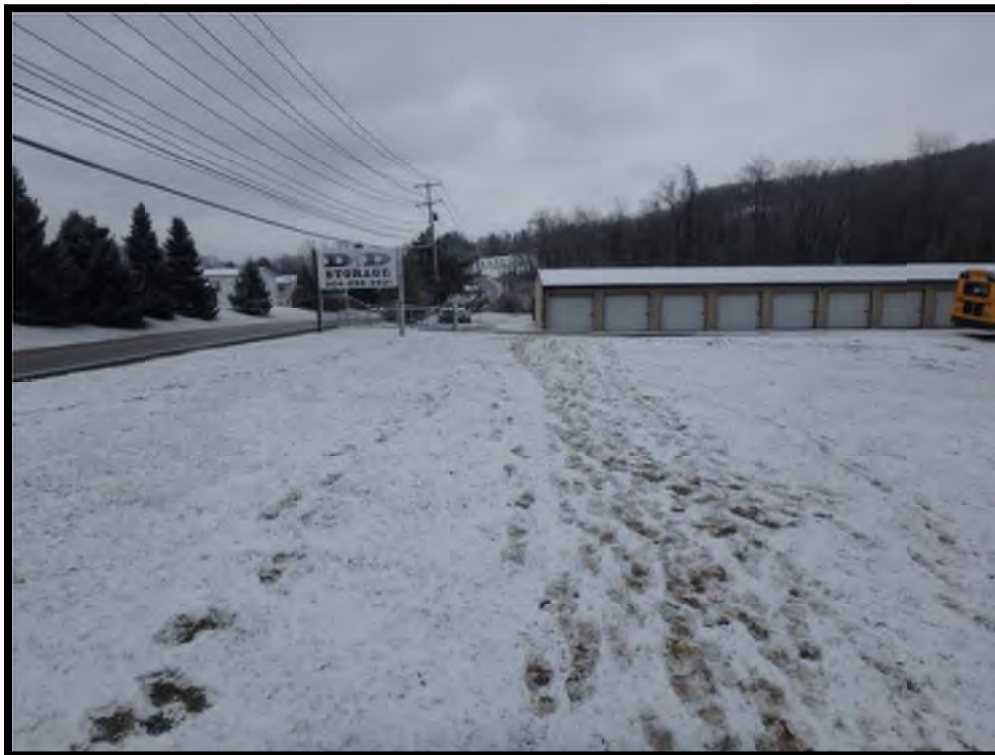
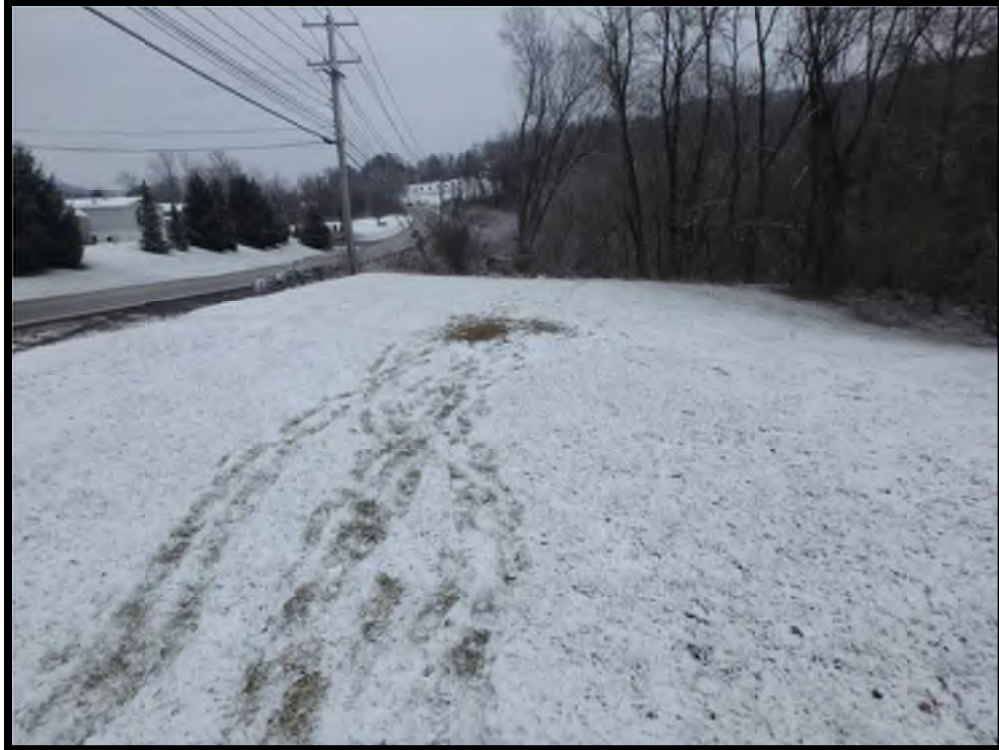
Test Area 6 is located on the south side of Greenbag Road at D&D Storage Facility (see **Figure 16: Sheet 4**). The test area is on hilltop and terrace landforms with elevations ranging from 287.4 to 292.0 m (943.0 to 958.0 ft) above mean sea level. At the time of the survey, vegetation consisted of a maintained grassy lawn (**Photographs 66 and 67**). Soils in the test area are mapped as Gilpin-Culleoka-Upshur silt loams, 8 to 15 percent slopes. The test area is 0.09 ha (0.23 ac) in size. In total, seven STPs were excavated in Test Area 6. The natural soil profile was different between the east and west sides of the existing storage unit facility. On the west side, the upland landform consisted of A-Bt, which closer toward the storage facility showed impacts from grading and fill (**Figure 22**). This disturbance to the A and upper Bt horizon soils was likely due to the construction of the storage units. The excavated STPs on the east side of the storage facility exhibited A-Bw-Bt profiles with fill emplaced over the natural soils (see **Figure 22**). STP A3 exhibited very thick fill deposits over intact natural soils. The STP was expanded into a test unit in this location to survey to appropriate depths. The soils in TU1 consisted of multiple fill layers over a natural profile of Ag-Bw-BC-C1-C2 (**Figure 23**), which illustrates a Late Wisconsin stream terrace above an unnamed tributary to Cobun Creek. No pre-contact or historic period cultural materials were identified in Test Area 6.

Photograph 66. View of Test Area 6, facing east.

Photograph 67. View of Test Area 6, facing east.

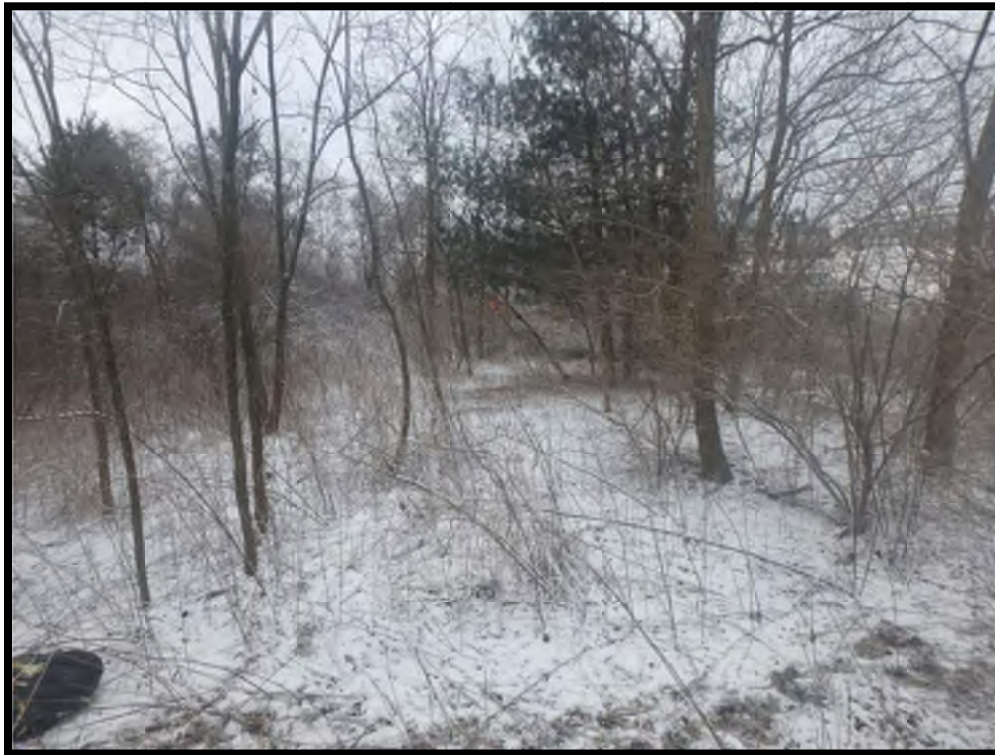
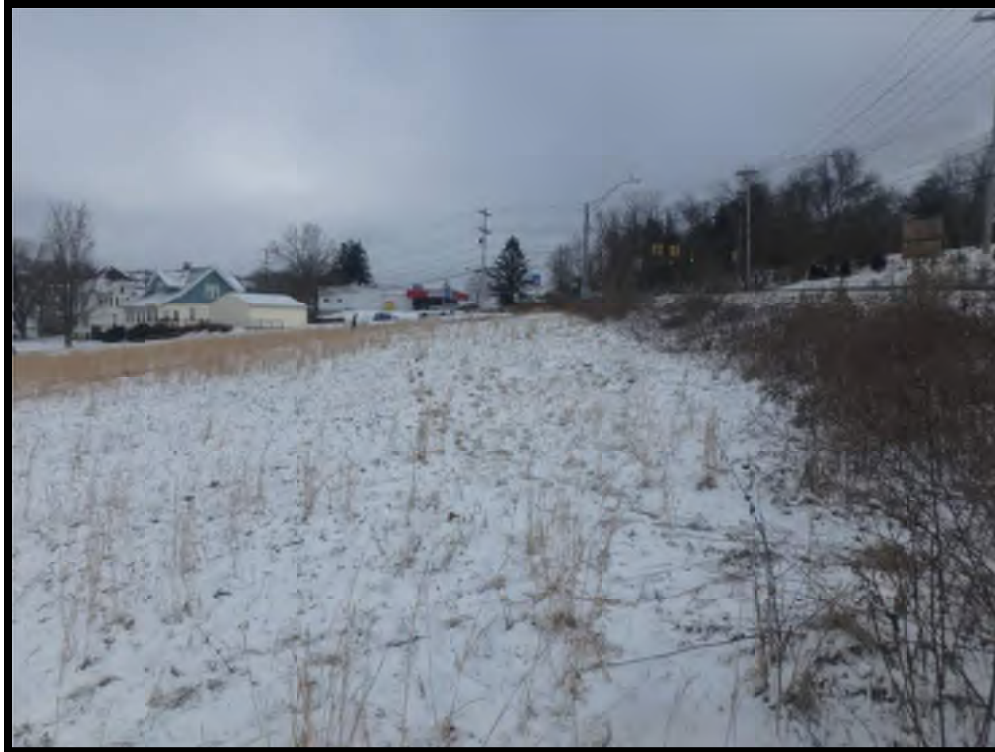
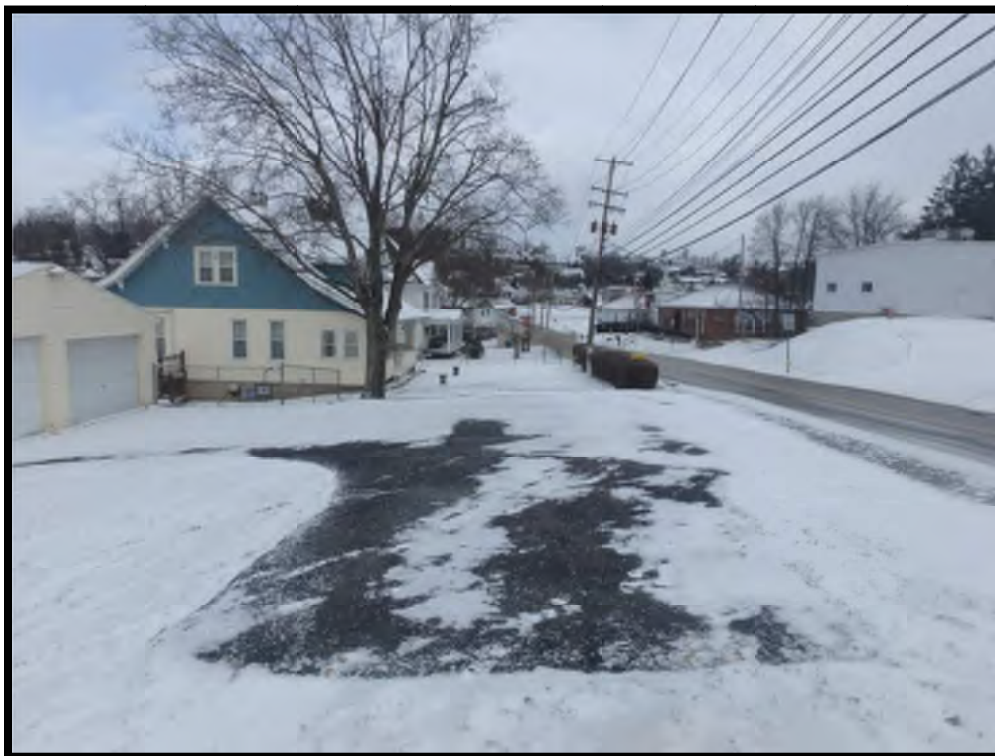
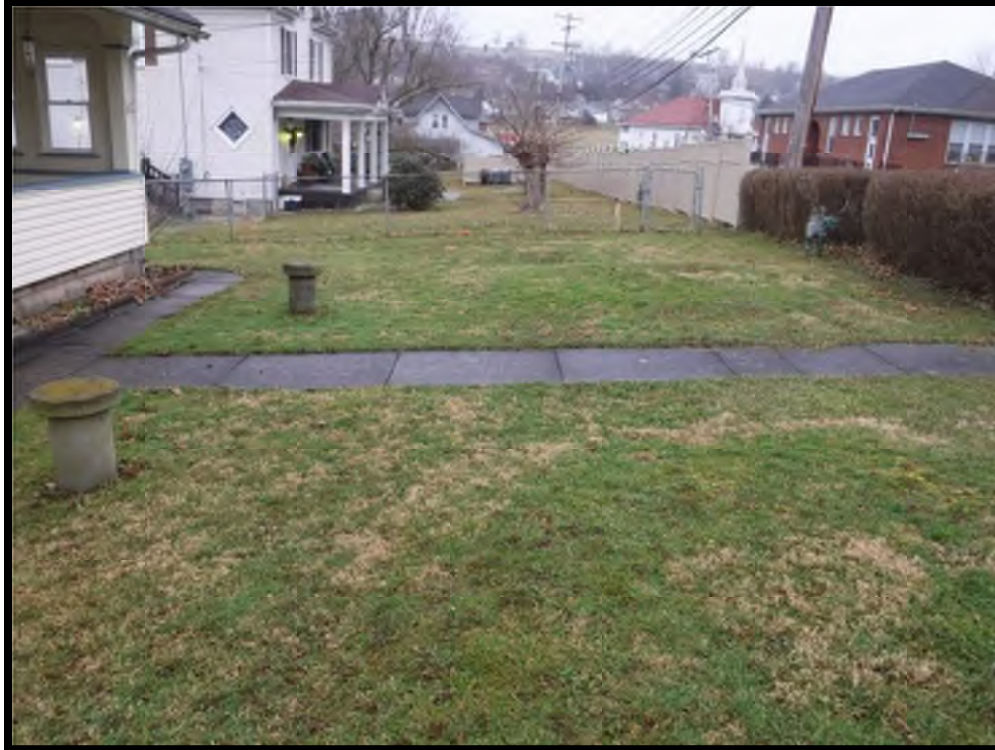
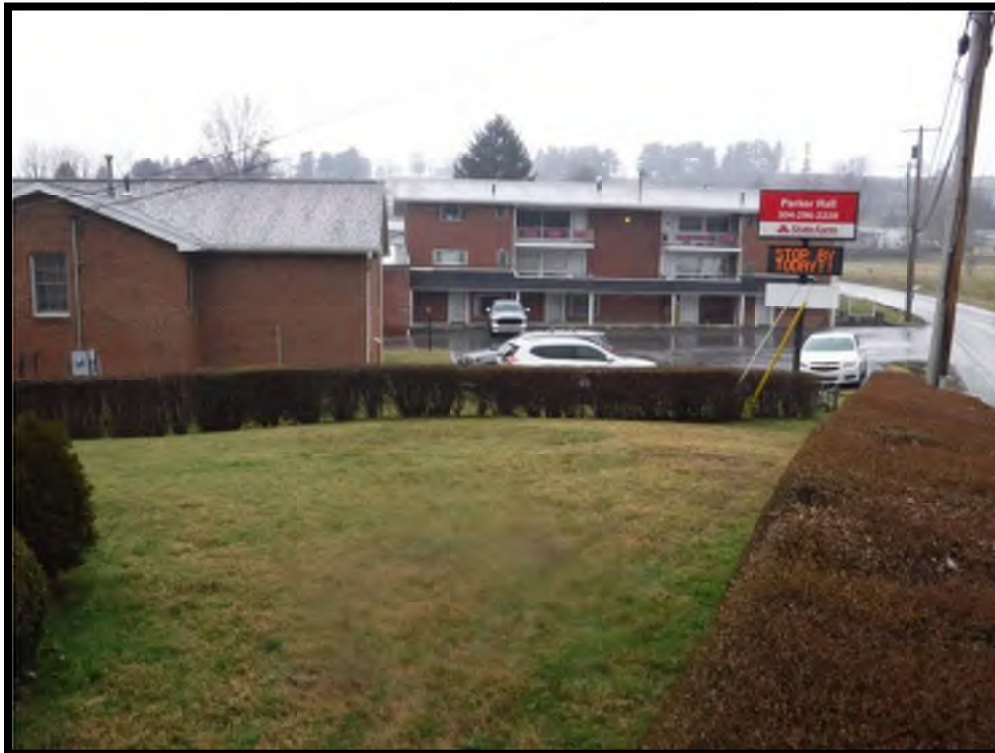
Test Area 7 is located in the northwest quadrant of the intersection of Greenbag Road with Dorsey Avenue (see **Figure 16: Sheet 5**). The test area is on a hillslope landform with elevations ranging from 290.5 to 299.9 m (953.0 to 984.0 ft) above mean sea level. At the time of the survey, vegetation was variable and consisted of a wooded area with dense underbrush, an area with grasses and weeds; and maintained grassy lawns (**Photographs 68-72**). Soils in the test area are mapped along Greenbag Road as Clarksburg silt loam, 8 to 15 percent slopes (CkC) and along Dorsey Avenue as Zoar silt loam, 3 to 8 percent slopes (ZoB). The test area is 0.50 ha (1.24 ac) in size. In total, twenty-eight (28) STPs were excavated in Test Area 7. The soil profile typically consisted of A-Bt or Ap-Bw-Bg (**Figure 24**). Some STPs revealed disturbed soils or fill layers over natural soils. No pre-contact or historic period cultural materials were identified in Test Area 7.
