**Greenbag Road Improvement Project
Environmental Assessment
Monongalia County, West Virginia**

State Project: U331-857-0.67
Federal Project: STP-0857(019)D

August 2020

ENVIRONMENTAL ASSESSMENT

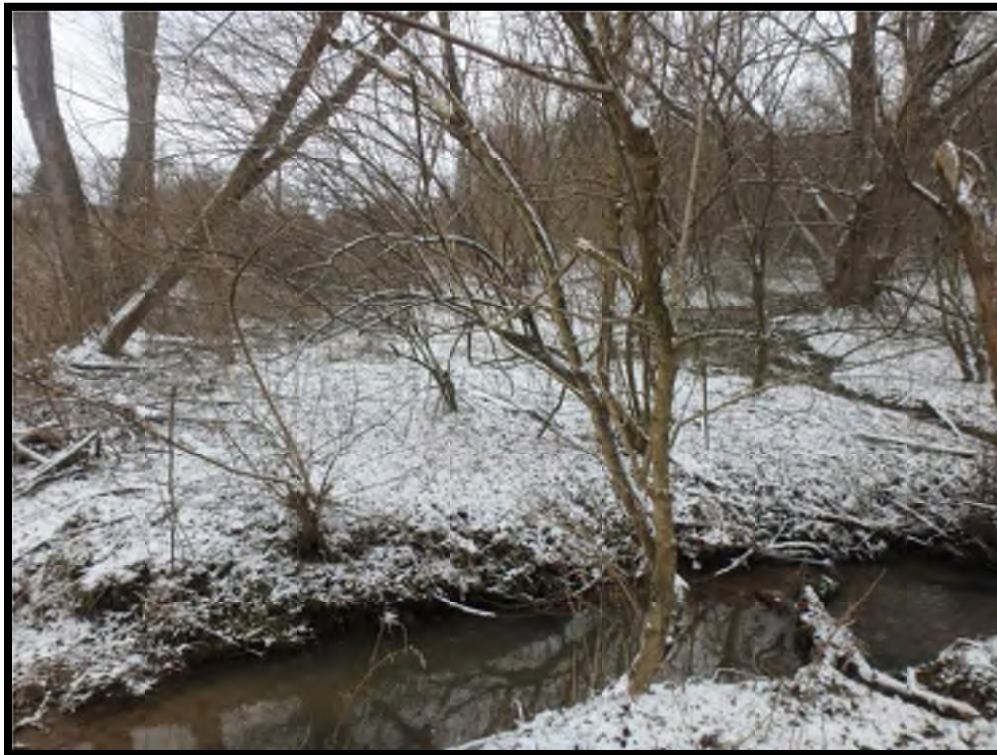
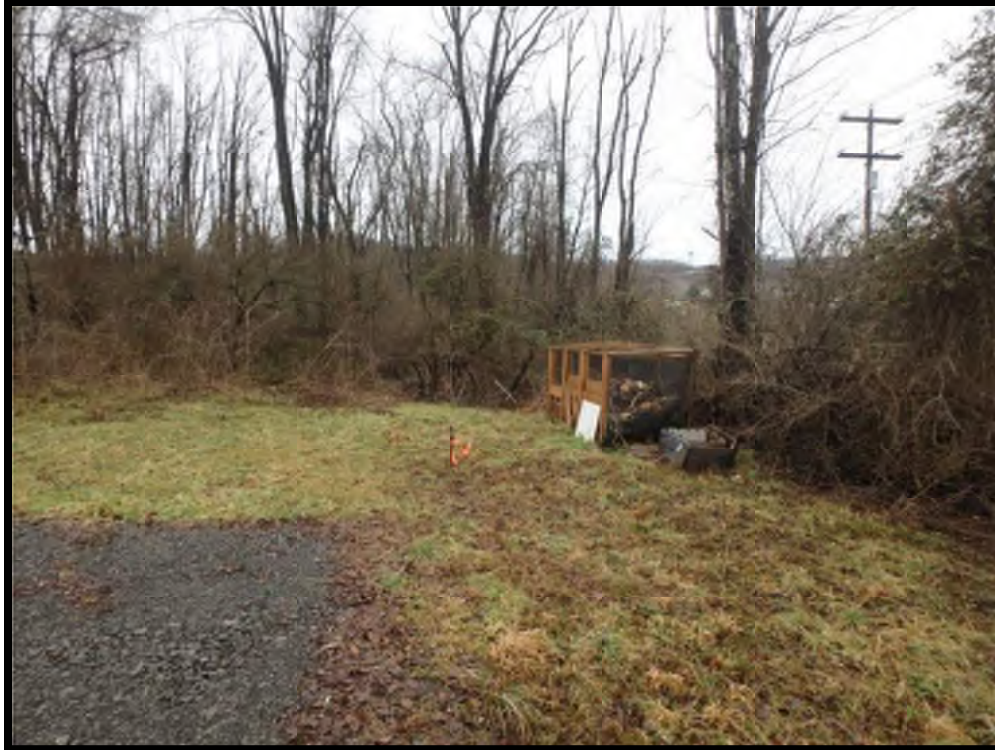
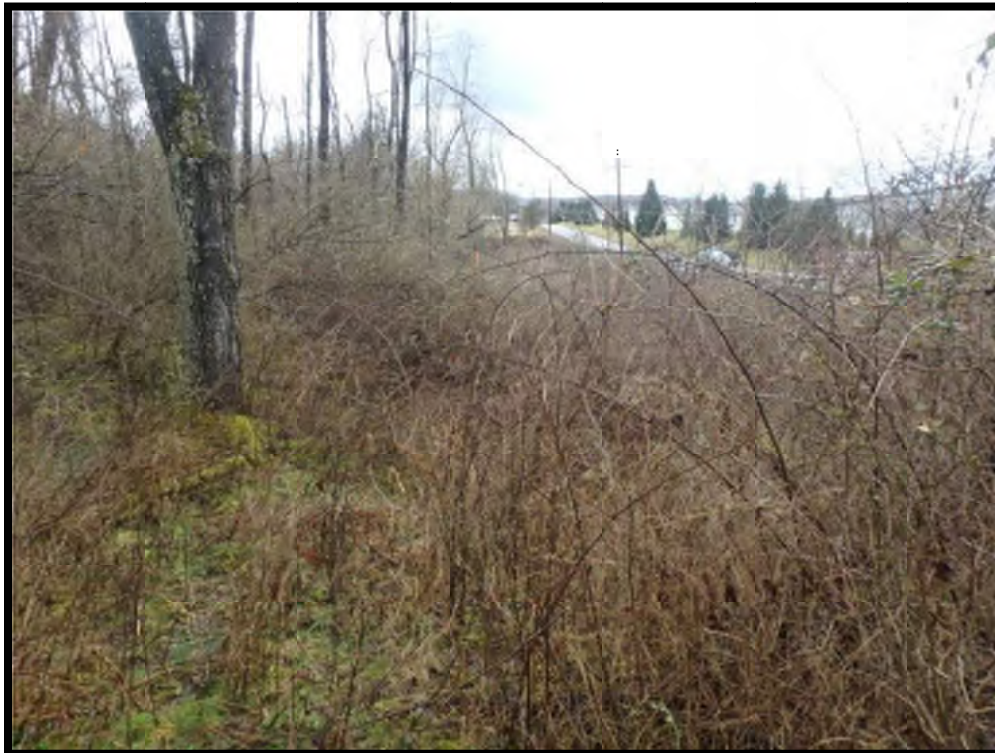
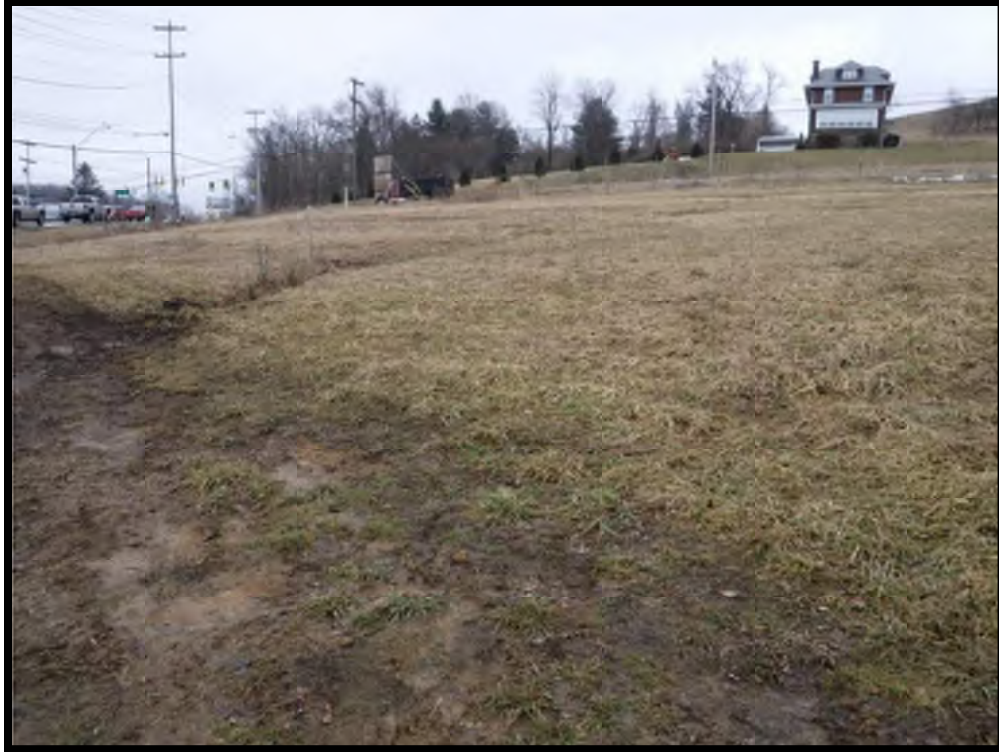
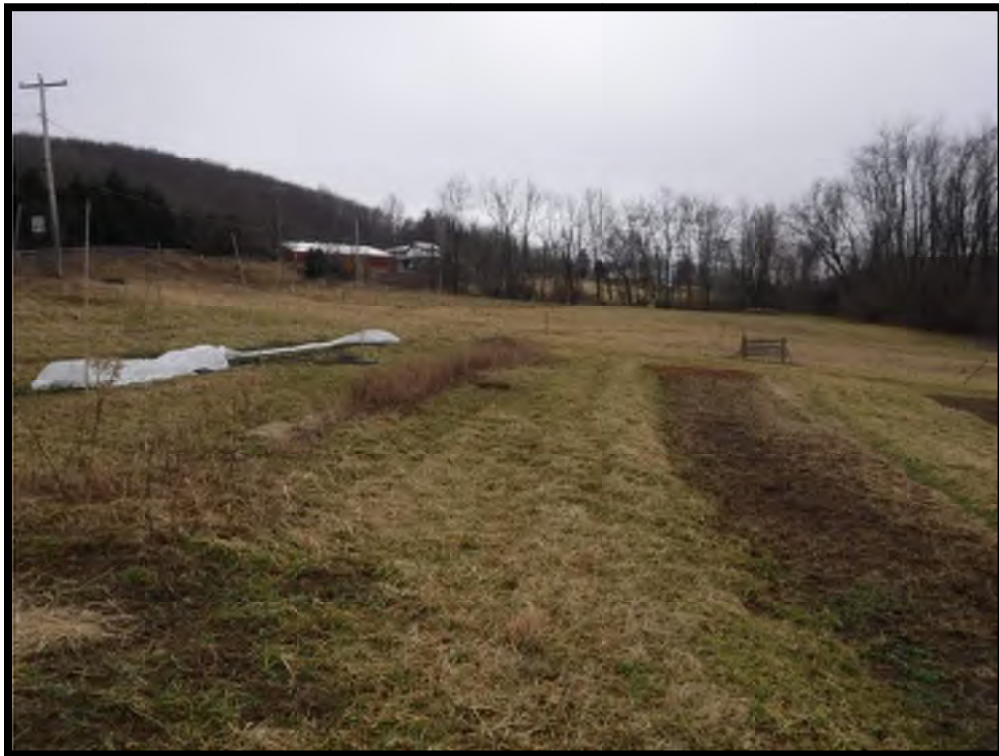
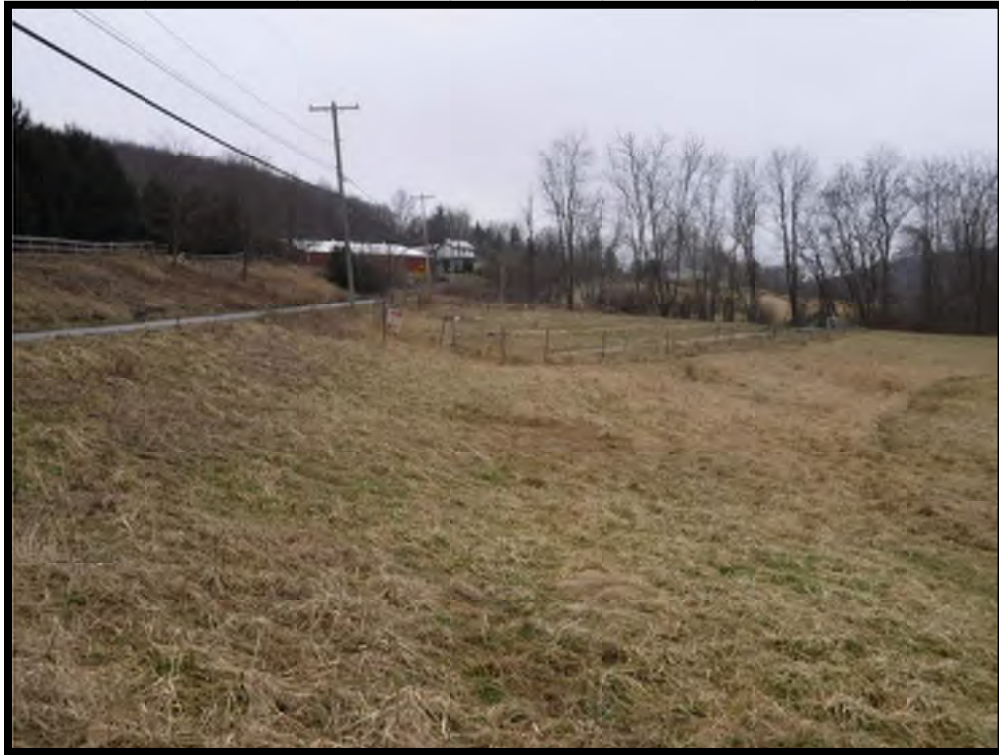
Test Area 8 is located in the southwest quadrant of the intersection of Greenbag Road with Kingwood Pike (see **Figure 16: Sheet 6**). The test area is on a hillslope landform with elevations ranging from 291 to 293 m (927.0 to 1,025.0 ft) above mean sea level. At the time of the survey, vegetation consisted of forested areas with dense underbrush and grassy fields (**Photographs 73-80**). Soils in the test area are mapped as Clarksburg silt loam, 8 to 15 percent slopes (CkC) and 15 to 25 percent slopes (CkD) although all test locations were less than 20 percent slope. The test area is 1.21 ha (2.98 ac) in size. In total, sixty-two (62) STPs were excavated in Test Area 8. The soil profile generally consisted of Ap-Bw-Bt, except at two locations in the test area where an unnamed tributary passes through. At the western extent of the test area in vicinity of the tributary, the soils consist of A-C1-C2 and in the southern extent of the test area in the vicinity of the tributary, the soils consist of AC-BC-C-Cg (**Figure 25**). No pre-contact or historic period cultural materials were identified in Test Area 8.

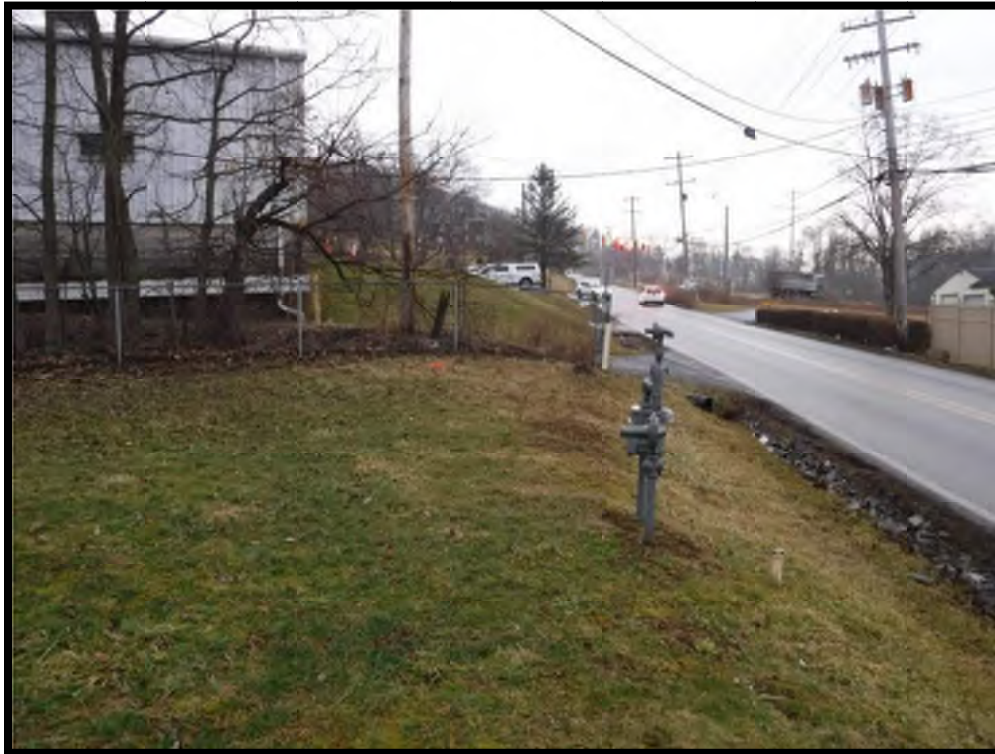
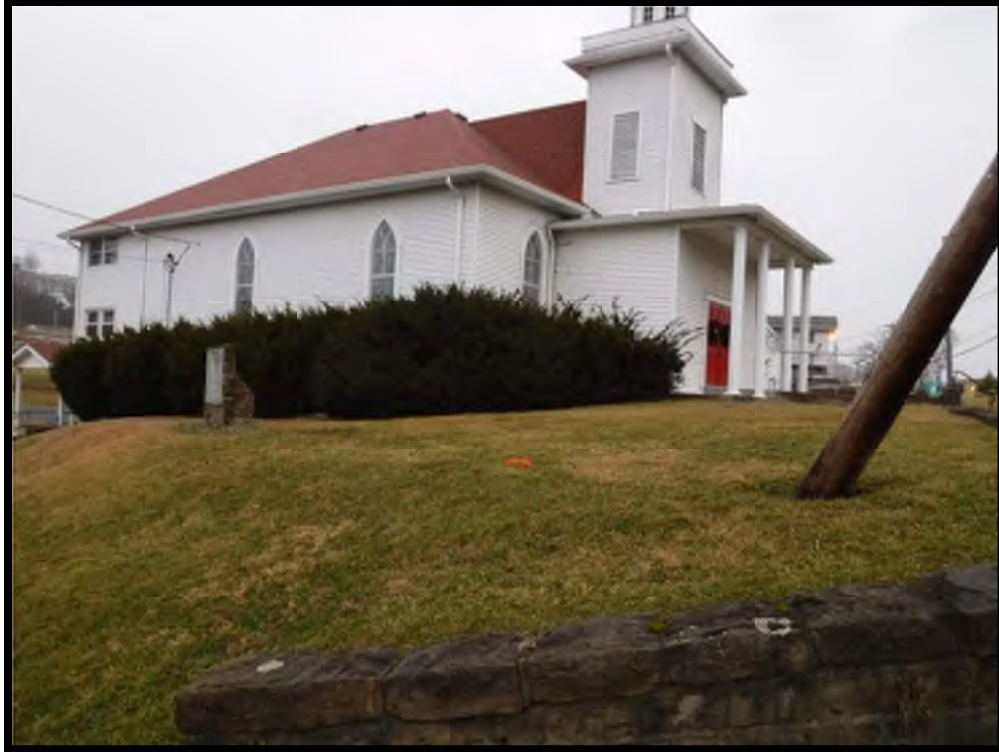
Test Area 9 is located in the northeast quadrant of the intersection of Greenbag Road with Dorsey Avenue (see **Figure 16: Sheet 5**). The test area is on a hillslope landform with elevations ranging from 293.2 to 297.8 m (962.0 to 977.0 ft) above mean sea level. At the time of the survey, vegetation consisted of maintained grassy lawns (**Photographs 81 and 82**). Soils in the test area are mapped as Zoar silt loam, 3 to 8 percent slopes (ZoB). The test area is 0.02 ha (0.05 ac) in size. Two (2) STPs were excavated in Test Area 9. The soil profile consisted of A-Bw-Bg in STP 9A1 (**Figure 26**). STP 9A2 exhibited disturbance from grading and fill. No pre-contact or historic period cultural materials were identified in Test Area 9.

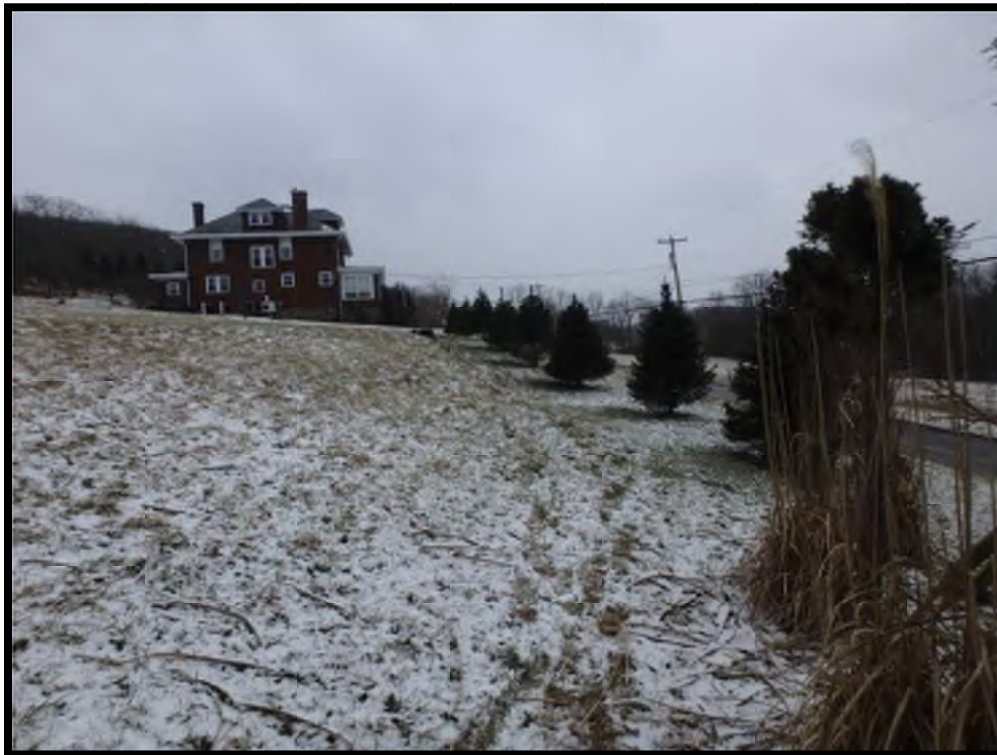
Photograph 83. View of Test Area 10, facing south.

Test Area 10 is located in the southeast quadrant of the intersection of Greenbag Road and Kingwood Pike (see **Figure 16: Sheet 6**). The test area is on a hillslope landform with elevations ranging from 302.4 to 319.1 m (992.0 to 1,047.0 ft) above mean sea level. At the time of the survey, vegetation consisted of a maintained grassy lawn; grassy meadows; and some mature, planted trees (**Photographs 83-87**). Soils in the test area are mapped as Clarksburg silt loam, 8 to 15 percent slopes (CkC) and 15 to 25 percent slopes (CkD). The test area is 0.58 ha (1.44 ac) in size. In total, 30 STPs were excavated in Test Area 10 in areas with less than 20 percent slope. The soil profiles consisted of A-Bw-Bt-Cr and A-Bt-Cr (**Figure 27**). No pre-contact or historic period cultural materials were identified in Test Area 10.
