9000 South

Redwood Road to State Street

1075 W Traffic Signal FAQs

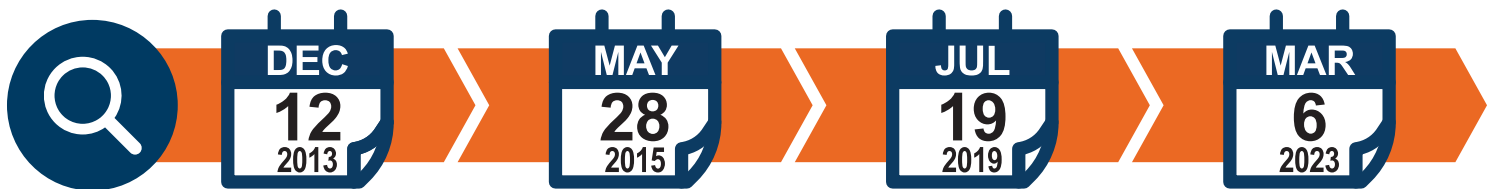
When were the studies UDOT completed at 1075 West?

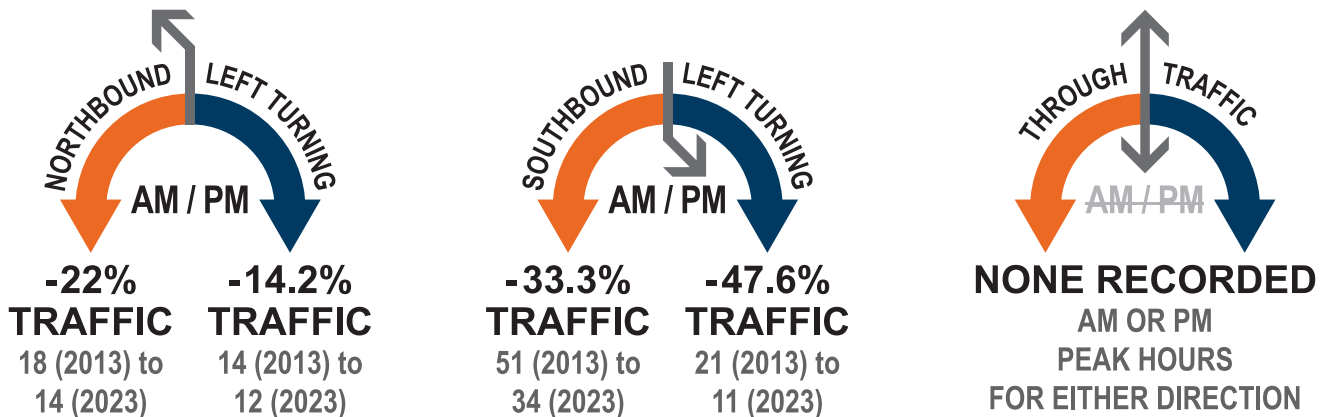
The traffic on 9000 South has seen a decrease of vehicles during morning peak hours of 7.5% (1791 AM Peak EB – 2013, 1655 AM Peak EB – 2023) and a decrease of 6.1% for the afternoon peak hours (1863 PM Peak WB – 2013, 1749 PM Peak WB – 2023).

Based upon the traffic study, traffic on 1075 West would need to increase by 75% to meet Warrant #3 and by more than 100% to meet either Warrant #1 or #2.

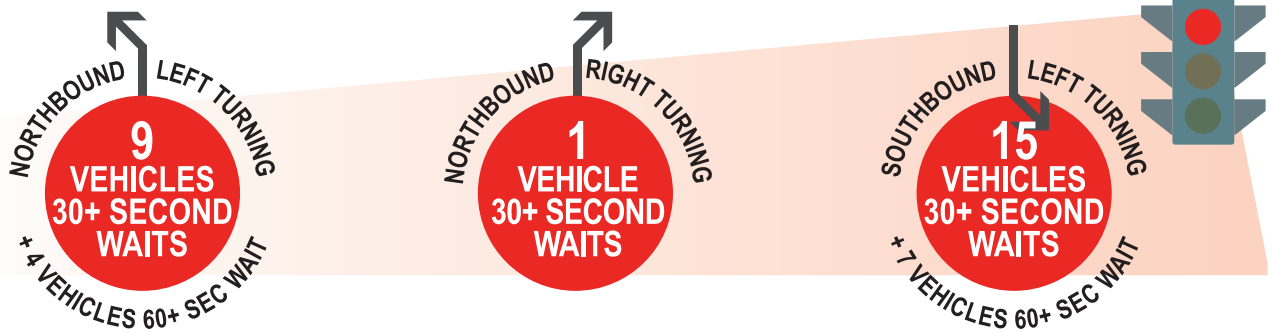
Based upon data from the 2023 study, the average motorist on 1075 West had the following wait times:

The installation of a traffic signal at this location would likely have programming to allow east and west traffic to flow for up to two (2) minutes prior to giving the signal to 1075 West. This would increase the wait time for these vehicles on 1075 West.
